**Spring Bank Conservation Area
Management Plan (South side)**
Draft for Review

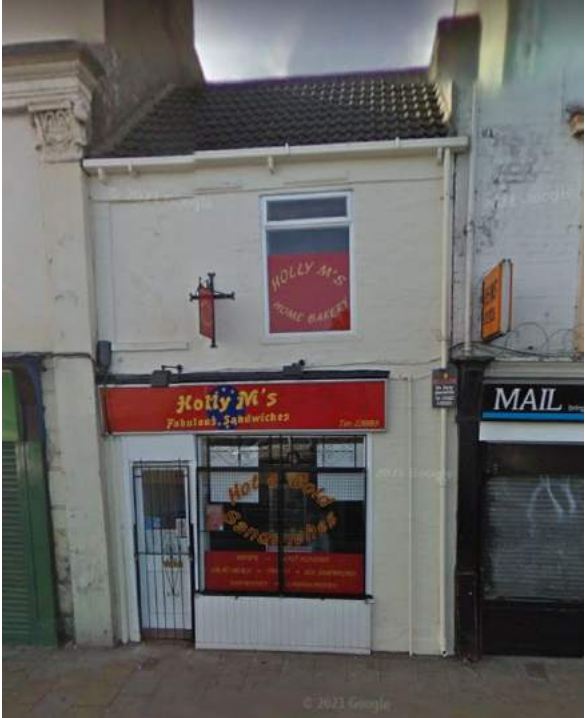
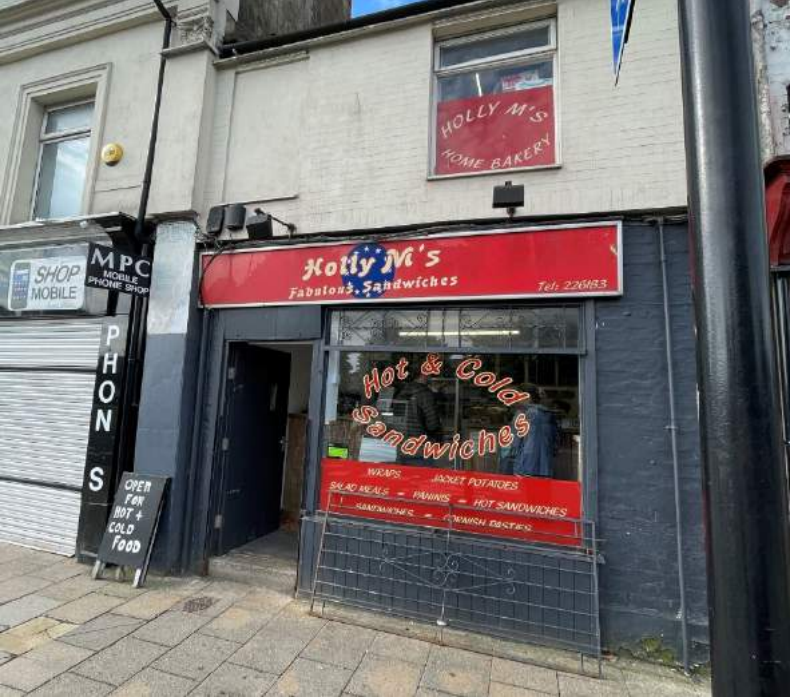
Street: Spring Bank	Address: Holly M's Sandwich shop 21 Spring Bank
Historic Photo from 2009 (Google Maps)	Current Photo – 11.05.2023 (author)

Building Notes	Built pre-1836 as one of the earliest urban blocks developed along Spring Bank featuring the following :- <ul style="list-style-type: none"> • Brickwork external façade, later painted. Soldier course brickwork at first floor level would suggest that the ground floor shopfront has been infilled with part brickwork at a later date. • Decorative cut brickwork detailing to lintels to windows at first floor level still in situ and in good condition. • Modern low quality timber shopfront and entrance door with external security grills. • LHS window boarded up, RHS window modern timber casement window. • uPVC rainwater goods in poor condition and require replacing. • Concrete pantile roof. • Visual clutter including light fittings, conduits and alarm boxes

Monitoring Notes	<ul style="list-style-type: none"> • Rainwater goods are in poor condition. • No works to be undertaken to remove / cause damage to decorative cut brick lintels to first floor windows.

- Removal of the existing shopfront and reinstatement of a more appropriate timber shopfront with pilasters, stall risers, corbel and fascia details.
- Removal of clutter including conduits, alarm boxes, light fittings.
- Strip paint from brickwork throughout and reveal cut brickwork lintel details.
- Remove boarding to LHS window and replace two windows with timber sliding sash windows
- Replacement of concrete pantile roof with slate throughout
- Replacement of rainwater goods with cast iron including concealed downpipe behind shopfront pilaster.

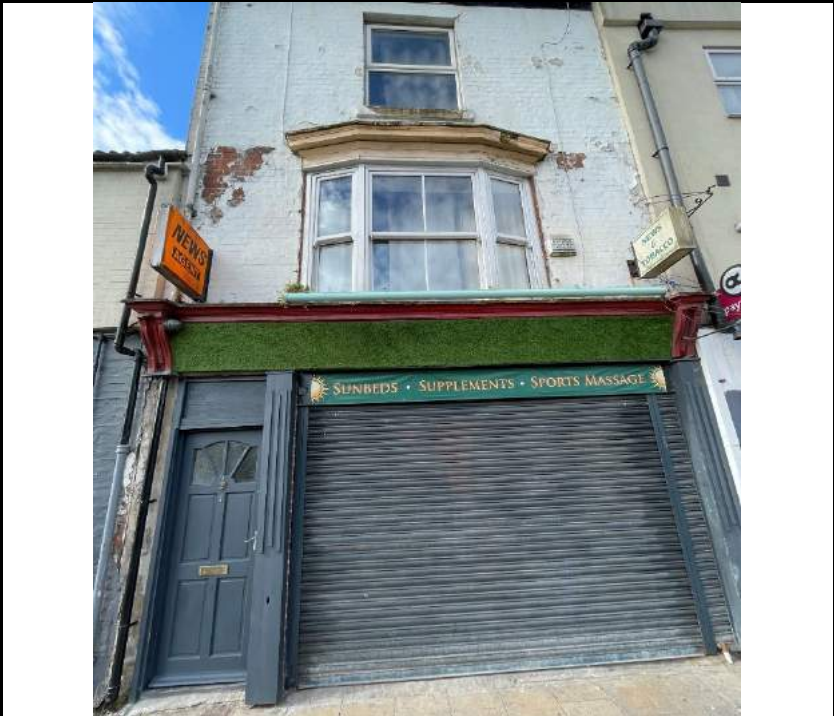
Street:	Spring Bank	Address	Beauty Shop, 23 Spring Bank Hull
Historic Photo from 2009 (Google Maps)		Current Photo – 11.05.2023 (author)

Building Notes	<p>Built pre-1836 as one of the earliest urban blocks developed along Spring Bank featuring the following :-</p> <ul style="list-style-type: none"> • Brickwork external façade, later painted, now peeling from brickwork. • Retained bay window at first floor level (although the timber sash windows have been replaced with new double glazed sash windows). • Timber casement window at second floor level. • Retained the earlier historic fascia, cornice and corbel details. • Historical pilaster details have been replaced to the RHS with low quality box-out. Pilaster to LHS missing. • uPVC rainwater goods in poor condition and require replacing. • Concrete pantile roof. • Visual clutter including light fittings, conduits and alarm boxes

<ul style="list-style-type: none"> • Low quality timber door to the apartment above. • Modern full height metal framed shopfront.
Monitoring Notes	<ul style="list-style-type: none"> • Retained historic fascia, cornice and corbel detail to be protected from removal. • First floor bay window to be protected from removal.
Recommended Actions	<ul style="list-style-type: none"> • Remove external roller shutters • Restore retained fascia and remove fake grass from signage • Reinststate pilasters to each side of shop front • Reinststate historic shopfront design with stall riser detail. • Remove illuminated projecting sign • Remove paint from brickwork and repair/repoint brickwork if required • Replace timber door and reinststate fanlight • Replace uPVC gutters and downpipes with cast iron

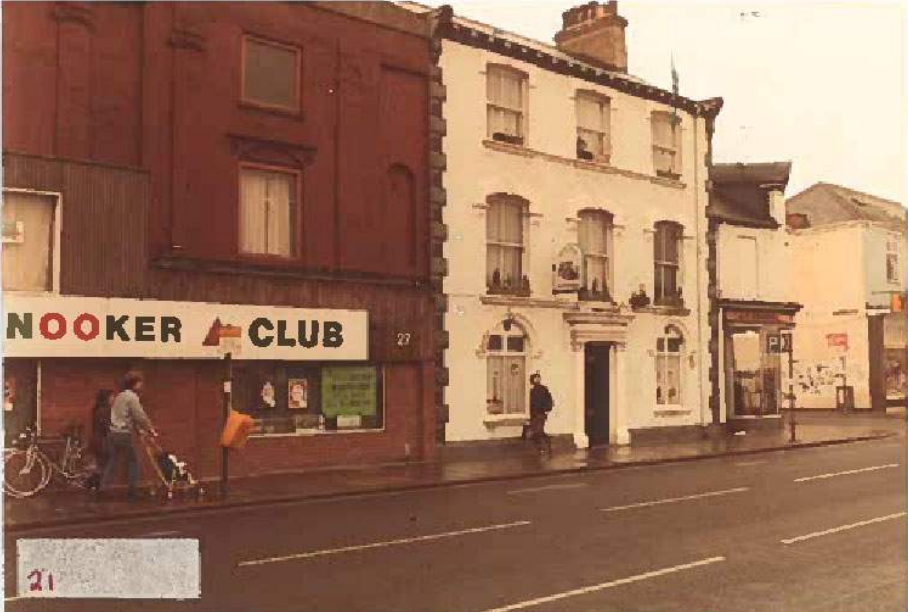
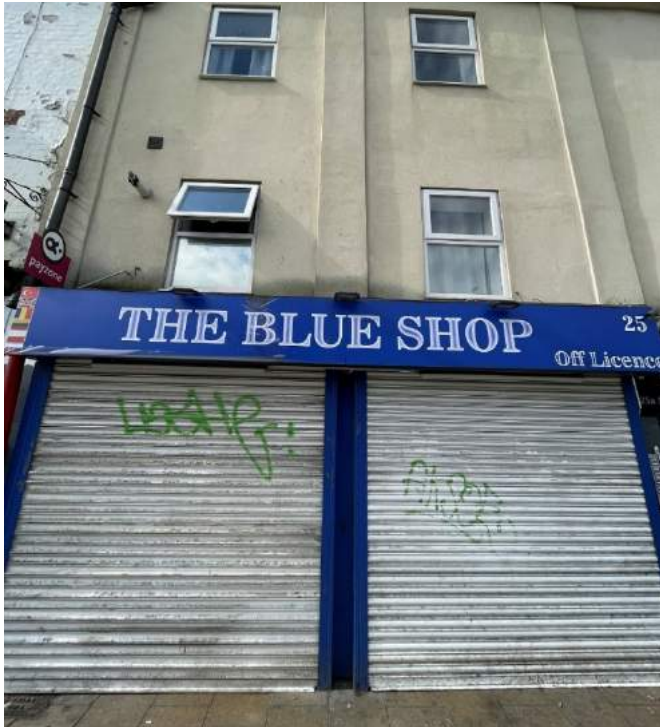
Street:	Spring Bank	Address	The Blue Shop, 25 Spring Bank
Historic Photo 24/11/83		Current Photo – 11.05.2023 (author)

Building Notes	Pre 1893 façade which has been externally insulated and rendered which has concealed any original details including the arched niches, decorative window lintels and decorative Corinthian column heads. Has undergone extensive redevelopment to the rear of the property to form a Snooker Club/Night Club. All timber windows have been replaced with new uPVC casement windows. Does not contribute positively to the Conservation Area in its current condition.		
Monitoring Notes	Shop front negatively contributes to the character of Spring Bank. Removal of external insulation should be encouraged due to harm caused to historic external walls and the concealment of decorative details that would add character to the Conservation Area.		
Recommended Actions	<ul style="list-style-type: none"> • Remove external insulation to reveal historic decorative features. • Replace UPVC windows with timber sash windows. • Remove roller shutters. Remove fascia signage and projecting signage.

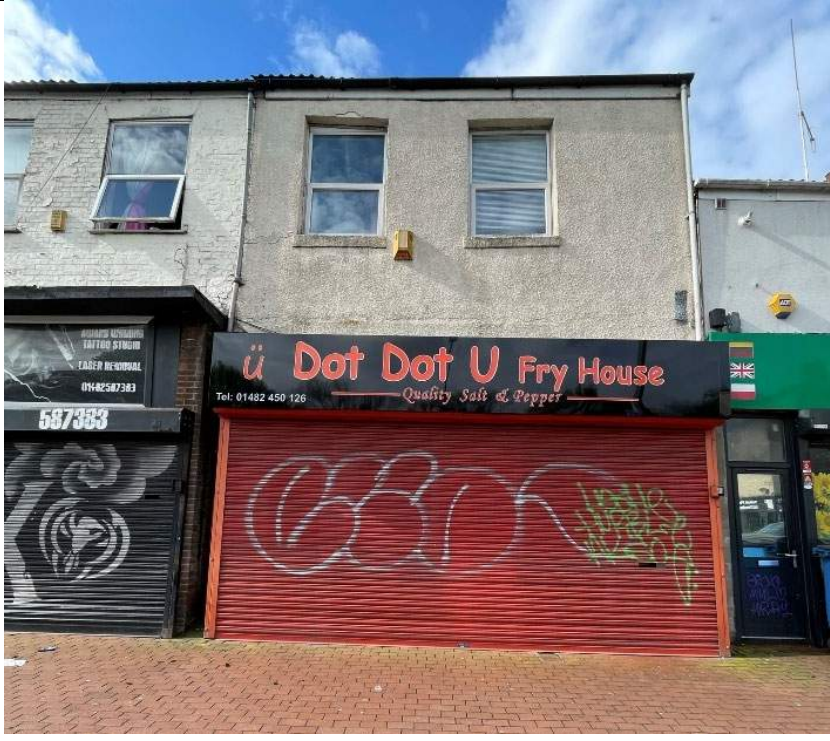
Street:	Spring Bank	Address	Dot Dot U Fry House/ Wins Chinese & English Takeaway, 35
Photo from 2008 (Google maps)		Current Photo – 11/05/2023 (author)

Building Notes	<p>Pre 1856 corner building likely to be built at the same time as the adjacent 33 Spring Bank. Originally built as a dwelling with generous front garden. Later converted to retail use. Building generally of low quality with limited historical features visible. First floor brickwork has been rendered (likely cement render) which is showing signs of cracking due to structural movement. Render has concealed historical features including decorative splayed lintels and stone cills. Render to side elevation above adjacent roof is cracking and dislodging which would suggest moisture is trapped behind the render.</p>

<p>Low quality terracotta concrete pantiles to roof. UPVC gutters and downpipes are low in quality and are sagging, likely due to lack of maintenance and build up of debris. Signs of structural movement with LHS first floor window stone lintel sloping. All first floor windows have been replaced with casement UPVC windows.</p> <p>No evidence of historic shopfront although this may be concealed behind fascia sign. Shopfront has been built out using blockwork which would suggest late 1990's installation. Limited depth of vinyl fascia sign with strip lighting above to full extent of sign. Roller shutter beneath fascia sign.</p>
Monitoring Notes	<p>Structural movement evident and should be investigated and/or monitored. Render to side elevation is dislodging and could cause health and safety risk. Removal of original stone cills and lintels to be avoided as last remaining elements from original design.</p>

Recommended Actions	<ul style="list-style-type: none"> • Cement render removal to first floor level and brickwork repointed and repaired as required. • Remove UPVC windows to first floor level and replace with timber sash. • Replace terracotta concrete pantile roof with slate roof finish. • Replace UPVC gutters and downpipes with cast iron gutters/downpipes. • Remove all redundant cables, alarm boxes, light fittings, etc. • Replace low quality shopfront with new shopfront and remove roller shutter.

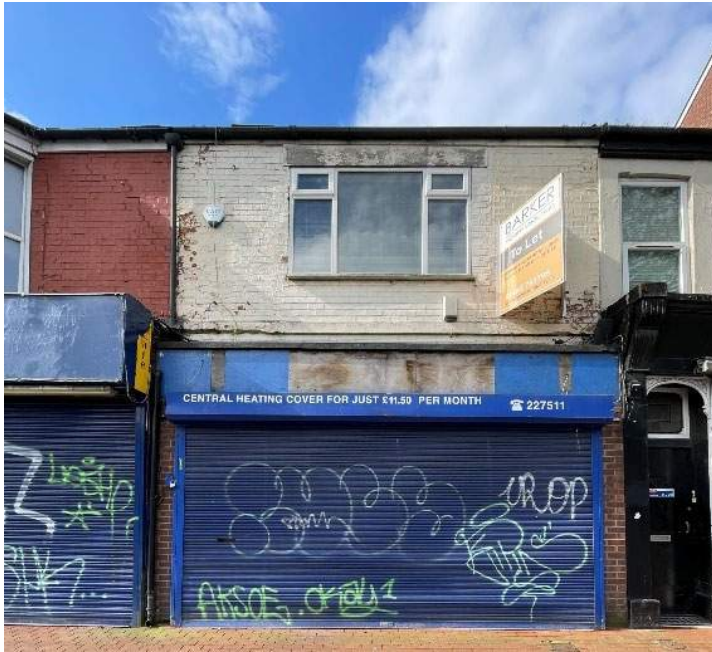
Street:	Spring Bank	Address	VACANT, 43 Spring Bank
Historic Photo from 2008 (Google Maps)		Current Photo – 11/05/2023 (author)

Building Notes	<p>Pre 1856 building, likely built at the same time as the adjacent No 41 Spring Bank. Originally residential use over two floors with generous front garden. Later converted to retail use on the ground floor with residential above. Originally built with bay window to ground and first floor, later removed in its entirety. Poor quality brickwork repairs to infill brickwork below new UPVC window. Brickwork has been painted to conceal brickwork repairs. Poor quality plywood fascia over head of bay window. No evidence of earlier shopfront. In 1987 an application was made to install a new shop front. Late 1990's shopfront comprising of brickwork stallriser and pier with timber framed windows. External roller shutter. Concrete pantile roof with low quality UPVC gutters and rain water goods.</p>

Monitoring Notes	<p>Signs of structural movement in the right-hand corner possibly caused by lack of sufficient structural support following removal of bay window.. Chimney has been reduced in height and rendered.</p>		
Recommended Actions	<ul style="list-style-type: none"> • Remove roller shutter • Remove signage fascia to investigate potential for remnants of earlier shopfront fascia or cornice. • Remove paint from brickwork.

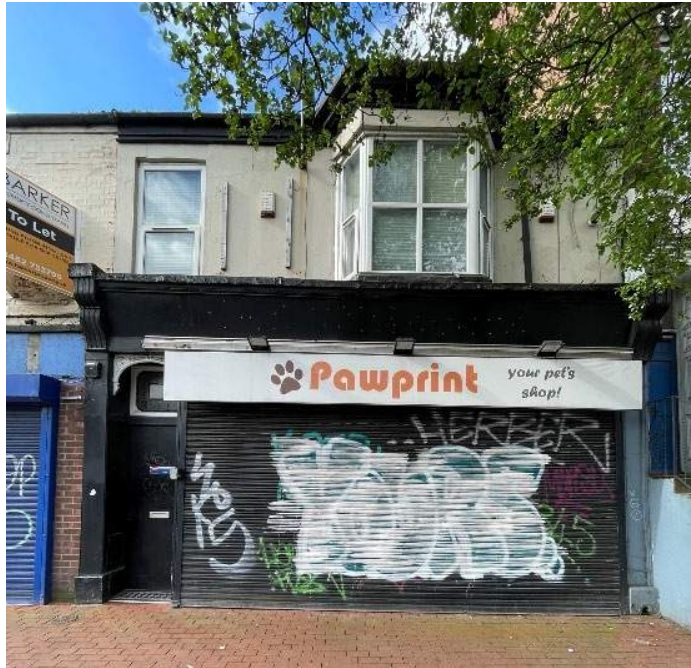
<p>Building Notes</p>	<p>Pre 1856 building, likely built at the same time as the adjacent No 41 and 43 Spring Bank. Original designed as residential property with generous front garden, later converted to retail at ground floor level in the early 1900's/ 1983 photo shows red brick external walls to the first floor level with painted finish, later rendered. Slate roof finish.</p> <p>Original shopfront details including console brackets, cornice, and pilasters with plinths retained. Original stained glass fanlight with corner details, decorative tiled threshold and cast iron archway detail to the original dwelling front door retained. Low quality timber door to first floor apartment. Early 1900's shopfront shown in the 1983 photographs with recessed door has been removed and replaced with new timber shopfront with external roller shutter. Bay window to first floor retained but earlier timber windows replaced with UPVC windows. Traditional awning still in situ.</p>

<p>Monitoring Notes</p>	<p>This shop front is one of the last remaining shopfronts from the early 1900's and should be retained in situ. Stained glass fanlight, tiled threshold and decorative cast iron arched details to be protected from removal.</p>

- Remove roller shutter and signage.
- Remove redundant services, wires and signage.
- Replace front door to first floor apartment.
- External render likely to be cement render. Recommend removal due to risk of render holding moisture within the brickwork.
- Protect the building from the removal of the existing retained historical features outlined above.
- Reinstate historic shopfront design and proportions.

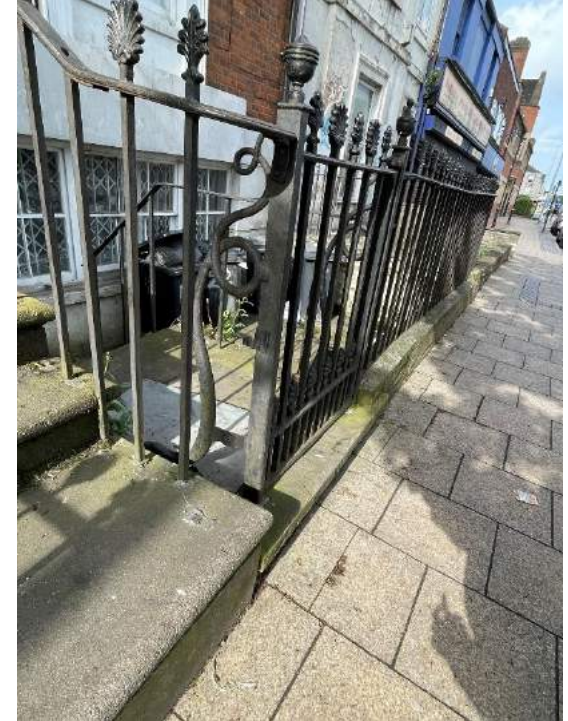
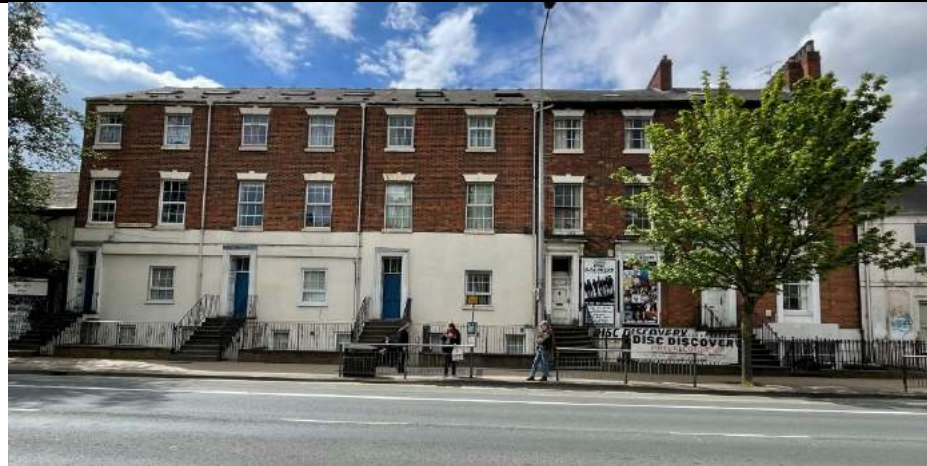
Current Photos – 11/05/2023 (author)

Building Notes	No 53 and 55 were built at a similar/slightly earlier time as the adjacent 47, 49 and 51 Spring Bank and date from C1830. 53 and 55 are Grade II Listed buildings, Listed as a group and form a wider group with No 47,49 and 51, having similar scale, proportions and detailing. Originally designed as grand four storey residential properties with an elevated ground floor reception level, basement service and kitchen accommodation and two floors of bedroom/dressing room areas, these properties still retain their original details and features. The ground and basement levels have been used as retail use with Disc Discovery in No 53 and 55 Antiques at No 55. Retained details include single glazed timber sash windows (to both front and rear elevation), splayed stone lintels and stone cills to all windows, decorative timber architrave and cornice entrance with panelled recessed doorway and panelled door. The original stone steps and iron railings with the decorative serpent support bracket have also been retained. Chimneys and decorative chimney pots still retained.

Monitoring Notes	In reasonable condition but would benefit from some localised repairs. Base of timber architrave to main entrance doors showing signs of decay and would benefit from localised repair to avoid further degradation of original details. Staining and moss growth to the projecting cornice of the entrance doors and ground floor windows would suggest that water is not being shed from the building and could cause increased rate of deterioration.
Recommended Actions	<ul style="list-style-type: none"> • Remove redundant cables, signs, lighting etc • Remove fascia sign to No 55 Basement to reveal original stucco. • Rationalise signage to No 53. • Install/reinstate lead flashing to projecting cornice details to entrance doors and window head. • Redecorate ironwork. • Undertake localised timber repairs to existing sash windows and redecorate. • Repair stonework to steps and low level boundary wall. • Repair stucco where damaged to basement (LHS) of No 53.

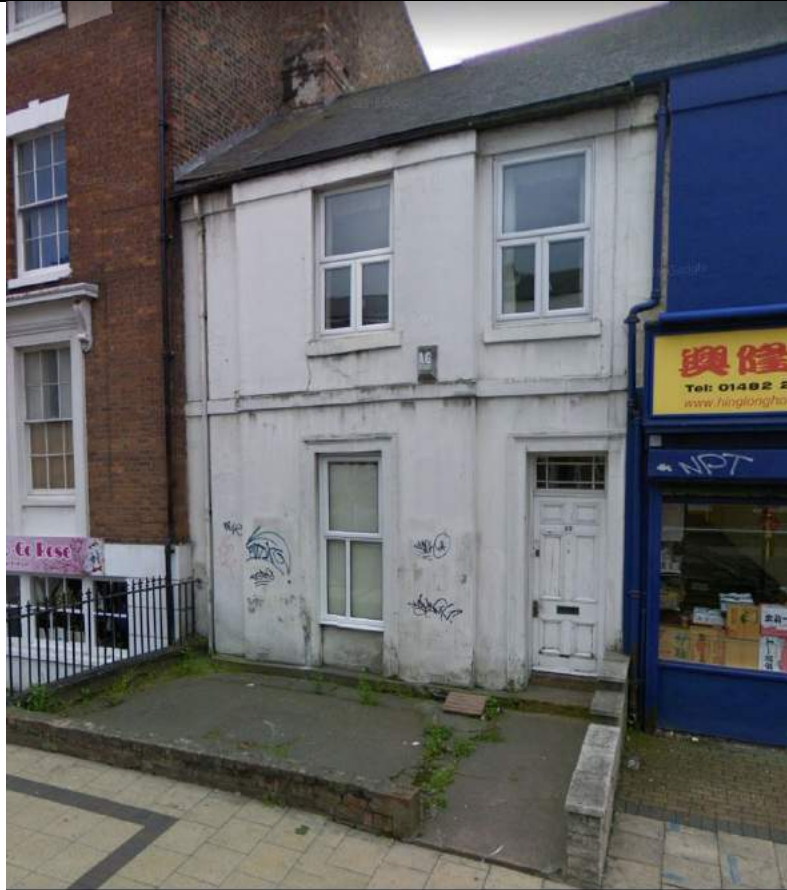
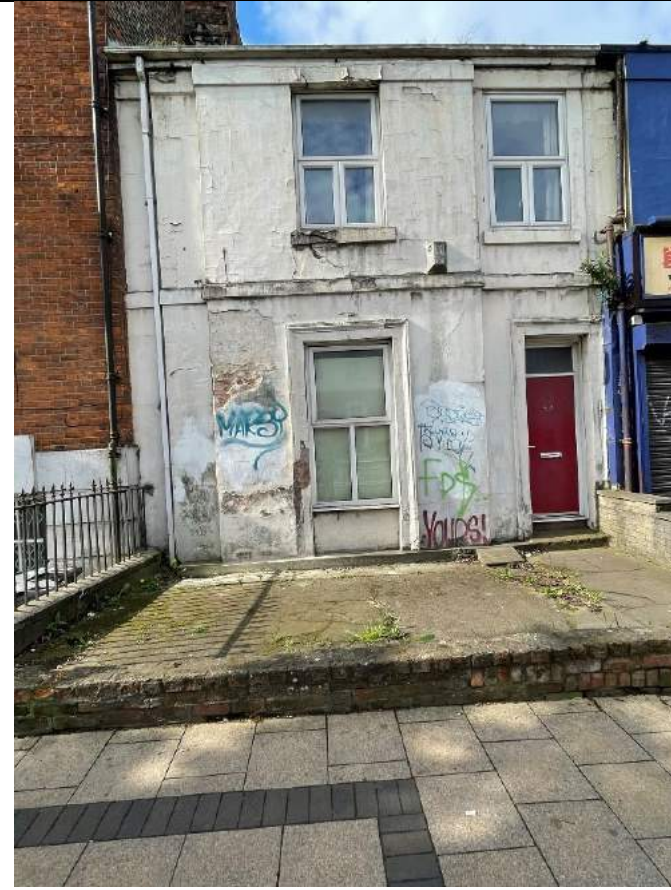
Current Photo – 11/05/2023 (author)

Dating from before 1856, 57 Spring Bank was built as a two storey residential property with a front garden providing privacy from the street. The full height architrave to the ground floor window would suggest that this was originally a full height window or door leading onto the front garden. Slate roof to front of the property with PVC rainwater goods. Roof to the rear of the property is in very poor condition having been extended on multiple occasions using a variety of materials. Later addition rear extensions have led to the substantial loss of the large rear garden to the former residential property. A planning application was submitted and approved in 2004 (Ref. No 04/00952/COU) to convert the building from two apartments into a single dwelling which was approved.

<p>A later application in 2005 (Ref : 05/00263/FULL) to approve the previously installed UPVC windows to the front elevation was refused but the UPVC windows are still retained. The uPVC windows installed without permission are inappropriate in terms of proportion and have a detrimental impact on the overall quality of the building. The 2008 google maps image shows that the original timber panelled door and decorative fanlight which has since been replaced with a new composite/uPVC door and fanlight. The cement render applied in the late 1900's / early 2000's over the original brickwork is now delaminating and cracking substantially, likely to be caused by moisture within the brickwork trapped behind the render. The gutter appears to be blocked and sagging due to a build up of debris which is causing water to accumulate and cause damage to the LHS of the front elevation. The stone window cill to the top LHS window is spalling, likely to be exacerbated by the blocked gutter above. Externally the loss of the railings to the building perimeter and the low quality landscape treatment have a further detrimental impact on the setting of the Conservation Area.</p>

<p>Monitoring Notes</p>	<p>Building at risk of continued degradation if intervention is not undertaken in the short term. Structural movement evident that needs to be monitored. Recommend further investigation of the rear of the property where extended and adapted and appears to be of low quality/dilapidated condition. Removal of later addition extensions to the rear of the property would be supported to allow the creation of a rear garden to the residential property.</p>
<p>Recommended Actions</p>	<ul style="list-style-type: none"> • Remove cement render, undertake brickwork and stonework repairs and either retain brickwork or replace render with lime render system to prevent moisture build up in wall construction. • Remove UPVC windows and replace with new timber sliding sash windows to first floor and new door or full height window to ground floor. • Remove existing PVC rainwater goods and replace with new cast iron gutters and downpipes. • Reinstate timber panelled door and fanlight over to original design. • Reinstate railings to front garden (low level brickwork plinth to be retained and repaired)

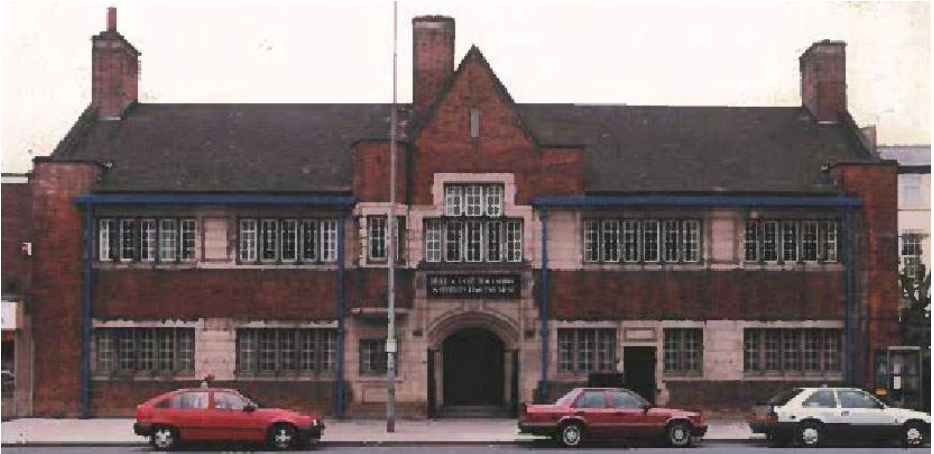
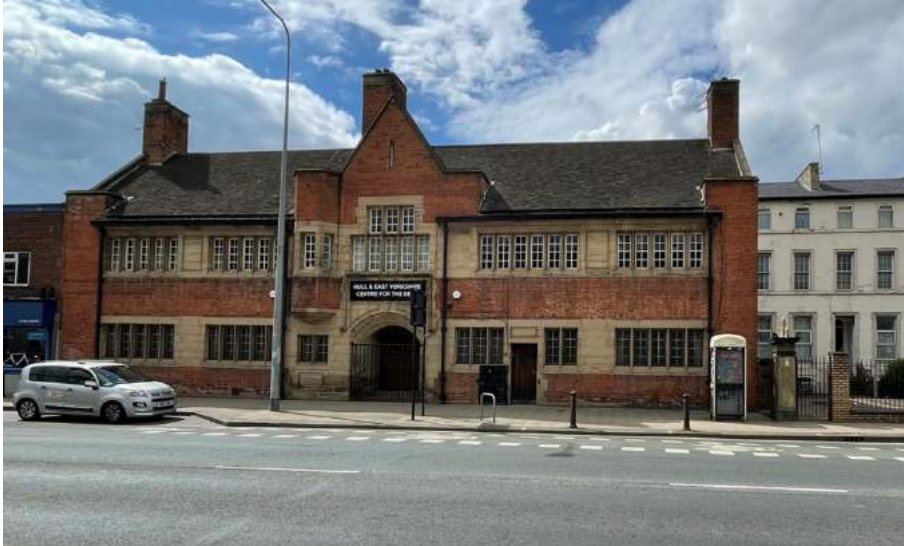
Street: Spring Bank	Address Hull and East Yorkshire Centre for the Deaf
Historic Photos taken 18 05 1995 (by Phil Hampelnell)	Current Photo – 11/05/2023 (author)

Building Notes	<p>The Deaf Institute was established in 1853 in High Street in Hull as a charity to provide support for deaf people to provide an opportunity to meet regularly with other people who communicate using sign language. After the charity continued to grow, they relocated No 53 Spring Bank and bought a plot of land further along Spring Bank at 63 Spring Bank. Following the demolition of the previous properties, the new purpose built Deaf Institute was built and opened in 1926. The architectural style is distinctively Arts & Crafts, with high levels of natural daylight, horizontal proportions and a high level of craftsmanship that is synonymous with the Arts & Crafts style. The building is a locally listed building and retains its original character and details externally.</p>

Monitoring Notes	No issues identified. Building in very good condition and well maintained.
Recommended Actions	No recommendations at this time.
