Muswell Court, Hull

Type 3 Fire Risk Assessment

Prepared for:	Rebecca Franks, Building Safety Manager
Prepared by:	John Askew, Fire Risk Assessor, Holistic Fire Safety
Date:	12/09/2025
Document Reference:	HFS.HCC.MuswellCourt.FRA.3.0

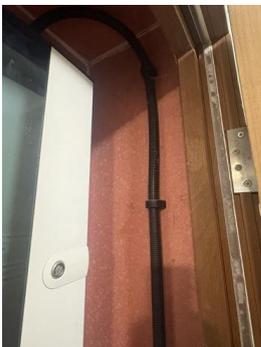
Photo 25

The mains electrical feed is located at the foot of the stair in a partially compartmented enclosure. Boards are mounted on MDF (combustible substrate), services penetrate MDF which could lead to uncontrolled fire spread and there are defects related to fire doors which enclose the area. Given its location at the foot of the single escape stair, it's strongly advised that a complete review of how the area is controlled is undertaken.

This should determine the requirement or not for air transfer grills located within doors to the enclosure which do not appear to be intumescent.

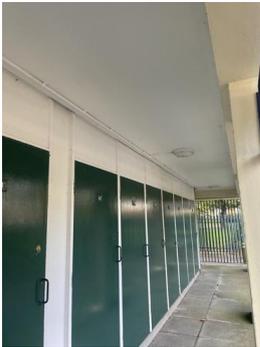
Photo 48

It has been confirmed the insulation present is flammable and should be removed. Any replacement should achieve Class A2-s1, d0 or better.

HCC have requested a replacement design from BDS through the Project Management Office (PMO) and are awaiting a response.

Remove insulation in areas on the ground floor. Any replacement should achieve Class A2-s1, d0 or better.

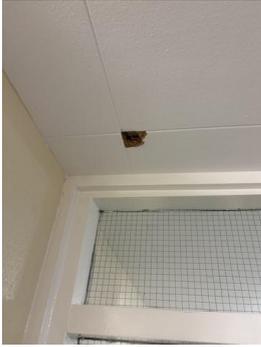
Photo 51

Ceilings within escape routes, however, are lined with ceiling tiles which are suspected to be of a combustible nature. Although there is a concrete slab which separates floors, should tiles be subjected to ignition, it is foreseeable that they would contribute towards fire growth; as a result, tiles should be removed throughout all areas.

HCC have requested a replacement design from BDS through the Project Management Office (PMO) and are awaiting a response.

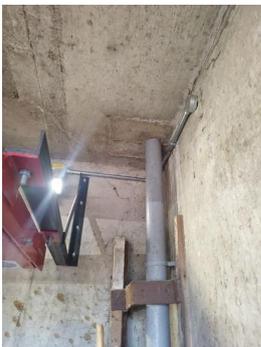
Photo 59

Large sections of what appear to be plywood boards, which make up the curtain walling, are located within the refuse areas to the south side of the building. It is unknown what is behind the boarding although it is suspected to be the lift shaft. HCC representatives believe there are voids behind the boarding therefore, it is advised to carry out intrusive investigation to determine if there are breaches to lines of compartmentation which would allow the passage of heat and smoke.

A significant breach in compartmentation was observed to head of the dry riser on the 16th floor. As this is open to the lift motor room, emergency fire stopping works should be carried out to compartmentalise and enclose this area.

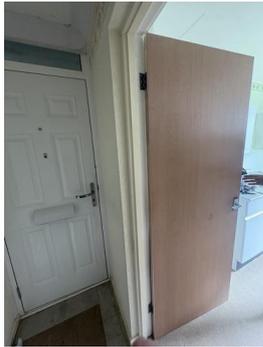
Photo 71

However, although travel distances in one bed flats do not exceed 9m, flats do not comply with diagram 3.3 of ADB B1 as the kitchen is located on the escape route next to the flat entrance door. The kitchen doors in the sampled flats were observed to be a mixture of 35mm nominal doors or egg box carton type doors fitted with two 75mm non-fire-rated hinges and no intumescent strips or cold smoke seals.

A survey of kitchen doors in one bed flats should be undertaken to identify doors that do not meet a minimum of E20 fire resistance and replaced where this is not achieved.

Undertake a survey of kitchen doors to identify doors that do not meet a minimum of E20 fire resistance and replace where this is not achieved.

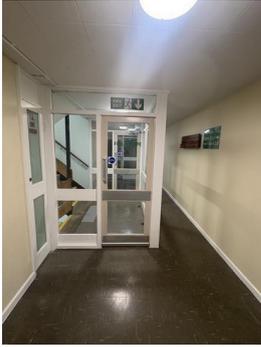
Photo 79

It has been mutually agreed that stairwell fire doors cannot be left in their current status as residents are unable to use them as the closing device is fighting against the floor springs/pivot hinges. If closing device are removed, doors do not close flush within their rebate as pivot hinges are defective.

- Remove the existing fire door leaf and dispose
- Remove the floor springs in the floor, fill the void left, use self levelling compound and reinstall the floor plate for aesthetics
- Carry out repairs by splicing a section of hardwood to fill the void left by pivot hinge
- Install a new certificated fire door leaf within the existing frame + compatible ironmongery
- Carry out the necessary adjustments to get perimeter gaps as close to tolerance as possible (4mm)

As detailed within the attached statement, these are not certified repairs, but they are applying the principle of betterment and making current provisions usable for residents within the block whilst upgrading fire safety provisions until wholesale replacements can be carried out through the gateway process.

Refer to document MCFDRS.01 - Statement on the Condition and Remedial Strategy for Fire Doors at Muswell Court.

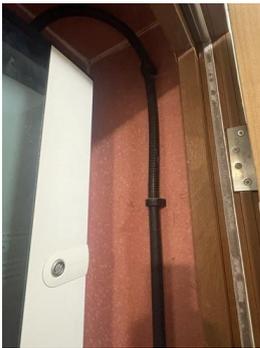
Photo 25

The mains electrical feed is located at the foot of the stair in a partially compartmented enclosure. Boards are mounted on MDF (combustible substrate), services penetrate MDF which could lead to uncontrolled fire spread and there are defects related to fire doors which enclose the area. Given its location at the foot of the single escape stair, it's strongly advised that a complete review of how the area is controlled is undertaken.

This should determine the requirement or not for air transfer grills located within doors to the enclosure which do not appear to be intumescent.

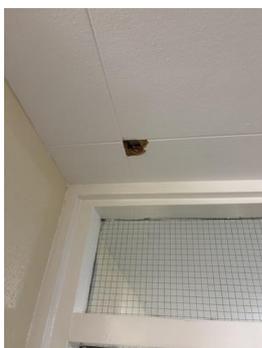
Photo 51

Ceilings within escape routes, however, are lined with ceiling tiles which are suspected to be of a combustible nature. Although there is a concrete slab which separates floors, should tiles be subjected to ignition, it is foreseeable that they would contribute towards fire growth; as a result, tiles should be removed throughout all areas.

HCC have requested a replacement design from BDS through the Project Management Office (PMO) and are awaiting a response.

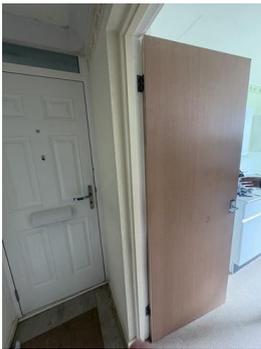
Photo 71

However, although travel distances in one bed flats do not exceed 9m, flats do not comply with diagram 3.3 of ADB B1 as the kitchen is located on the escape route next to the flat entrance door. The kitchen doors in the sampled flats were observed to be a mixture of 35mm nominal doors or egg box carton type doors fitted with two 75mm non-fire-rated hinges and no intumescent strips or cold smoke seals.

A survey of kitchen doors in one bed flats should be undertaken to identify doors that do not meet a minimum of E20 fire resistance and replaced where this is not achieved.

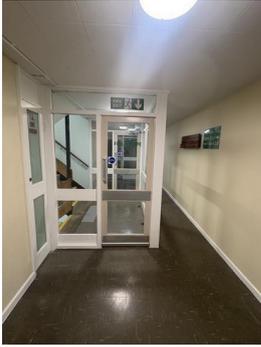
Photo 79

As detailed within the attached statement, these are not certified repairs, but they are applying the principle of betterment and making current provisions usable for residents within the block whilst upgrading fire safety provisions until wholesale replacements can be carried out through the gateway process.

Refer to document MCFDRS.01 - Statement on the Condition and Remedial Strategy for Fire Doors at Muswell Court.

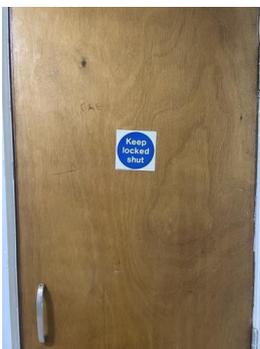
Photo 124

Ancillary room doors were observed to be missing appropriate fire safety signage e.g. 'Fire door, keep locked' 'Fire door, keep shut'.
