**Avenues and  
Pearson Park  
Conservation Area  
Character  
Appraisals**

# Character Appraisal 2: Pearson Park

Published 2015

Published by Hull City Council, Kingston upon Hull, UK

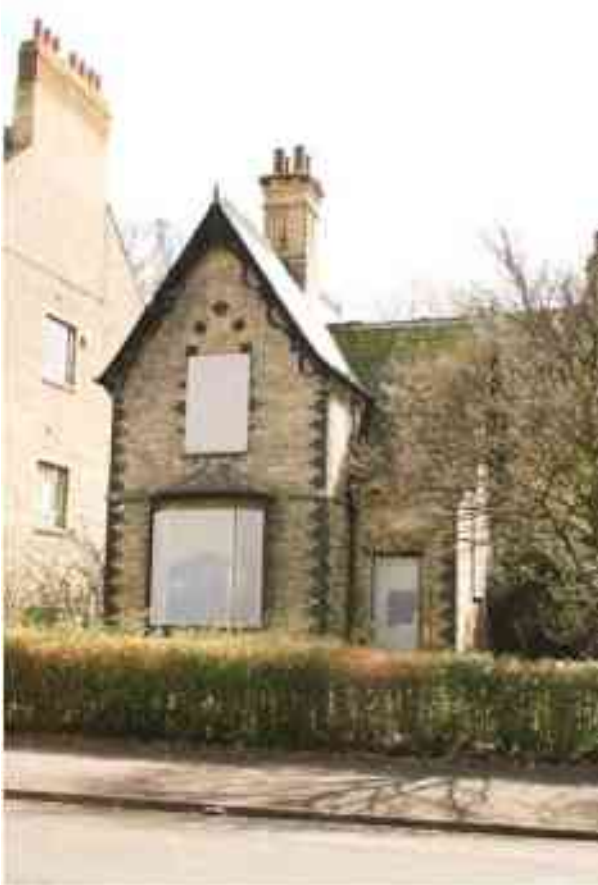
**Figure 45** No.1 front angle

- 7.1.4.2 The ornate ridge tiles are mostly damaged or missing and the state of the windows cannot be seen due to the anti-vandalism screens. However, the decorative barge-boards are still in place, as is the patterned slate roof and contrasting black brick quoins. The lodge is Victorian Gothic, as the top window suggests, with patterned brickwork creating the high arch, and a ground floor bay window in stone. The garden is important to this house and, if restored, the house would be a fitting balance to the open corner. Entering the park through the gates, this openness is a gentle introduction, enabling an appreciation of the size of the park and scale of the trees.

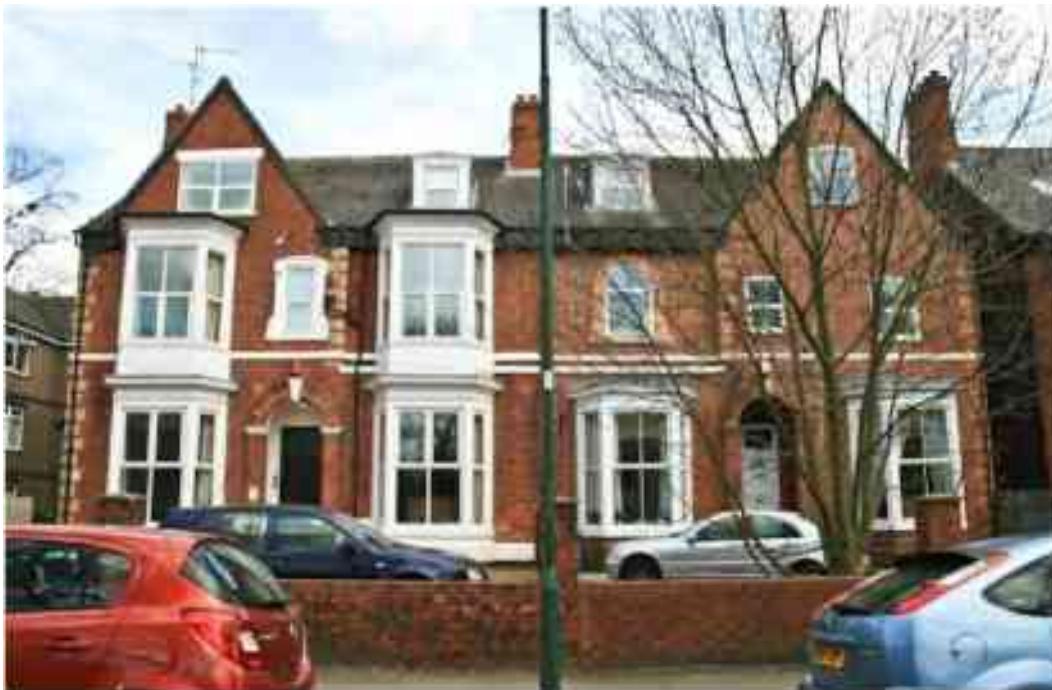
**Figure 49** Nos. 6 & 7 front

7.1.8.1 These houses are in semi-detached form and have been significantly altered in the last ten years. No.7 was rebuilt in 2000 following fire damage. The symmetry and sense of proportion that once existed between the two villas is evident only from a distance, with few features retaining the original specifications. No. 6 retains two sets of bay windows on both ground and first floor, whereas those on the first floor of No. 7 were not reinstated. The original sliding sashes have been replaced with top-hinged windows in UPVC. The replacement second floor windows increase the loss of visual unity. The brickwork of the arched doorways and ornate stonework are vital to the integrity of this pair of houses.

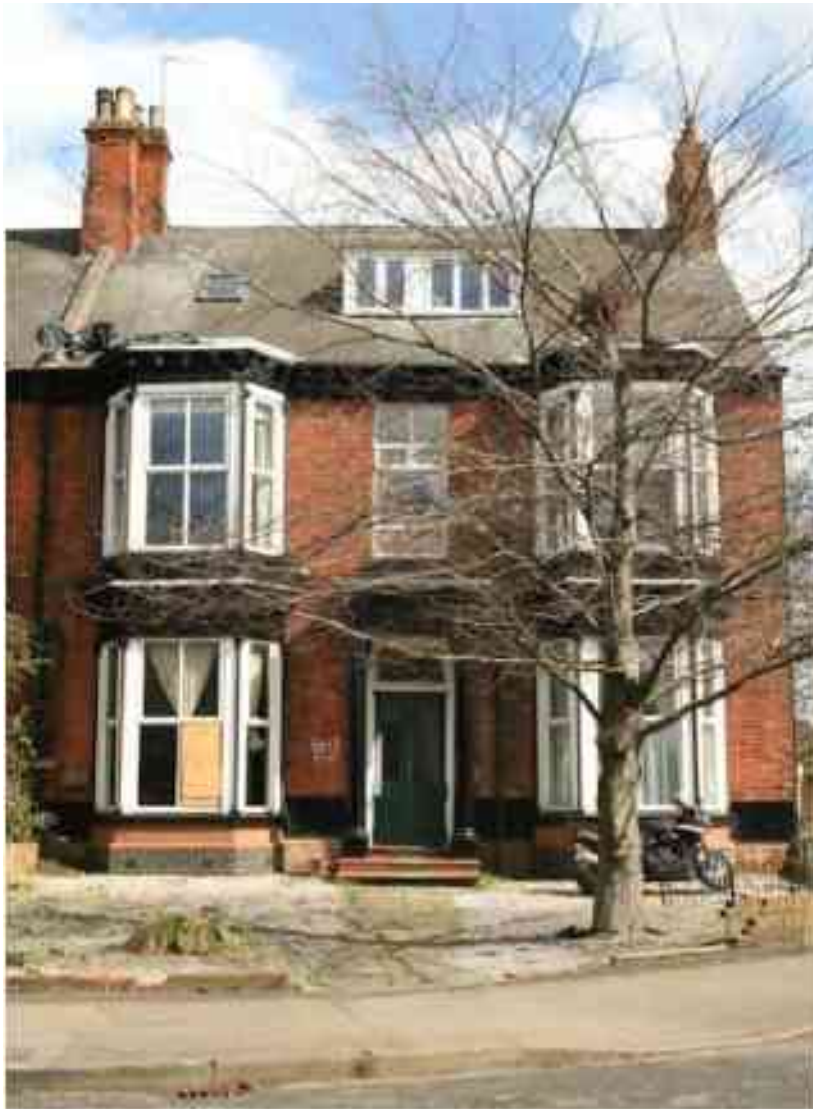
**Figure 53** No. 9 front

7.1.11.2 The timber window frames and casement windows on the tall bays have been removed and replaced with UPVC frames and top-hinged windows. Some attempt has been made to replicate the mullion dividers, topped with original ornate capitals - matching the sister house at No. 8 - but the dividers are now plastic instead of timber.

7.1.11.3 The missing conical roofs from top of the bay windows create disharmony with its sister house. The additional window at ground level in the side elevation and the cementing over of an original arched attic window are unwelcome changes.

7.1.11.4 The Velux and dormer windows, together with the unattractively modernised window above the front door and replacement PVC gutters (instead of traditional substantial timber ones) are not in character. However, the ornate capitals atop the door columns, chimney pots (shared with No. 8), carved timber fascia boards with large gutter blocks, and original doors can be appreciated due to the open frontage, which could be improved by the planting of a low hedge.

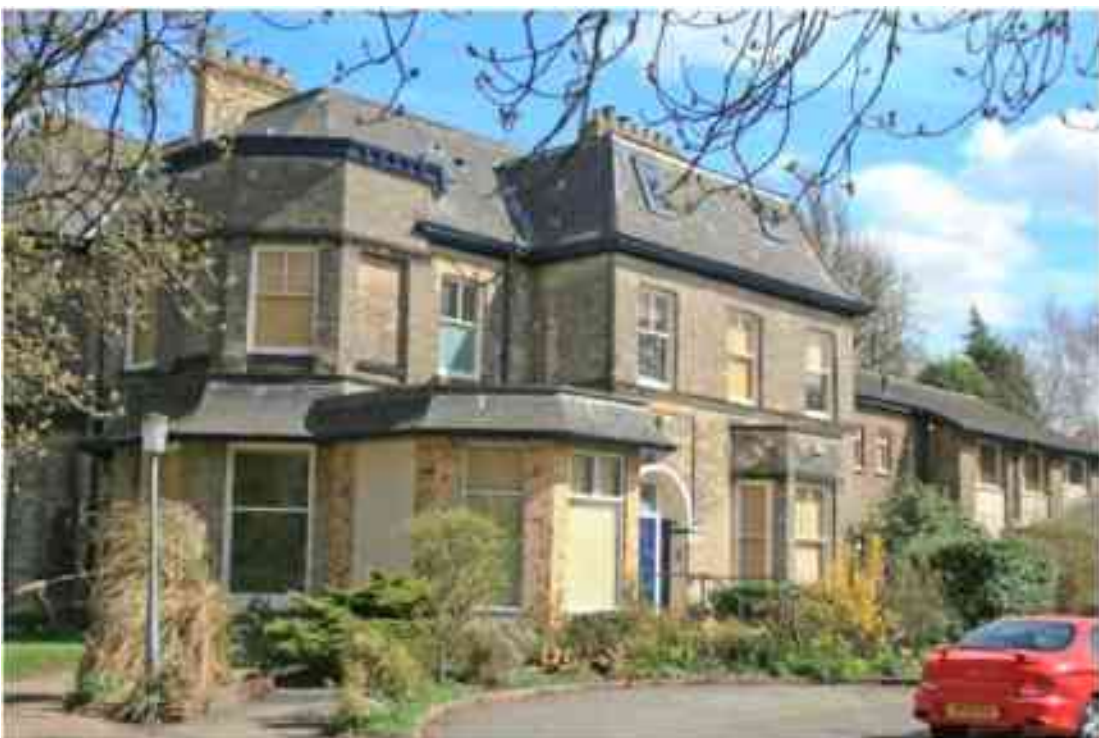
**Figure 81** No. 35 side

7.2.10.1 Made from smooth buff-grey brick with a slate roof and timber windows. The projecting left-hand side of the building is a strong semi-hexagonal design with simple three-pane sash windows to the first floor. The ground floor windows are particularly noteworthy: they have kept their unusual frames with carved mullions and curved corners. The hexagonal design is repeated on the corner facing the entrance to the house, with the downstairs bay emphasising this with sprocketed eaves and slate tiling. In creating an extension, protruding from the bay and reaching to the front door, care has been taken to recreate the hexagonal shape but the result disrupts the form of the original design and appears confusing.

7.2.10.2 Velux windows punctuating the slate roof, blocked-up windows, appendages to the front door for accessibility, the modern extension to the rear – but visible from the entrance - and the car park which replaces the original landscaping all detract from the original character. Worthy of note are the timber fascias with dentil detailing in places, the window frames, original chimneys with dentilated brickwork and traditional-style downpipes.

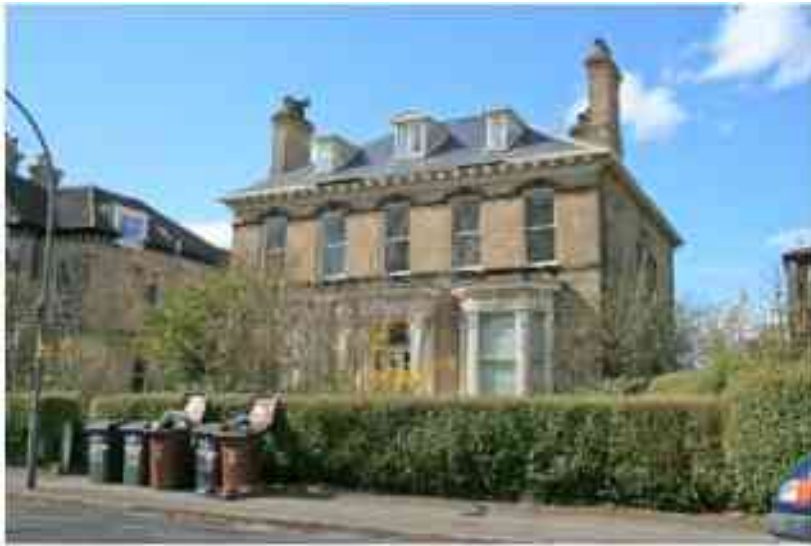
**Figure 104 No. 43 angle**

- 7.4.6.5 Sadly there are features in a state of neglect: deteriorating stonework above both bay windows, and large portions of the gutter at the front are missing or decaying which, if not rectified, will cause substantial damage to the fabric of the building.
- 7.4.6.6 However, the sash windows look to be intact and the front path remains as flagstones, probably from when it was built, giving the dwelling a sense of place within its surroundings. The PVC downpipe and satellite dish to the left of the house are unattractive. Several bins are kept on the pavement: a disadvantage of houses in multiple occupation is the number of bins required for each flat.

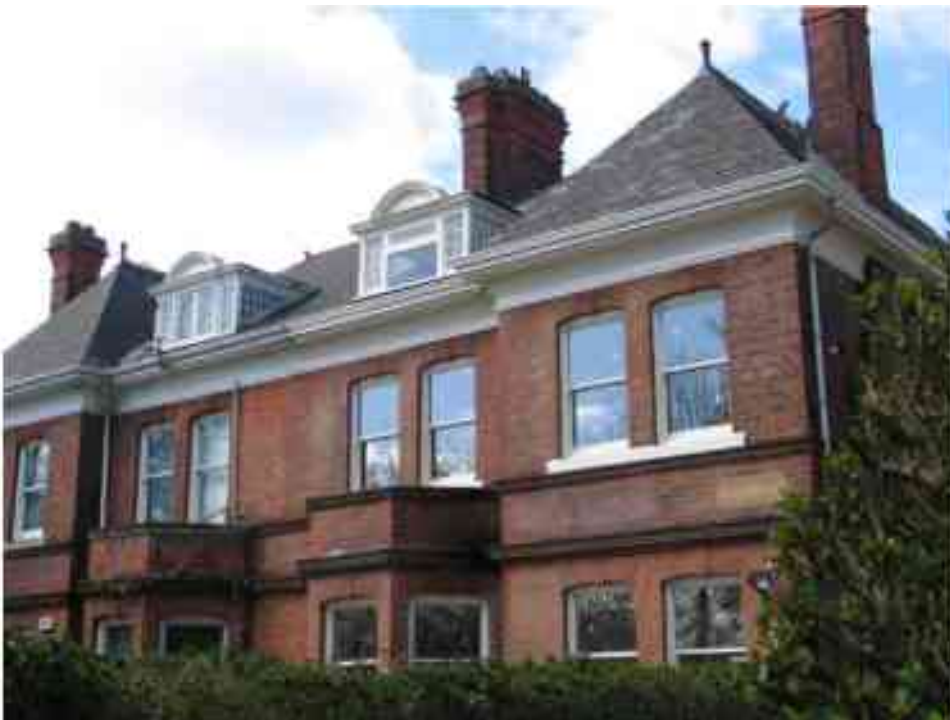
**Figure 114 No. 49 angle with replacement double-glazed timber sash windows**

7.4.10.3 The state of repair of this dwelling was cause for concern: timber window frames were clearly rotting. However, the beautifully ornate timber porch to the side was still intact. Update: *Beechwood* has recently been sold and is undergoing refurbishment and conversion to flats.

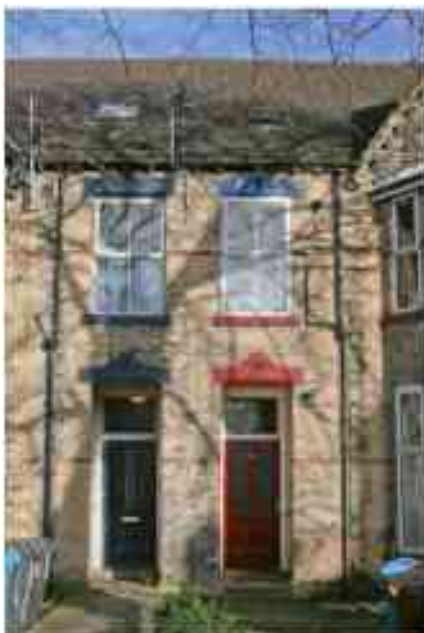
**Figure 141 Nos. 62 & 63 front doors**

7.4.19.2 Each has lost its original slate roof and had a Velux-style window implanted in its roof, located roughly above the front entrance. Nos. 62 to 64 also have a replacement finish to their bay window roofs: felt and bitumen, rather than lead which is seen on No. 65 and is likely to be the original material used. No. 64 & 65 have finials atop their gable: both appear to be replacing the originals.

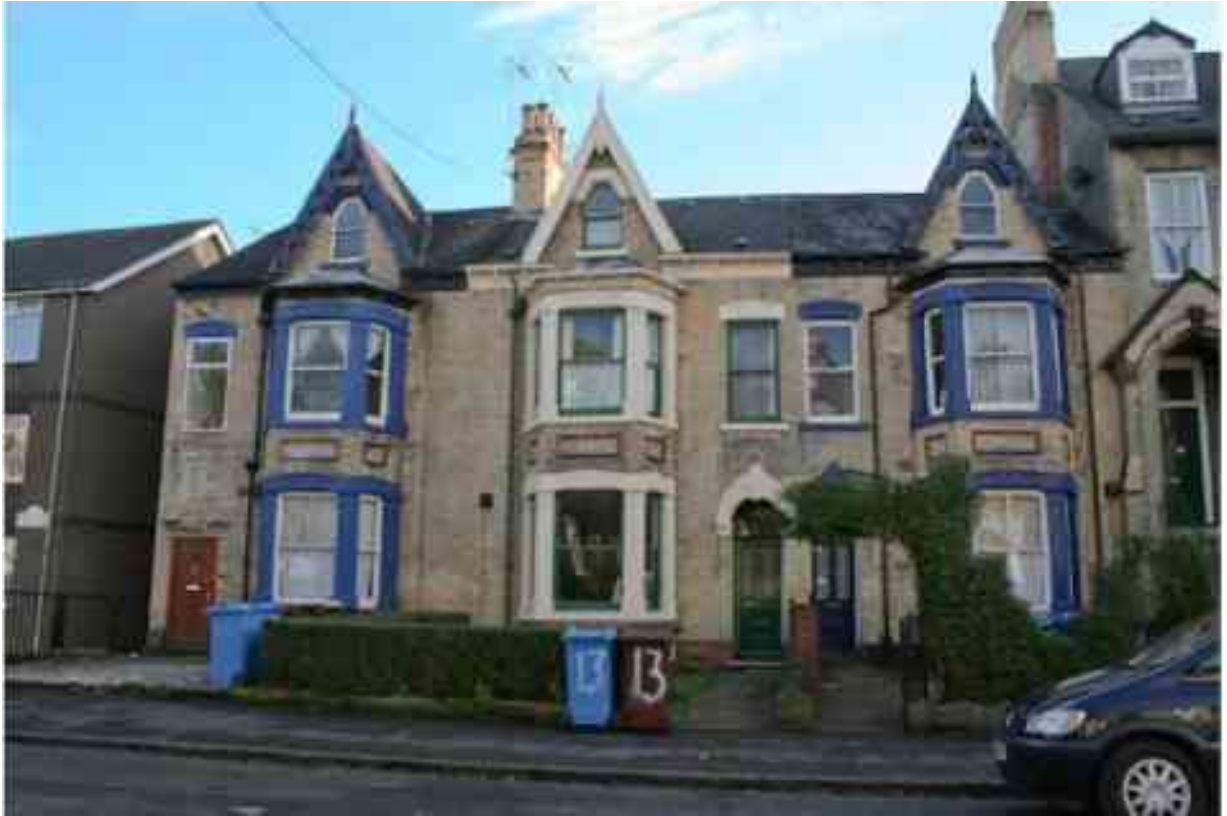
**Figure 165 Nos. 11 to 15 Pearson Ave**

7.5.5.1 Three adjoining two-storey properties with ground and first floor bay windows below gables encompassing rectangular windows with bevelled top corners. All three bays retain the traditional roofing material of lead, and finials remain on all three gables. The diamond-shaped relief on the timber fascia boards is repeated on the front doors, except in the case of No. 11 which has lost part of its fascia board and original front door.
