Broadway Conservation Area Character Appraisal

Conservation Area Character Appraisal

- 2.1 Broadway conservation area was designated in March 1994. It is located approximately 2.5 miles (4.1 km) north-east of Hull City centre (just off Holderness Road). The conservation area covers 3.57 ha (c. 8.84 acres) and contains 80 dwelling houses and 1 community building. At the time of writing, none of the buildings is statutory or locally listed.

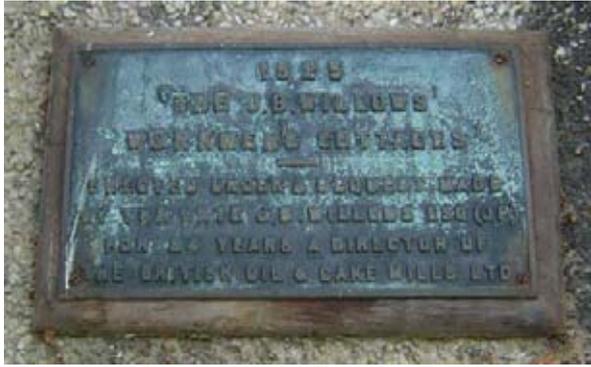
Photo 4: Bronze plaque, The J.B.Willows' workmen's cottages.

- 3.5 Development after this first phase was slow. More houses were added to the Garden Village along Willows Avenue in 1925, after a bequest of £10,000 by the late Mr J.B.Willows (a director of the BOCM) was left to assist in building. The street bears his name, and one of the 18 half-timbered houses built along it was affixed with a bronze plaque (photo 4):

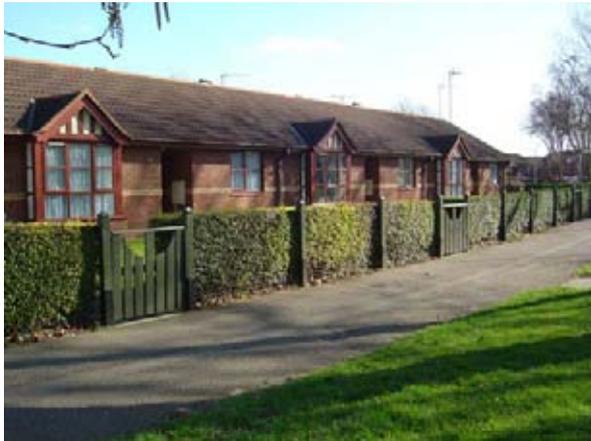
Photo 5: Bungalows on the north side of The Broadway.

- 3.9 In the early 1990s the 'prefabs' were cleared and replaced by bungalows and sheltered housing. The bungalows on the north side of The Broadway (outside the conservation area) are of this period of construction. Although outside the conservation area, they provide a sympathetic and complementary backdrop by virtue of their subordinate scale, subtle Vernacular style, and soft gardens and boundary treatment (photo 5).

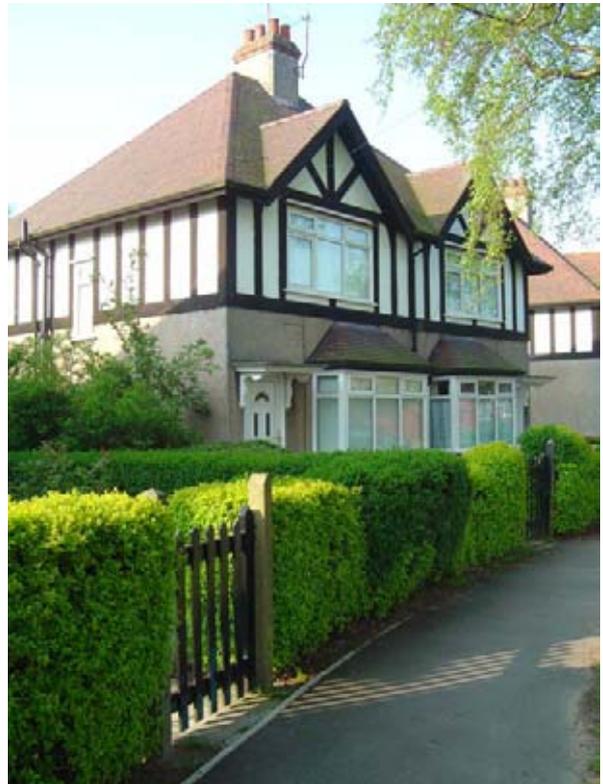
Photo 8: Typical inter-war housing with soft front gardens, privet boundary hedges and wooden garden gates.

- soft front gardens, boundary hedges (typically privet) with wooden garden gates (photo 8);
 - grass verges and open spaces; and
 - tree-lined streets.

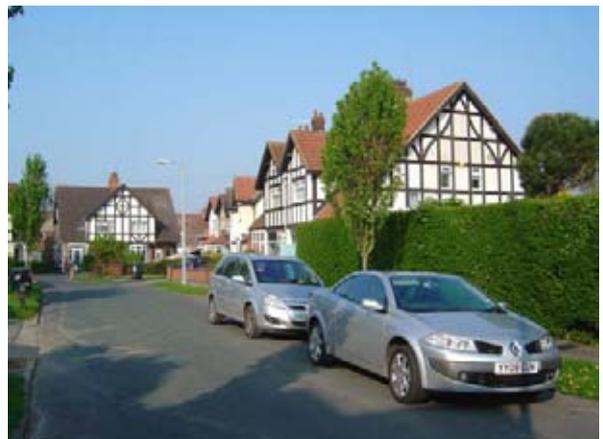
Photo 9: Half-timbered 2-storey semis with steep gabled roofs and dormers.

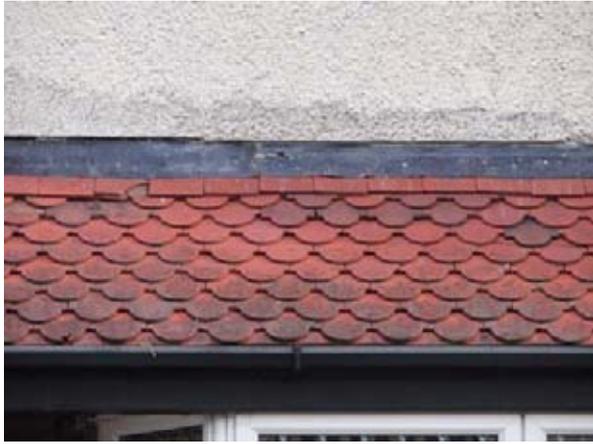
Photo 10: Ornamental 'club' tiles.

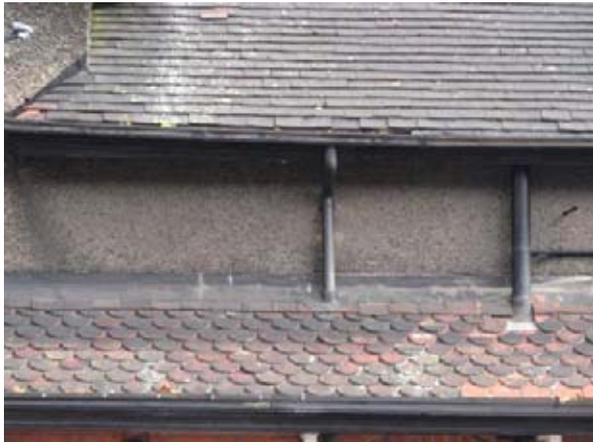
Photo 11: Plain tiles (top) and ornamental 'bullnose' tiles (bottom).

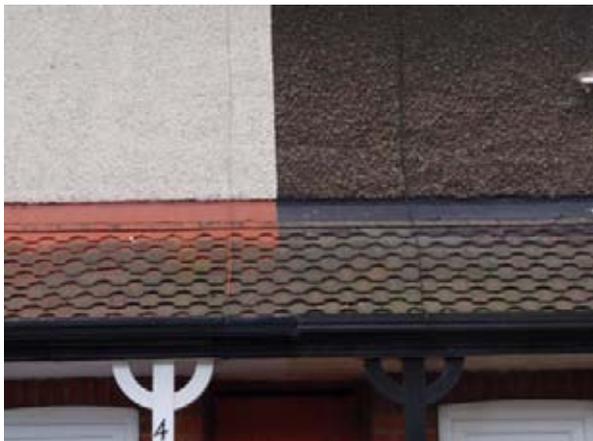
Photo 12: Ornamental 'fish-tail' tiles.

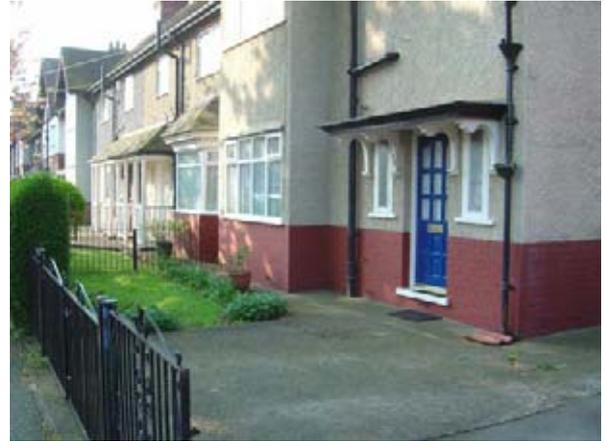
Photo 13: Brick & roughcast terrace-of-4 featuring square and cant bay windows, canopies and projecting open porches.

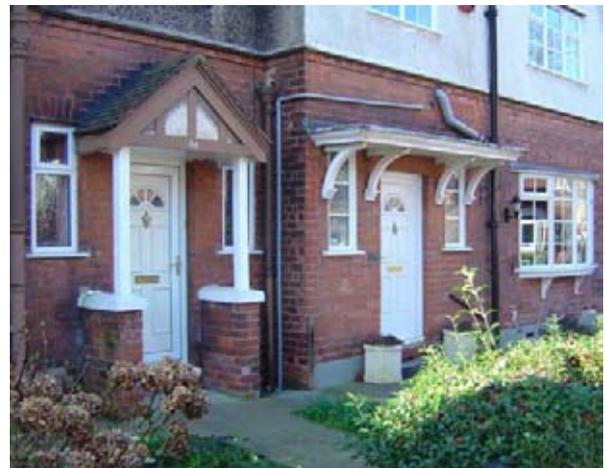
Photo 14: Positive features – projecting open porches and canopies. However, the composition is let down by the PVCu replacement doors and windows, particularly the uncharacteristic bow window (far right) in place of a flush window.

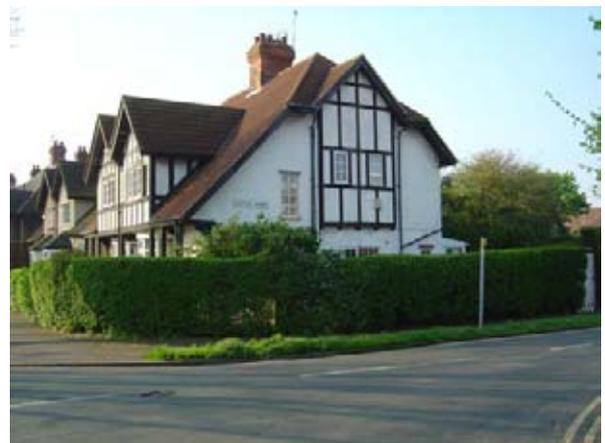
Photo 15: Half-timbered 2-storey semis with half-hipped roofs and massive gabled dormers set on roofs sloping down to ground floor eaves.

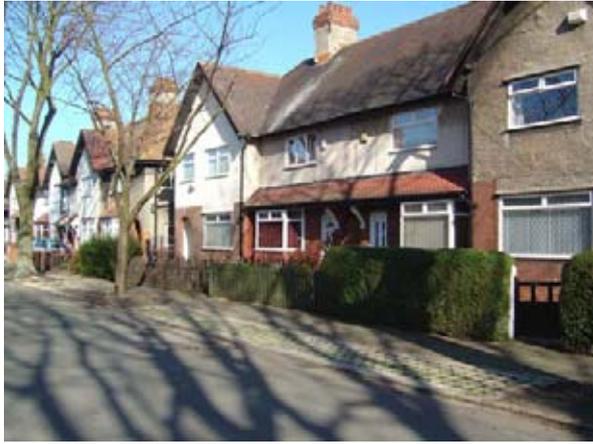
Photo 16: Positive features – front-facing gables, deep eaves and stout chimney stacks. However, poor PVCu replacement windows, loss of boundary hedges and grass verges degrade the scene.

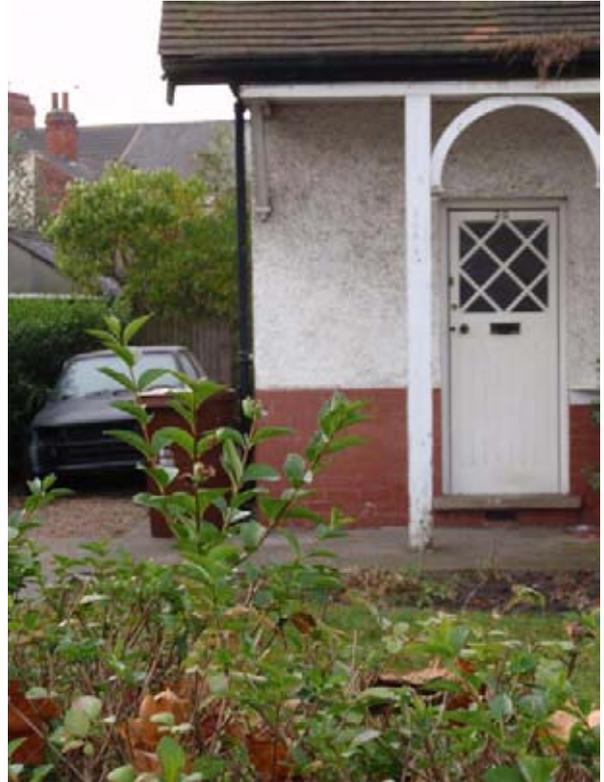
Photo 18: The last remaining example of an original front door within the conservation area (2009).

- 4.4 Sadly, some original features, such as the vast majority of timber doors and windows, have been lost in the conservation area, replaced almost entirely by PVCu facsimiles that bear little resemblance to the design and style of the originals (photo 17). At the time of writing only one original front door survives (photo 18) and only two houses retain their original front windows (complete with the odd bull's-eye pane) (photos 19 & 20). Some inappropriate modern bow windows have also appeared in place of original bays and flush windows (photos 14 & 21). Loss of traditional and characteristic plain/ornamental roof tiling has occurred too at some properties. However, despite the loss of some original features, the character of the individual buildings remains strong.

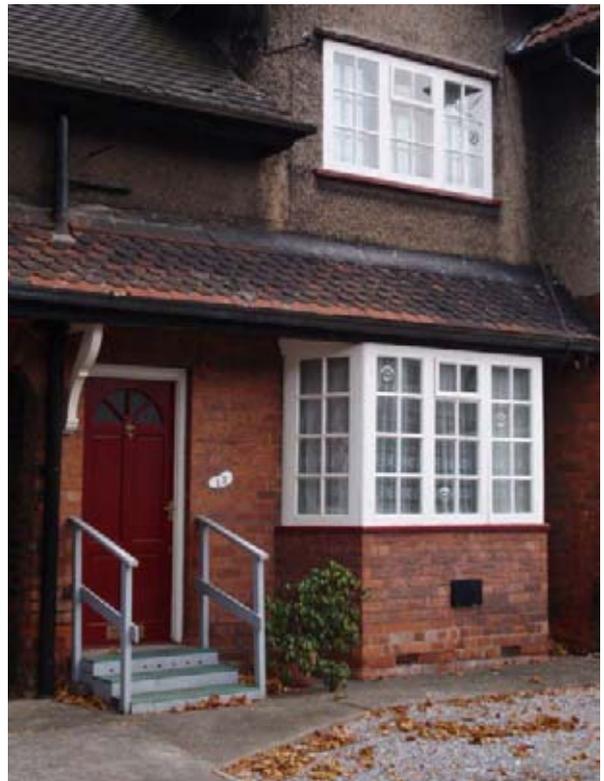
Photo 19: Rare original multi-paned timber windows, complete with the odd bull's-eye pane. One of only two houses to retain its original fenestration in 2009.

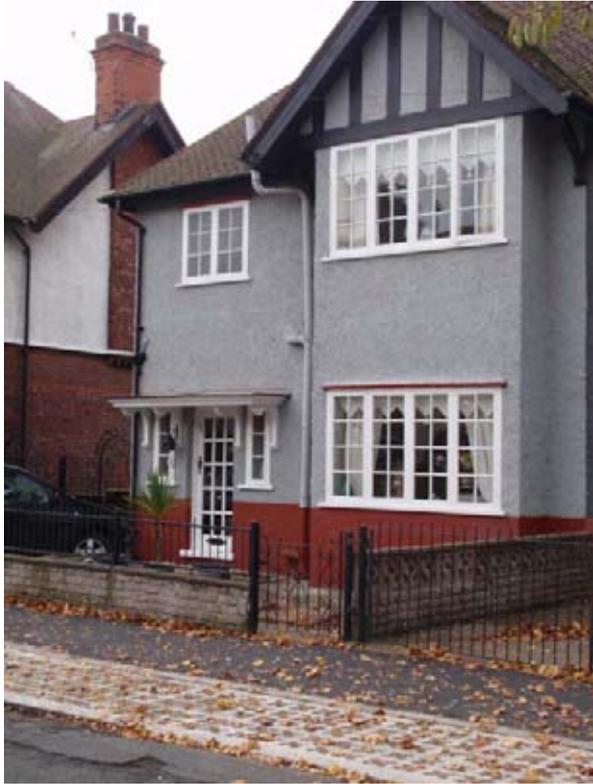
Photo 20: Rare original multi-paned timber windows, complete with the odd bull's-eye pane. One of only two houses to retain its original fenestration in 2009.

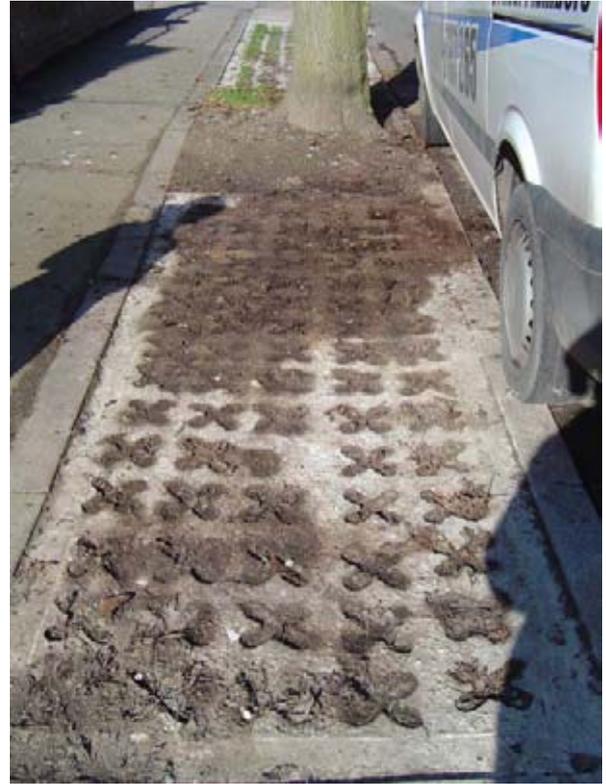
- 4.6 Other negative elements contributing to the erosion of the character and appearance of the area include:
- the replacement of soft grass verges with ill-considered grass-crete (photo 23);

Photo 23: Ill-considered 'grass'-crete in place of soft grass verges.

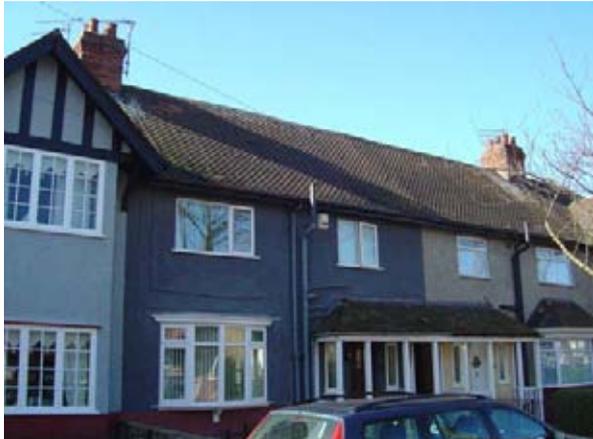
Photo 21: Unsympathetic modern bow window in place of an original canted bay.

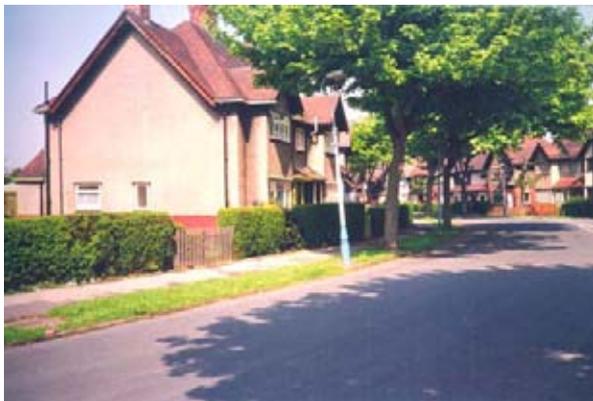
Photo 22: One of the old 'electrified' gas lamp columns in 1993, all now replaced (see photo 24).

- 4.5 Roads and pavements are of tarmac and kerbs generally of concrete, although some good quality granite and York stone kerbs survive here and there. Street lighting is modern and replaces the old 'electrified' gas lamp columns that survived until the turn of the century (photo 22). The new pressed aluminium street lighting (photo 24) has undermined the 'village' appearance of the area, and robbed it of valuable historic street furniture which added charm, character, richness and variety to the street scene.

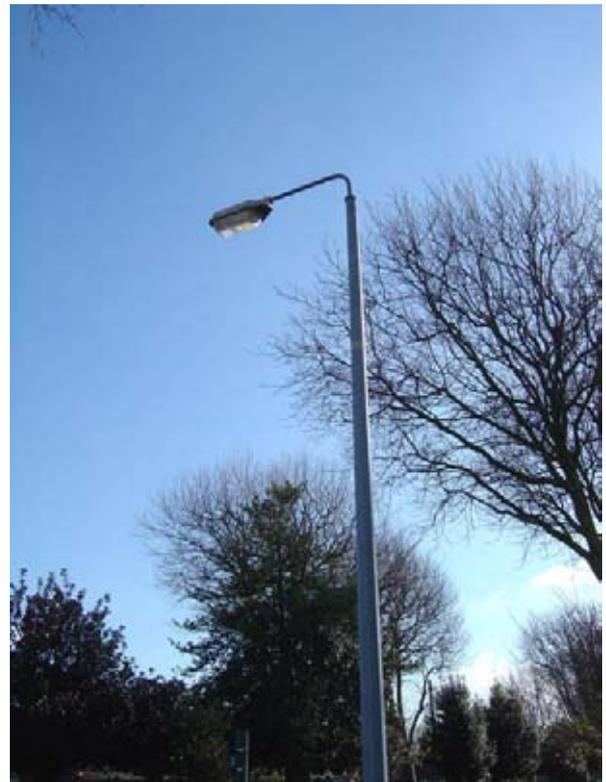
Photo 24: Standard modern pressed aluminium lamp-post in place of old 'electrified' gas lamp column.

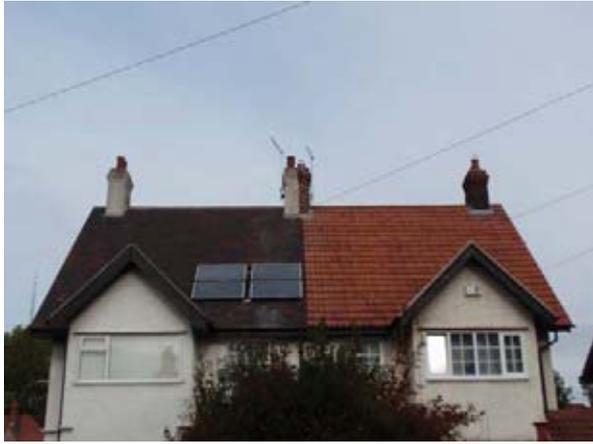
- the replacement of traditional roofing materials with out-of-character materials (eg plain tiles for concrete double Roman tiles) (photo 25);
 - the repair of ornamental roofs with plain tiles (photo 26);

- installing solar panels on front roof slopes (photo 25);
 - installing inappropriately designed rooflights (photo 30); and
 - enclosing recessed and open porches (photo 31).

Photo 25: Traditional plain tile roof (left), with unsympathetic solar panels, and non-traditional concrete double Roman tile roof (right).

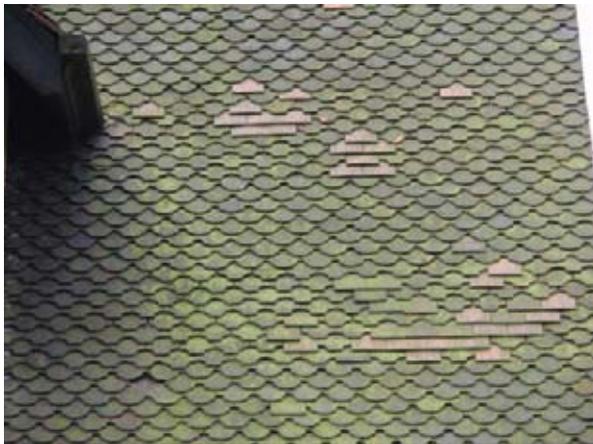
Photo 26: Unsympathetically repaired ornamental tile roof.

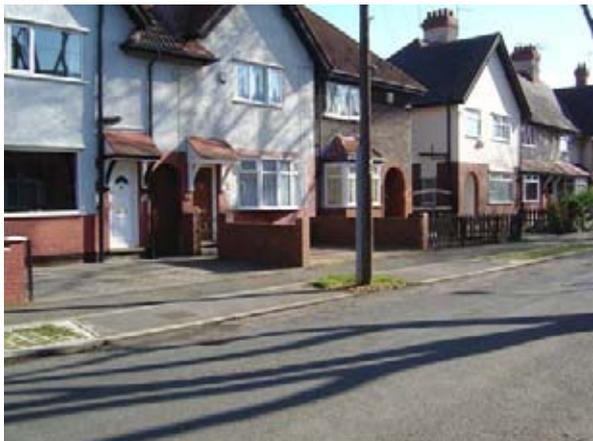
- the removal of boundary hedges (photo 27);
 - leaving boundaries open or installing hard boundary treatments (eg walls, railings and fences) (photo 27);

- the replacement of soft front gardens with hard standings (photo 27);
 - installing satellite dishes on chimneys, walls or roof slopes which face onto, and are visible from, a highway (photo 29);

Photo 27: Negative features: open boundaries with hard front standings.

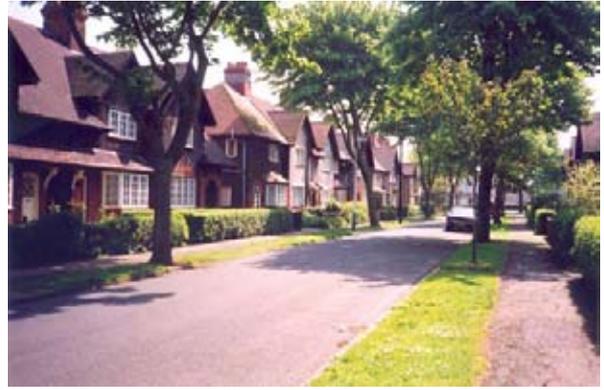
Photo 28: The same scene as previous (photo 27) in 1993.

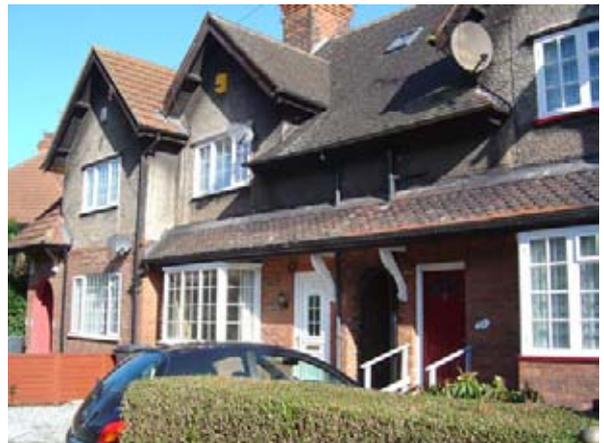
Photo 29: Satellite dishes facing onto and visible from the highway.

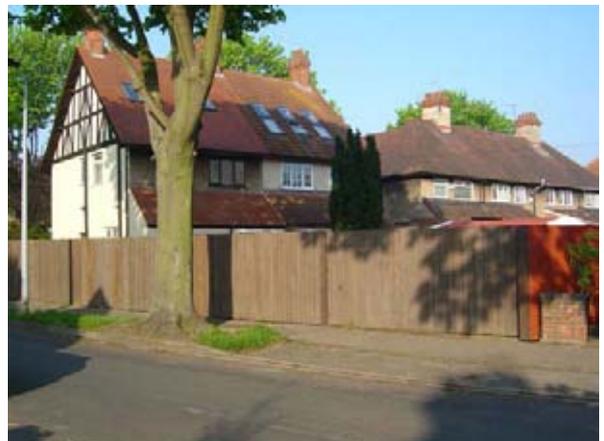
Photo 30: Unsympathetic (non- conservation type) rooflights.

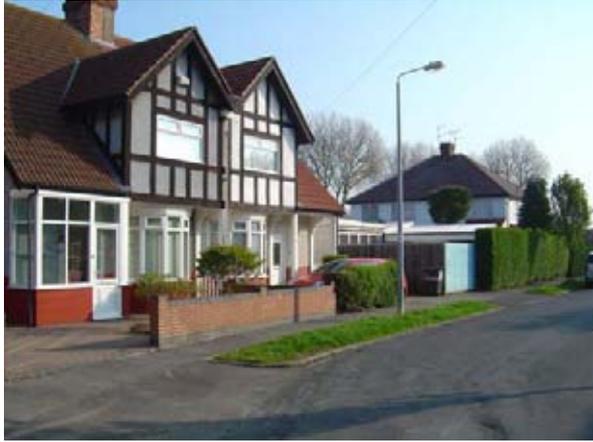
Photo 31: Original open porch (right) and enclosed 'open' porch (left).

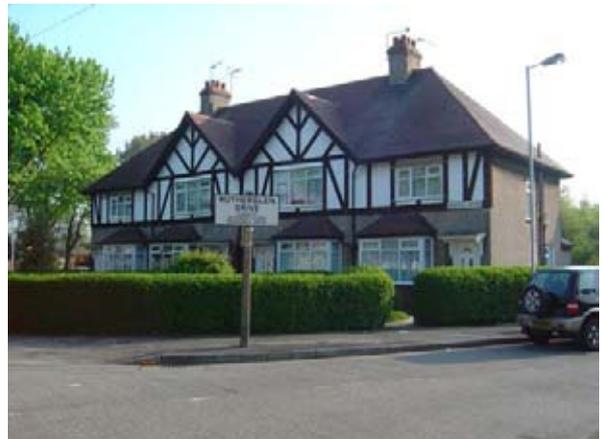
5.3.2 The 12 Willows' cottages, grouped into three terraces-of-4 all retain their original plain roof tiles, and have a uniformity of build which is very pleasing to the eye. Although re-fenestrated with PVCu windows, some thought and reference has been made again to the uniformity of the terraces and the original windows. The replacement windows and doors are still, however, poor facsimiles of the originals, particularly the windows which were multi-paned originally. The doors also lack the character and charm of the originals (photos 3, 37-39).

Photo 37: One of the three J.B. Willows' terraces-of-4 in 2009 (north side of 'Rutherglen Drive'), with modern PVCu front doors and windows which bear little resemblance to the originals (see photo 3).

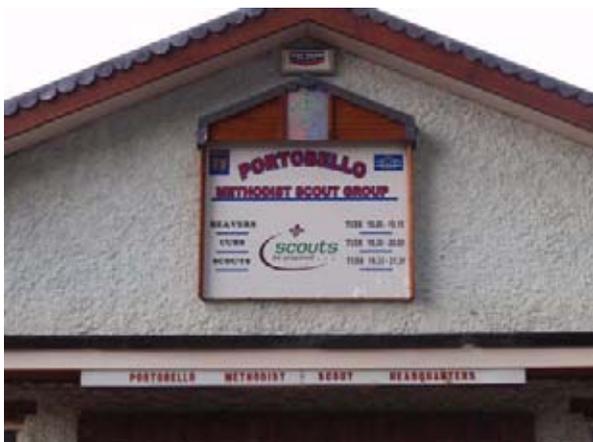
Photo 34: Distinctive gabled sign on the front gable of the Scout Group Headquarters.

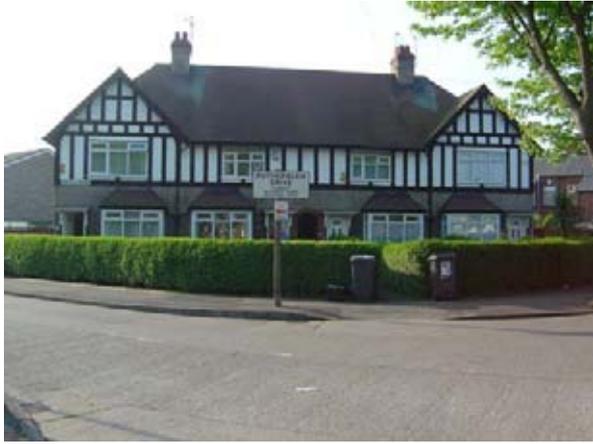
Photo 38: One of the three J.B.Willows' terraces-of-4 in 2009 (south side of 'Rutherglen Drive'), with modern PVCu front doors and windows which bear little resemblance to the originals (see photo 3).

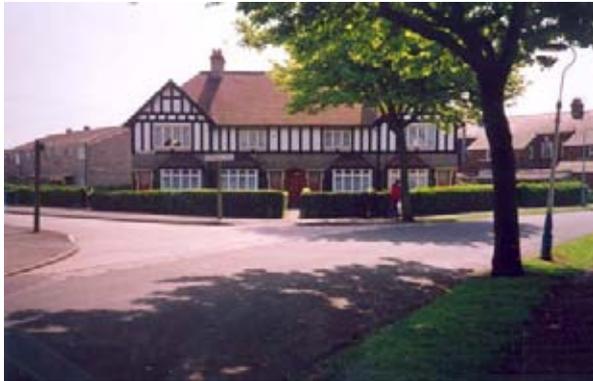
Photo 39: The same scene as above (photo 38) in 1993, with some original doors and windows (but without the multi-panes) still extant.

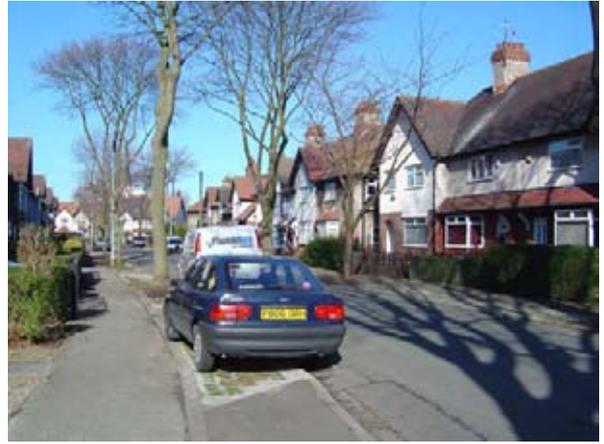
- 5.4.1 Seafield Avenue is the longest street in the conservation area and has the most housing; these houses were also the first to be built by the BOCM. This street is a little narrower than the other streets within the Garden Village, and with houses on both sides consequently has a little less of the airy, spacious feel about it. This street also seems to have suffered most over the years, in terms of original features being lost and greenery being reduced (photo 40).

Photo 40: Seafield Avenue in 2009.
