# Coltman Street

## Conservation Area Character Appraisal

Adopted February 2006

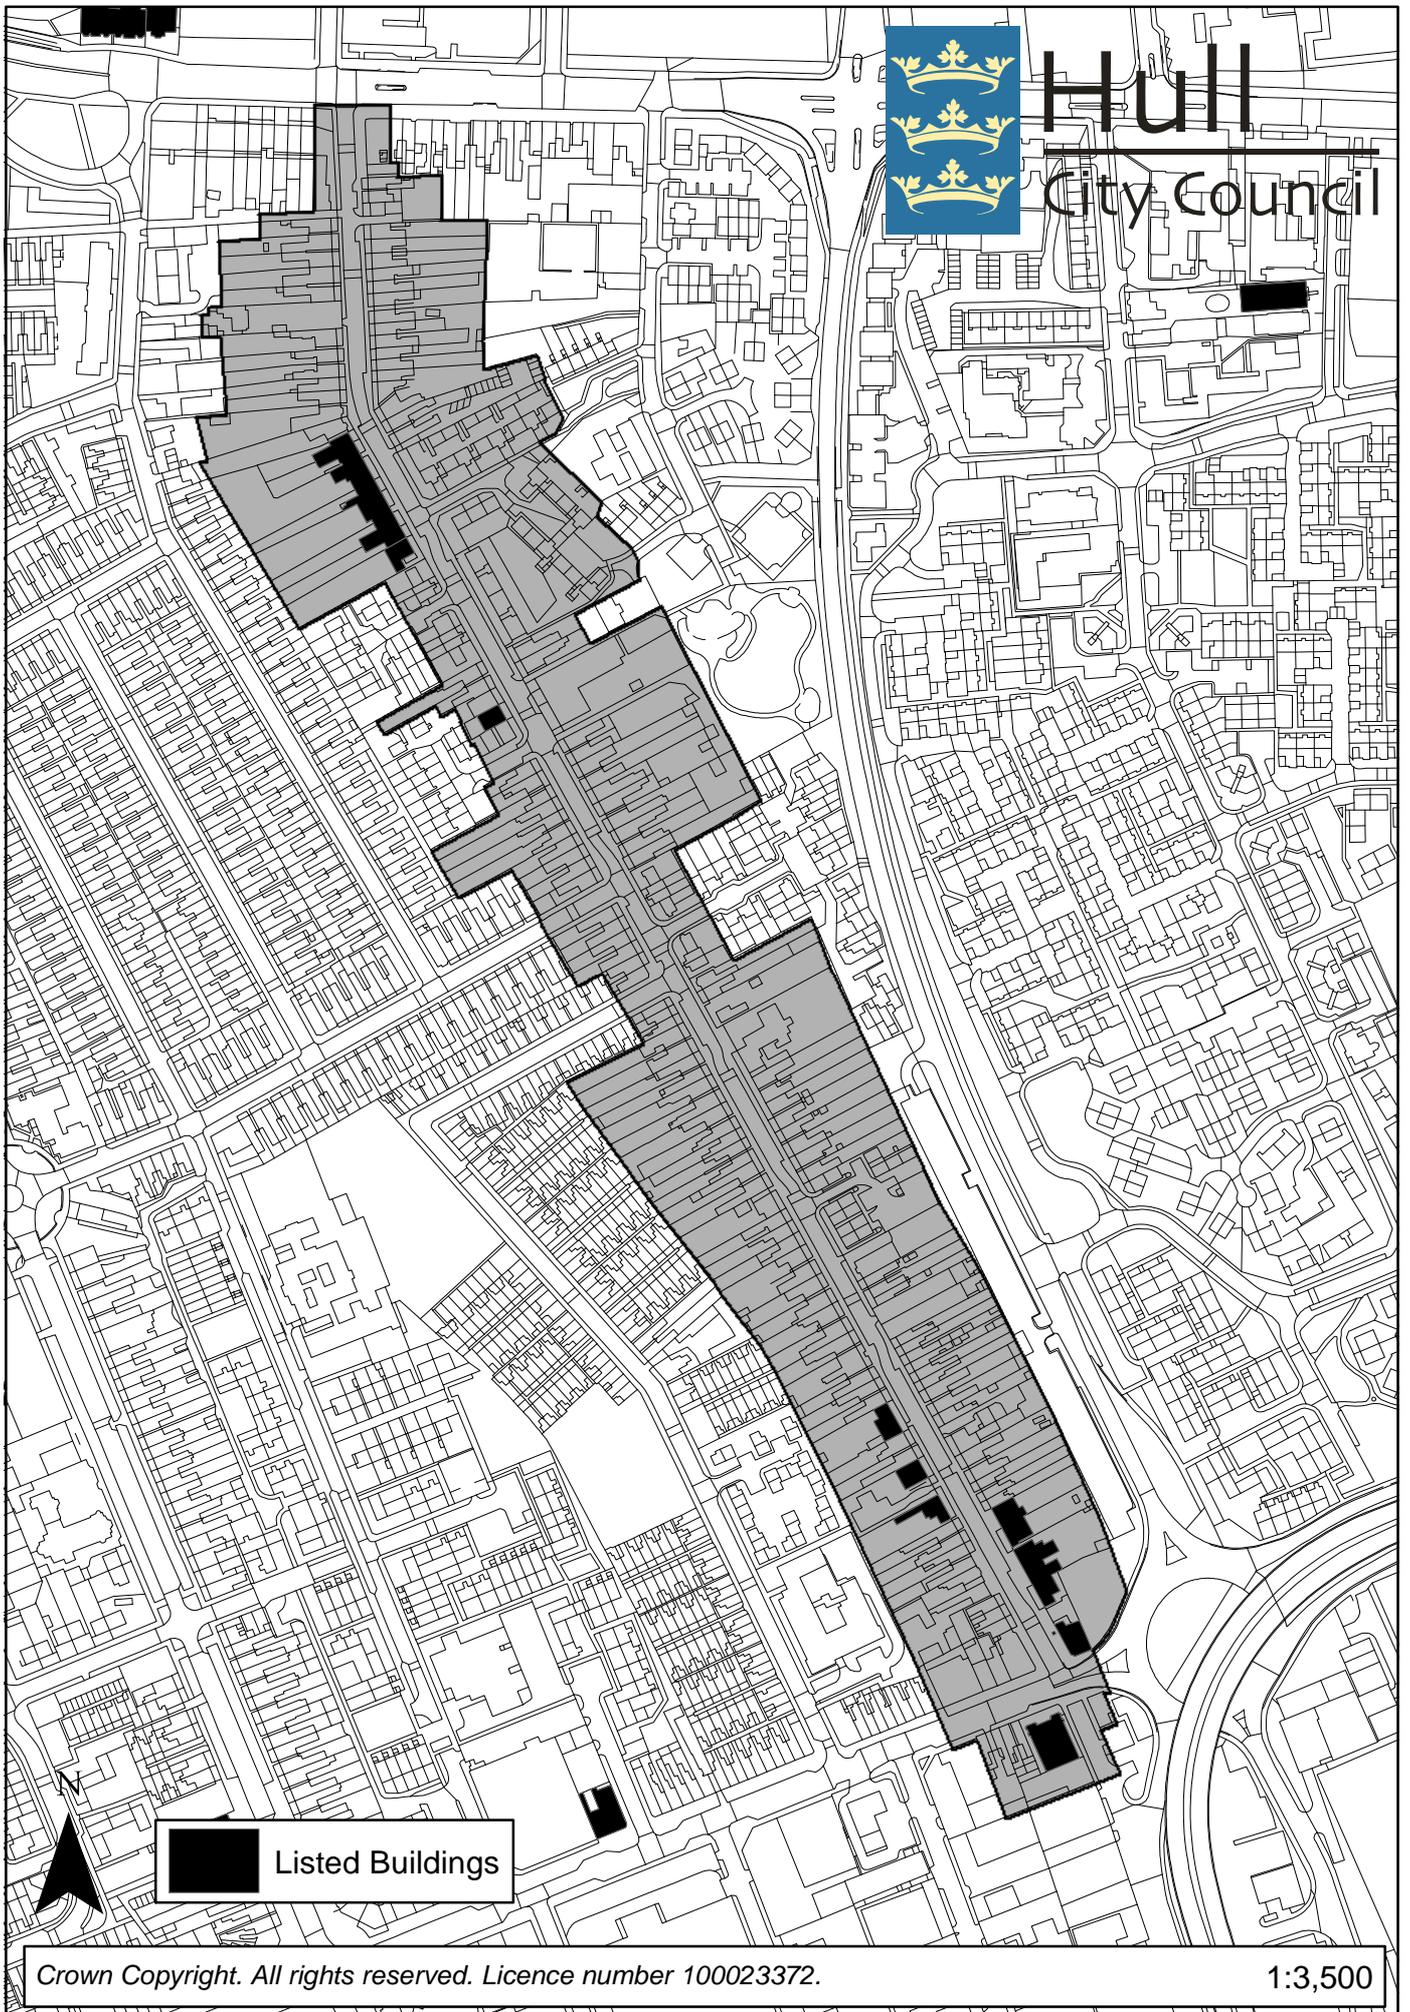
Figure 1: Coltman Street Conservation Area Boundary

- 3.1 The Coltman Street conservation area includes the whole of Coltman Street and a short section of Hessle Road (*Fig.1*). It is situated within the St Andrews ward between Anlaby Road and Hessle Road. It was designated by Hull City Council as a conservation area in March 1994. The Street is named after a famous member of the wealthy landowning Coltman family, the Reverend Joseph Coltman (1775-1837), clergyman, public benefactor and at 37 stones the heaviest man in England at the time.

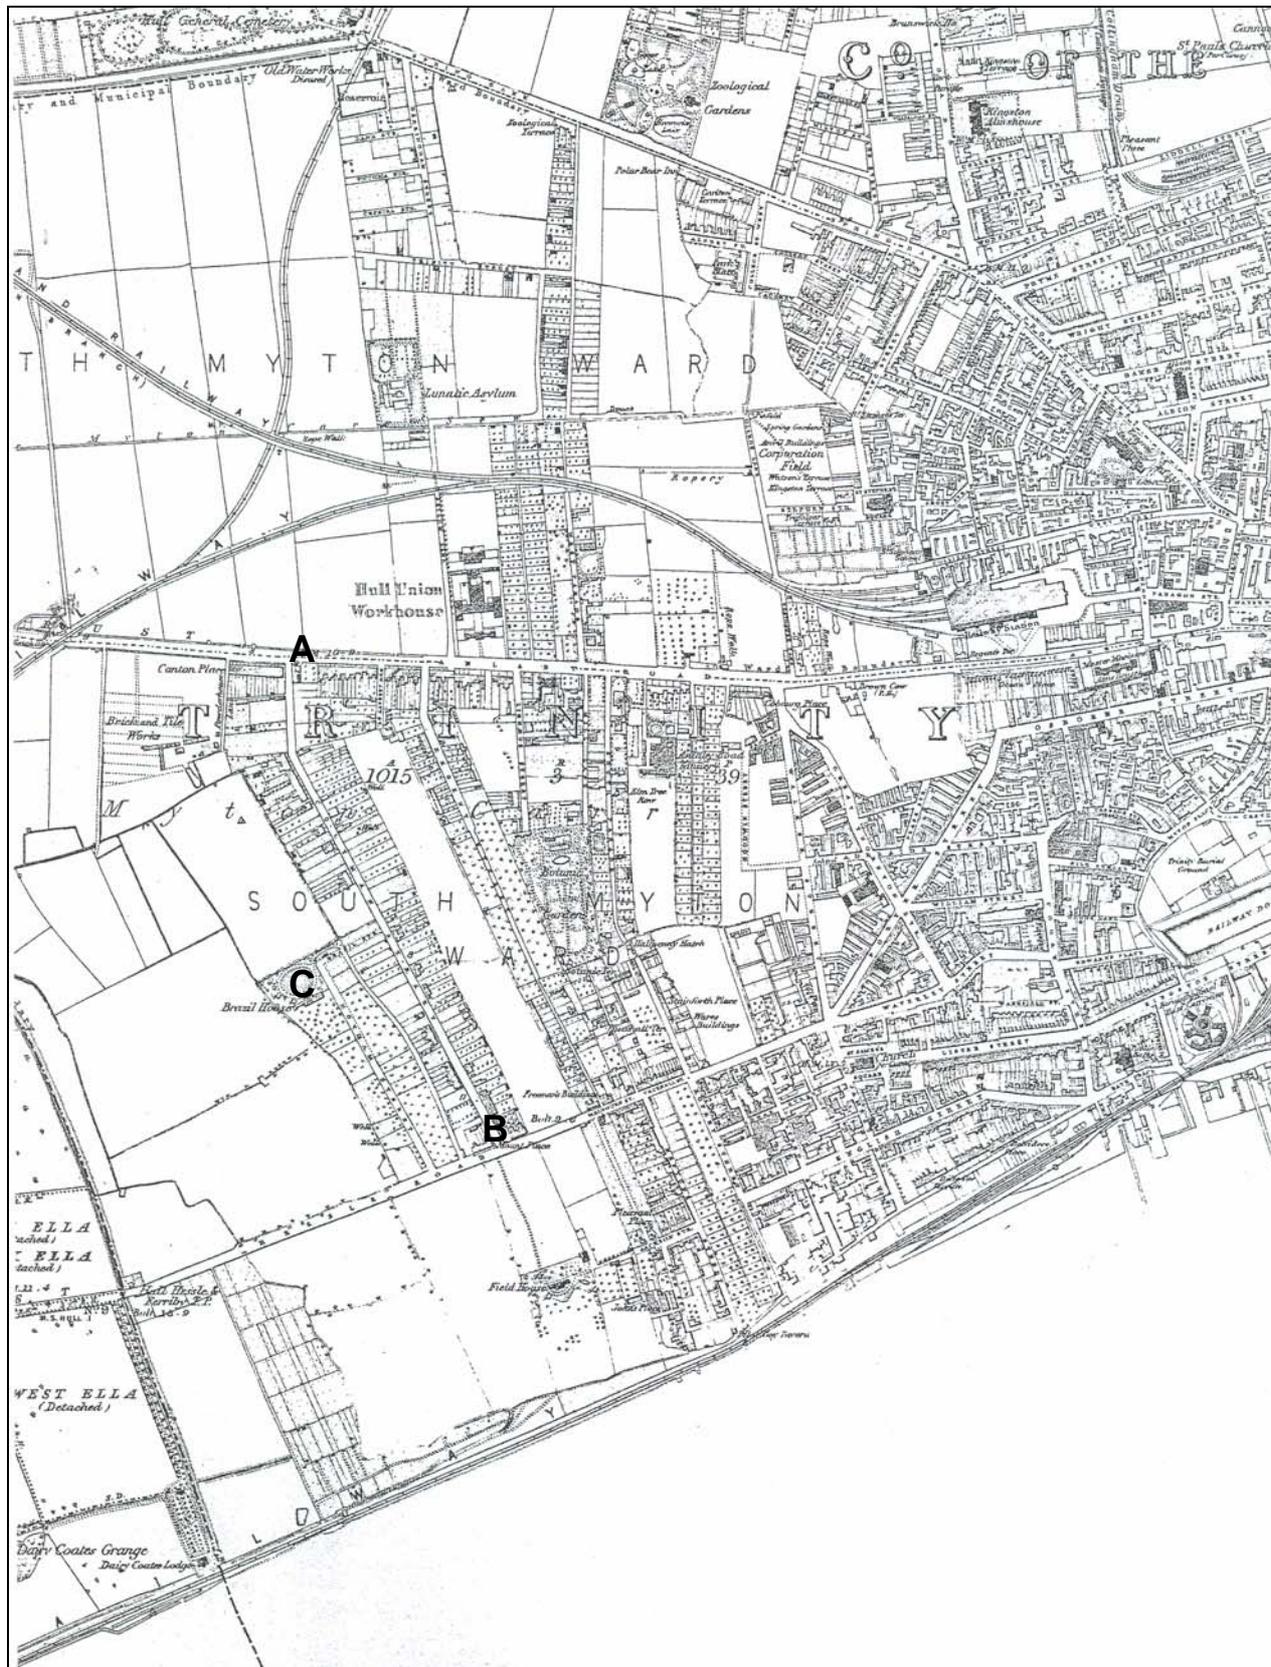
Figure 4: Part of the 1853 OS map of Hull showing Coltman Street (A-B) on the edge of the town and Brazil House (C).

- 6.3 The development of Coltman Street was slow, however, and by the 1860s many of the plots still remained undeveloped (*Fig.4 & 5*). For much of the Victorian period the Street remained at the interface of town and countryside (*Fig.6*). By the end of the Edwardian period it was a different story; the Street was fully developed and surrounded by a sea of working class terraces.

**Gee Street** (west side) – Originally Brazil Street (1853 OS), named after Brazil House (*Fig.4*) and the popular Brazil Tea Gardens nearby (where picnic parties used to go in the summer season to eat fruit, especially strawberries, and take tea). Renamed in 1886, probably after Joseph Gee, a former merchant, ship-owner and sheriff (1854) who had died in 1860; the change avoided duplication with another Brazil Street on Holderness Road. Only eastern tip within conservation area. Good view westwards to Boulevard conservation area and the 1904 former Sunday School and Institute of the Boulevard Baptist Church.

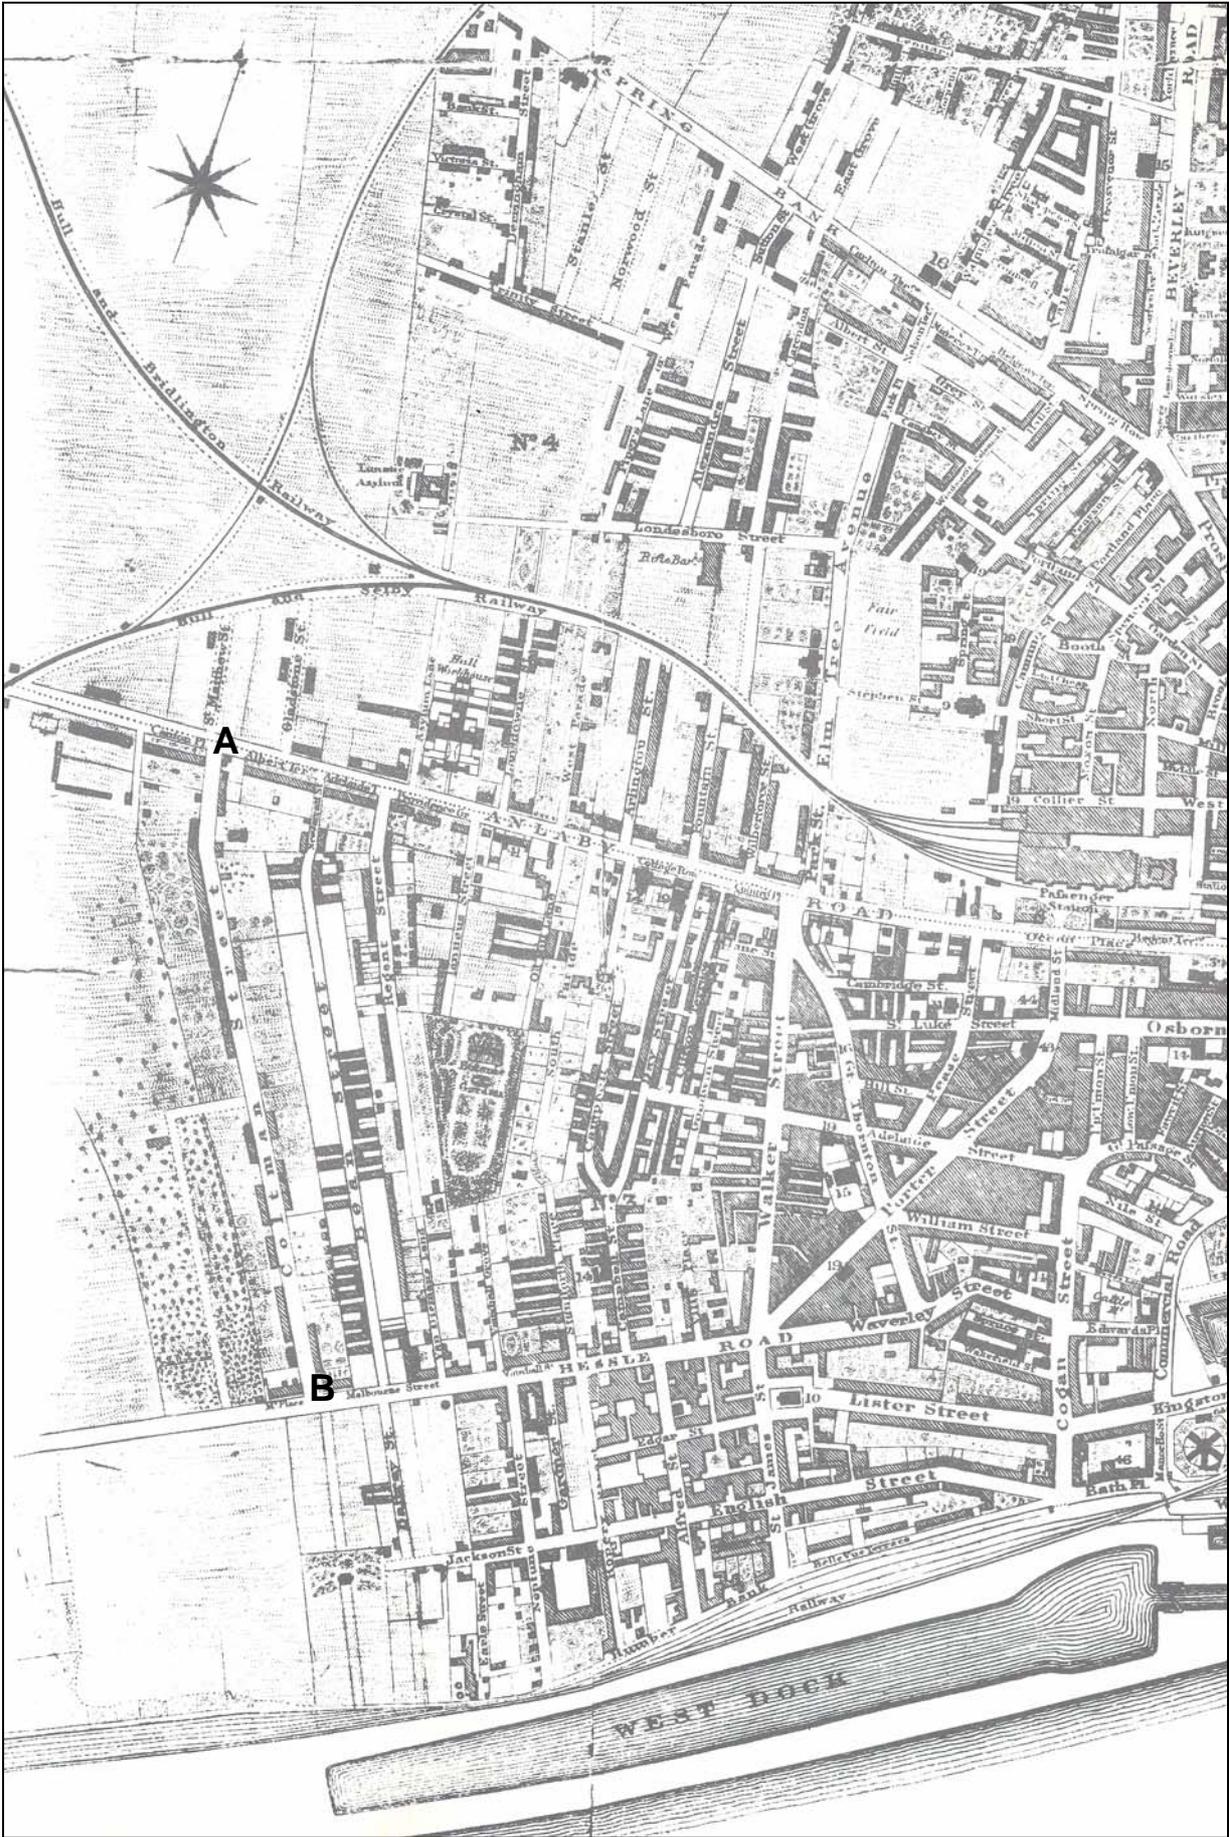
Figure 5: Part of the 1869 Goodwill & Lawson map of Hull showing the extent of development along Colton Street (A-B) by the end of the 1860s.

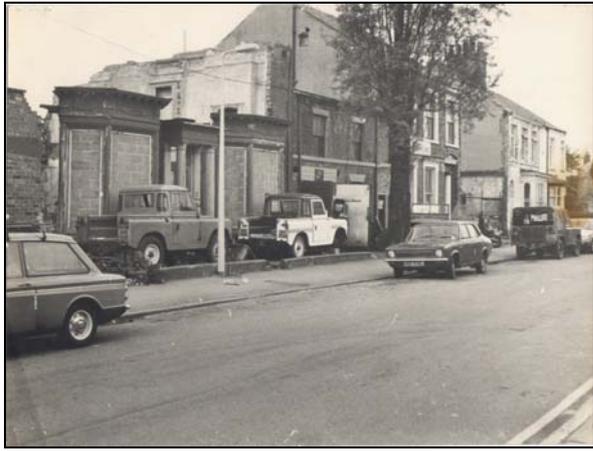
*Photo 1: 166-171 Coltman St., c.1970s.*

- 6.7 Post-Second World War, the Street went into a long decline and by the 1960s and 70s was known as a 'trouble spot' with a high turnover in population. Many of the houses were also extremely run down and lacking in amenities (*Photo 1 & 2*). In spite of this there were people in the area that cared about the Street, and in the 1970s they formed an action group to see if there was any way that things could be improved. Their local councillors applied considerable pressure, refusing to give up, until in June 1983 Coltman Street was declared a Housing Action Area.

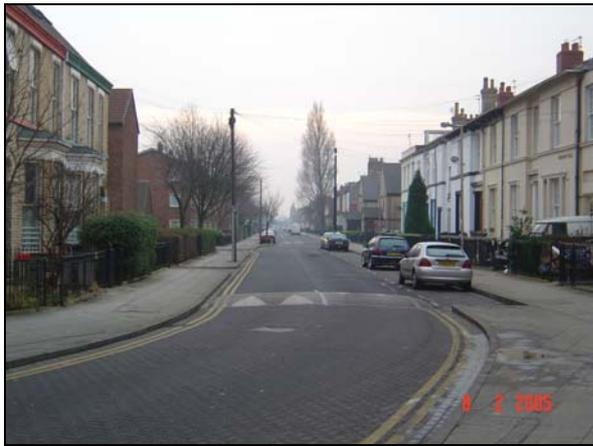
*Photo 3: Coltman Street (elbow bend).*

- 7.1 Coltman Street is a long linear residential street with a pleasing elbow bend which closes the vista at its northern end (*Photo 3*). It is also a street of surprising variety with many fine examples of early-Victorian middle-class housing and mid-late Victorian lower middle-class housing – all interspersed with odd pockets of late 20<sup>th</sup> century residential infill.
- 7.2 The early-Victorian middle-class housing tends to be at the north and south ends of Coltman Street and is characterised by large villas with simple Classical detail (*Photo 4*).

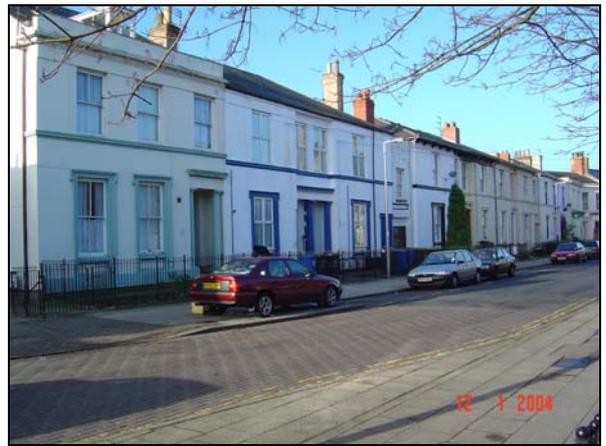
*Photo 4: 179-186 Coltman Street.*

**180-186 Coltman Street** – Stuccoed terrace linked by former stables (*Photo 2, 4, & 48*). c.1840 with late 20<sup>th</sup> century alterations. Recessed entrances with Doric columns *in antis*.

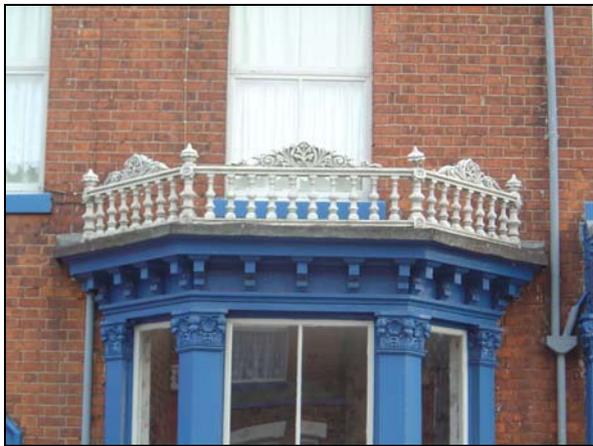
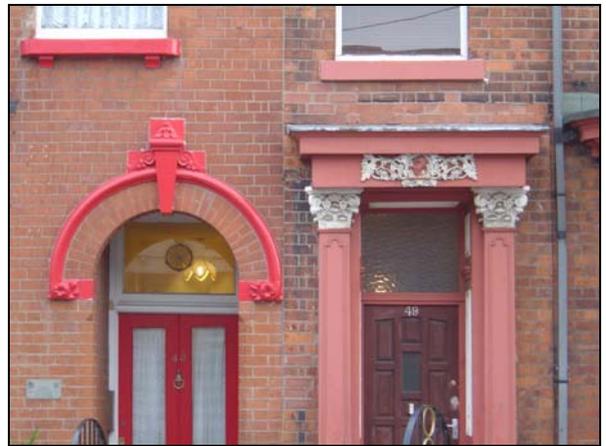
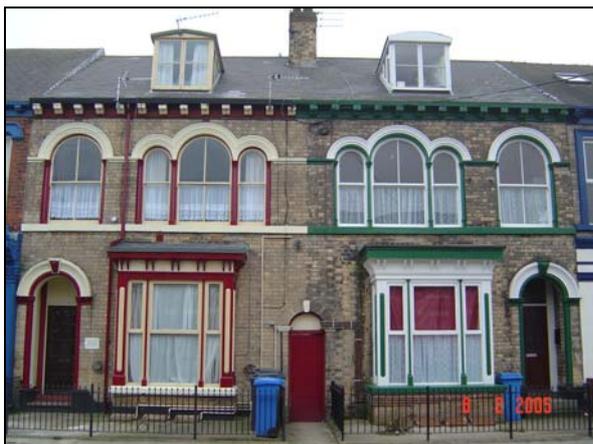
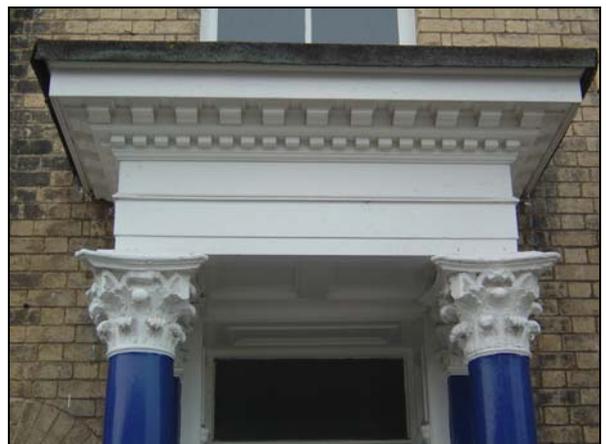
In complete contrast to this, the mid-late Victorian lower middle-class housing is highly eclectic in character – resulting in a cornucopia of styles, detail and decoration (*Photo 5, 6, 7 & 8*).

*Photo 5: 50 Coltman Street.*

*Photo 6: 48 & 49 Coltman Street.*

*Photo 7: 51 & 52 Coltman Street.*

*Photo 8: 199 Coltman Street.*

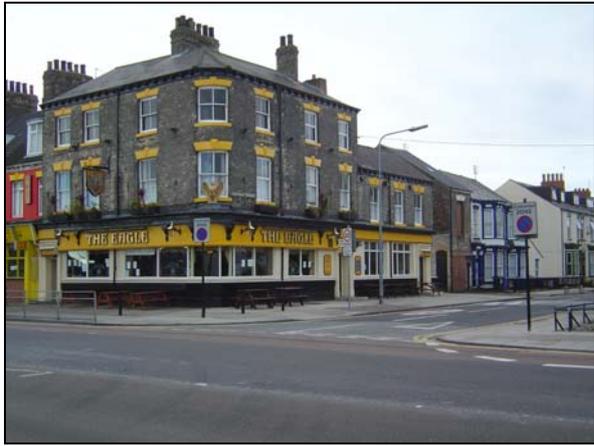
Photo 9: The Eagle public house.

- 7.3 The northern end of Coltman Street has a strong gateway building on its east side (The Eagle public house (*Photo 9*), where a magnificent golden eagle stands sentinel (see front cover). The gateway is weakened, however, by the loss of the building (287 Anlaby Road) on the west side (*Photo 10*). Looking south from this point, the view is closed by the elbow bend in the road. At the junction with Anlaby Road, there are good views looking west, with the spire of the listed St. Matthew's church (*Photo 11*) and the fine listed terrace of 252-260 Anlaby Road visible. St. Matthew's church spire is also visible from the tenfoot north of 200 Coltman Street. Looking north there is a distant view along Arnold Street, with the Spring Bank West conservation area visible, and to the east the view is dominated by the tower block of the Hull Royal Infirmary.

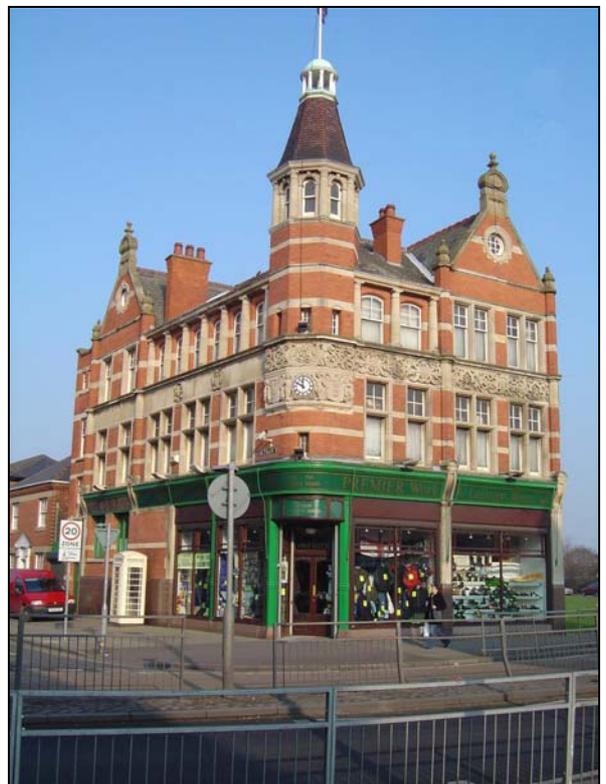
Photo 14: 152-154 Hessle Road & K6 telephone kiosk.

- 7.4 Prominent gateway buildings also dominate the southern end of Coltman Street. On the east side is the grade II listed Premier Store (152-154 Hessle Road (*Photo 14 & 34*)) – described in *The Builder* as "...the most showy piece of shop building in the town". In complete contrast, a plainer 'Jacobethanesque' building stands sentinel on the west side (*Photo 12 & 13*). Looking north from this point, the view is closed by the elbow bend in the road. The eye is drawn, however, to the lofty Poplar tree outside 167 Coltman Street (*Photo 32*) – one of only two mature trees along the street (the other being the fine Ash tree in the front garden of 85/86 Coltman street (*Photo 31*)). Beyond the Poplar tree, poking their heads above the roof tops, can also be seen the arched floodlight gantries of the KC Stadium. In the opposite direction, the view south is particularly pleasing, with the towers of the Premier Store and former City Temple on Hessle Road catching the eye (*Photo 15*). The latter two buildings, along with 156 and the good 1939 Art Deco shop front to 164-168 (*Photo 16*), also create a strong gateway into this section of Hessle Road (turnpiked in 1825).

**Former Public Benefit Shoe Company Shop at corner of Coltman Street, 152 & 154 Hessele Road** – 1890 by W. Alfred Gelder. Flemish Renaissance Revival style. Brick with much stonework including mullioned windows and a decorative carved frieze, squat Tuscan colonnade to second floor, octagonal corner turret with cupola and gables with raised segmental pediments. Ornate gabled façade with blank colonnade to the upper storey on west side (*Photo 14 & 34*).

**K6 Telephone Kiosk (outside above shop), Coltman Street** – 1930s design classic by Sir Giles Gilbert Scott, first produced in 1936, in traditional local (cream) livery (*Photo 14*).

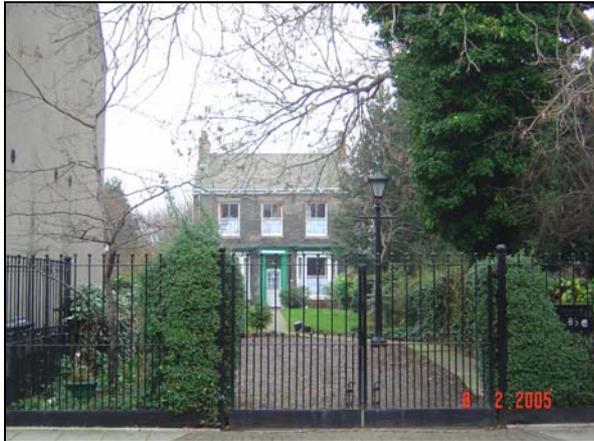
*Photo 17: 85 & 86 Coltman Street.*

- 6.4 Although the style and design of houses varies greatly along Coltman Street, most follow a uniform building line set back about 3m from the pavement. Early on in its development, however, several houses were built set back with long front gardens and short back yards. 4 of these (80½, 81, 82 & 83) have been lost but three survive at 85, 86 and 194 (*Photo 17 & 18*).

**85-86 Coltman Street** – 2 adjoined and setback early-Victorian houses (*Photo 17*).

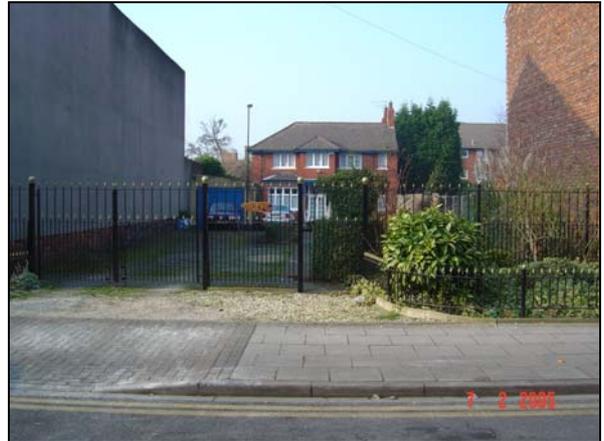
*Photo 18: 194 Coltman Street.*

- 7.5 Gardens, with 3 notable exceptions, tend to be short and hard at the front and long at the back. The 3 exceptions (85, 86 & 194 Coltman Street) provide a welcome change in the street frontage and introduce 2 long and green perpendicular views, of which more used to exist (*Photo 17 & 18*). Gracing the curtilage boundaries of many front gardens are low iron railings (*Photo 20*). The vast majority of these are modern, however, the originals having been compulsorily removed during WWII as part of a national salvage campaign. One notable exception is the early Victorian railings at 114 Coltman Street (*Photo 19*).

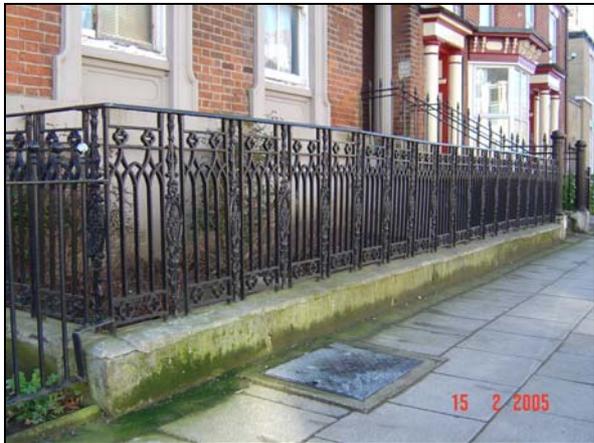
*Photo 19: Victorian railings.*

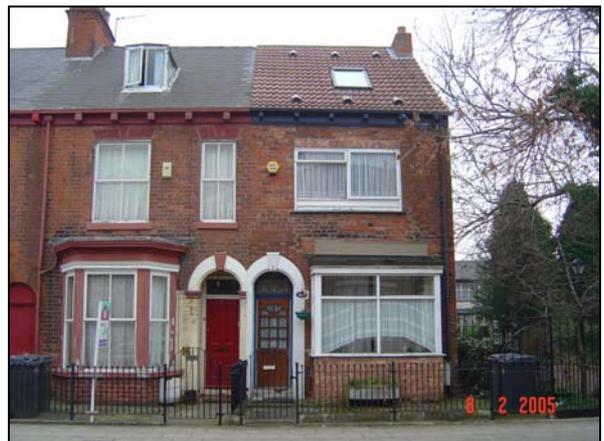
*Photo 22: Unsympathetic alterations.*

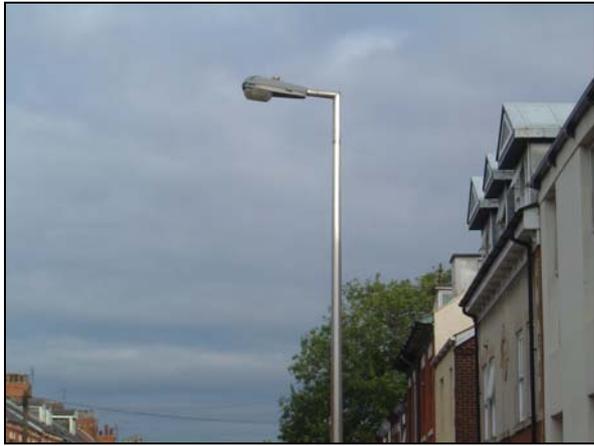
*Photo 23: Typical street lighting.*

10.1 A limited range of modern street furniture exists throughout the appraisal area. Particularly incongruous are the concrete bollards on the roadside islands and the style and design of street lighting along Coltman Street (*Photo 23 & 24*).

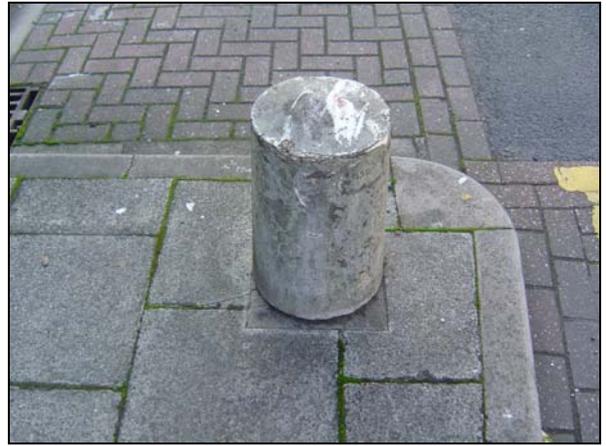
*Photo 24: Typical concrete bollard.*

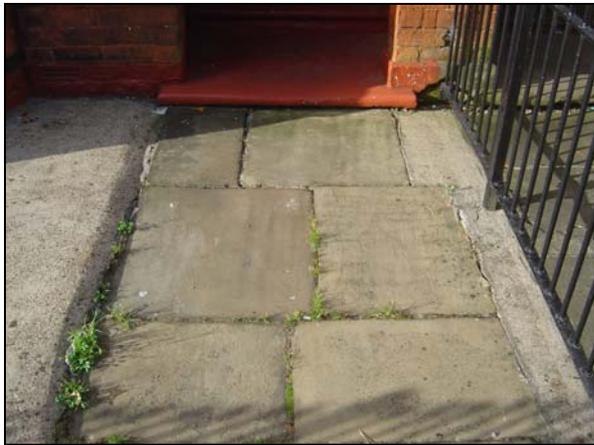
*Photo 27: York stone garden path.*

9.2 Traditional paving materials add charm, character, variety and richness to the appraisal area and where they survive in good condition they should be retained, maintained and, if damaged, replaced like-for-like.

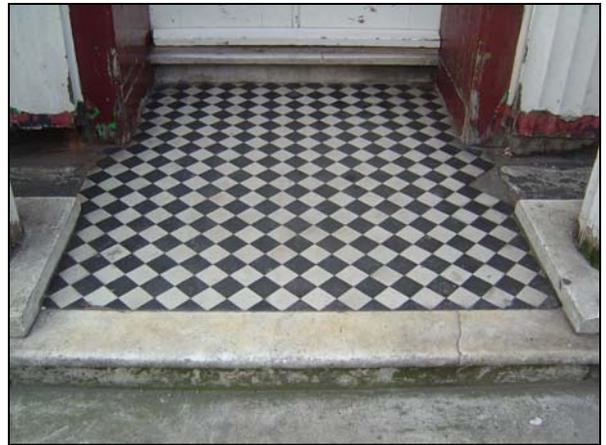
*Photo 28: Encaustic tile threshold.*

materials also survive including a granite sett crossover 'between' 168 & 172 Hessle Road, a York stone sett crossover in front of the carriage arch between 167-169 Hessle Road and a block of relocated granite setts west of The Eagle public house. Several dwelling houses also retain front garden and side entry paths paved with York stone flags (*Photo 27*) and thresholds paved with encaustic tile (*Photo 28*).

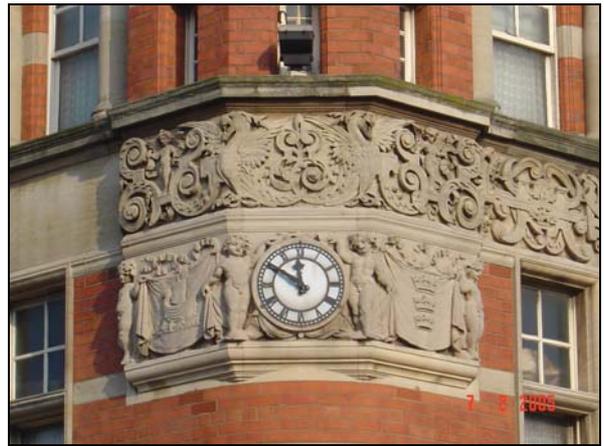
*Photo 34: 152 & 154 Coltman Street.*

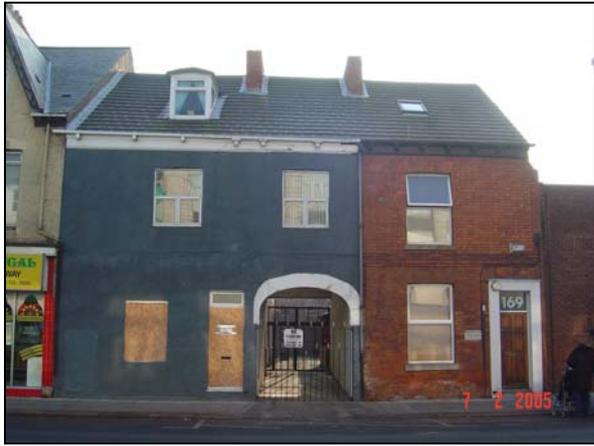
*Photo 37: Unsympathetic windows*

- 14.1 Although the appraisal area still retains a lot of traditional window styles and designs, many have been substituted by unsympathetic replacements (*Photo 37 & 38*). This has affected the current character, appearance and architectural harmony of several terraces and the street as a whole. The conservation of traditional windows and their details is therefore very important and is emphasized by Government guidance<sup>3</sup> and by the City Council's own planning policy on PVCu replacement windows<sup>4</sup>.

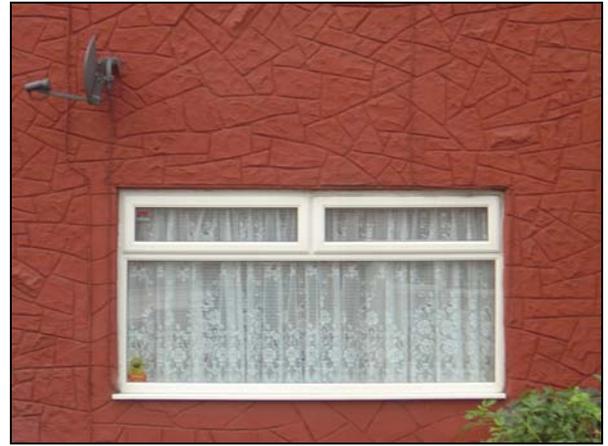
*Photo 38: Unsympathetic alterations.*

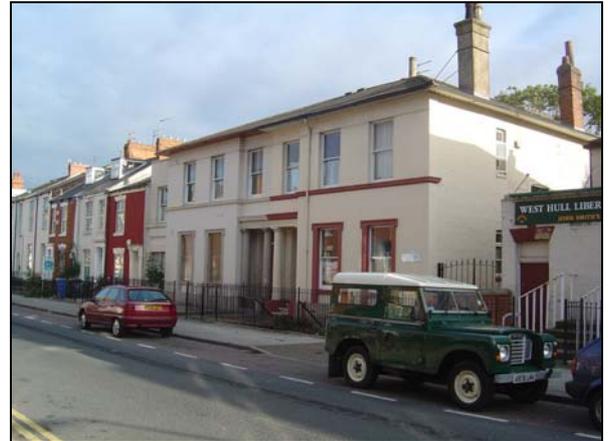
*Photo 40: 100 & 101 Coltman Street.*

**100 & 101 Coltman Street** – Stuccoed pair of semi-detached houses with adjoining former stable (*Photo 40*). c.1840 with late 20<sup>th</sup> century alterations. Recessed entrances with Doric columns *in antis*.

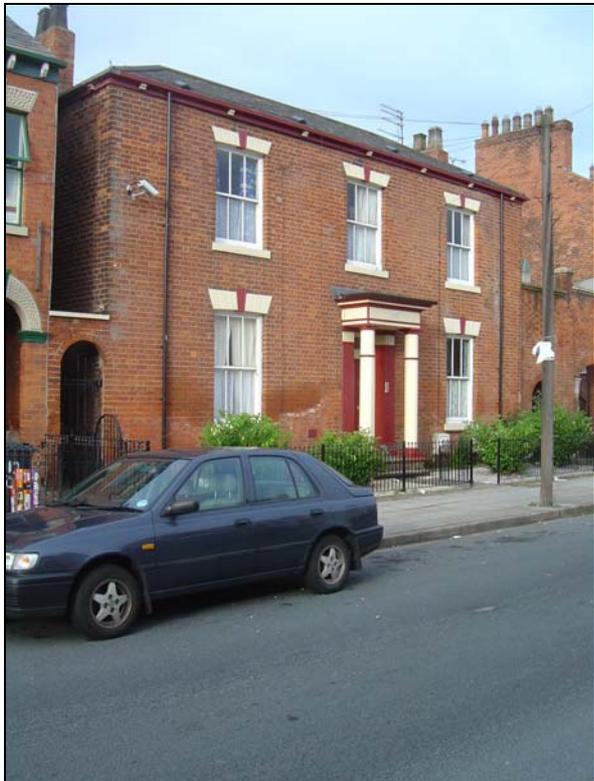
*Photo 41: 113 Coltman Street.*

**113 Coltman Street** – House and adjoining screen wall (*Photo 41 & 43*). c.1840 with late 20<sup>th</sup> century alterations. Red brick with Doric portico with entablature.

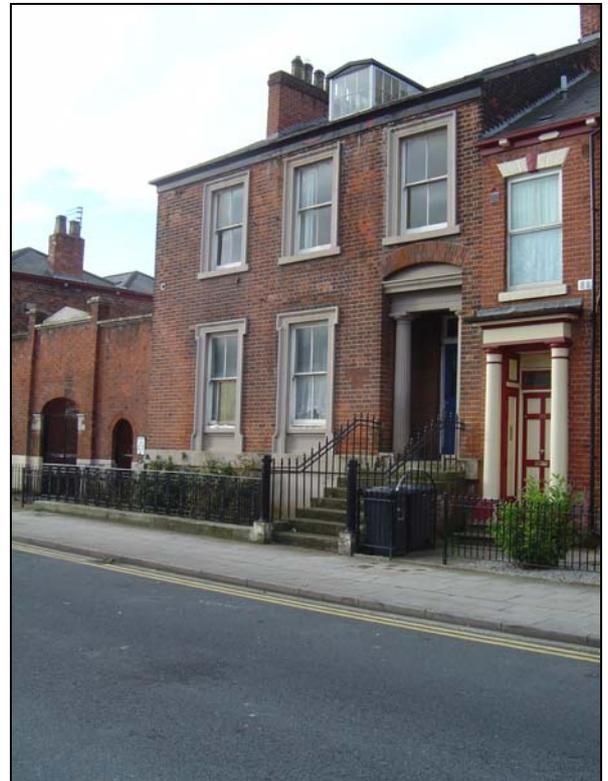
*Photo 42: 114 Coltman Street.*

**114 Coltman Street** – House by Benjamin Musgrave (*Photo 19 & 42*). Early-Victorian with late 20<sup>th</sup> century alterations. Red brick with Doric doorcase recessed in segmental arch.

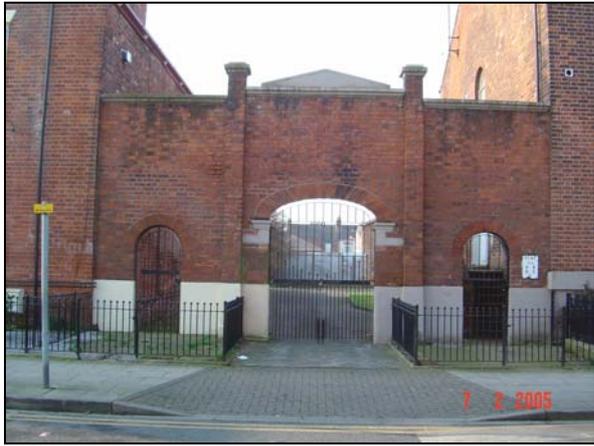
*Photo 43: Screen wall, 113-4 Coltman St.*

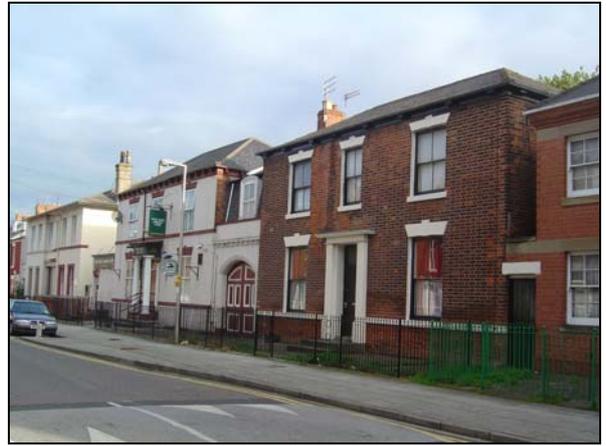
*Photo 44: 102 & 103 Coltman Street.*

**102 (West Hull Liberal Club) & 103 Coltman Street** – Remodelled pair of semi-detached houses linked by former stable (*Photo 44*). c.1840. Red brick (102 painted). Pilastered doorcase at 103 and Doric portico with entablature at 102. Coach-house to rear of 102.

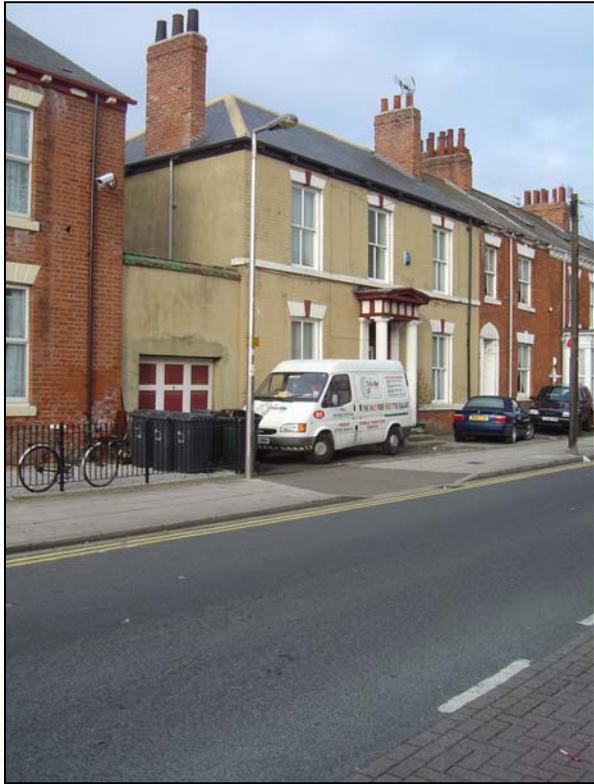
*Photo 45: 117 Coltman Street.*

**117 Coltman Street** – House. c.1840 (*Photo 45*). Restored and altered late 20<sup>th</sup> century. Red brick (now painted) with Doric portico with entablature and pediment.

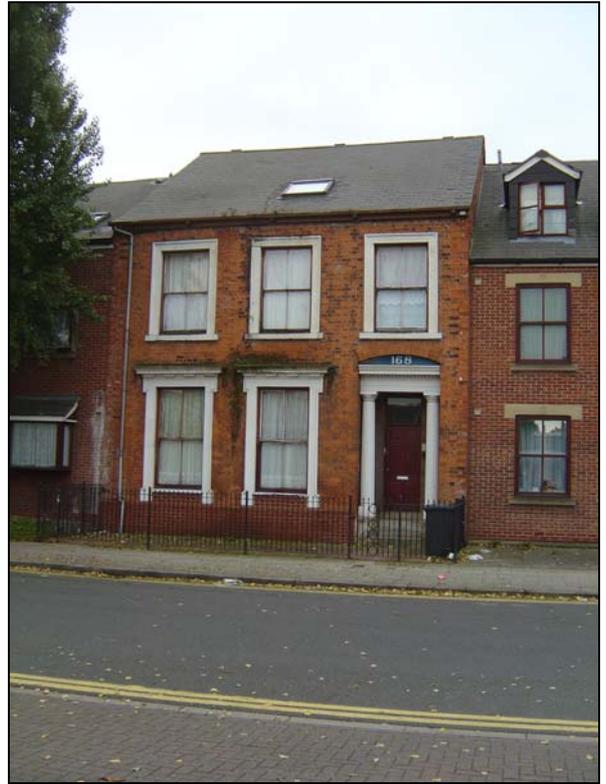
*Photo 46: 168 Coltman Street.*

**168 Coltman Street** – House by Benjamin Musgrave (*Photo 46*). Early-Victorian. Restored and converted into flats late 20<sup>th</sup> century. Red brick with Doric doorcase recessed in segmental arch.

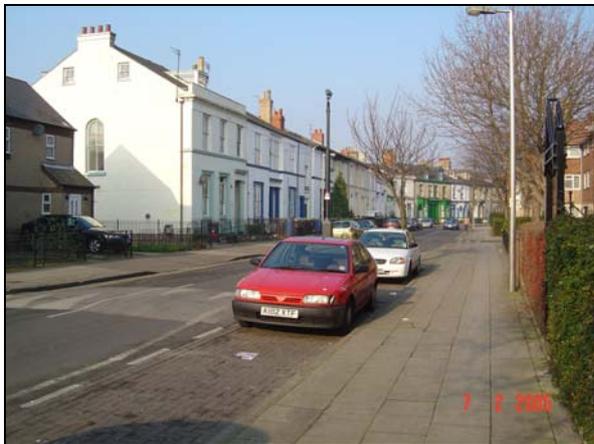
*Photo 47: 179 Coltman Street.*

**179 Coltman Street** – Stuccoed end of terrace house (*Photo 47*). c.1840. Restored late 20<sup>th</sup> century. Recessed entrance with 2 Doric columns *in antis*.

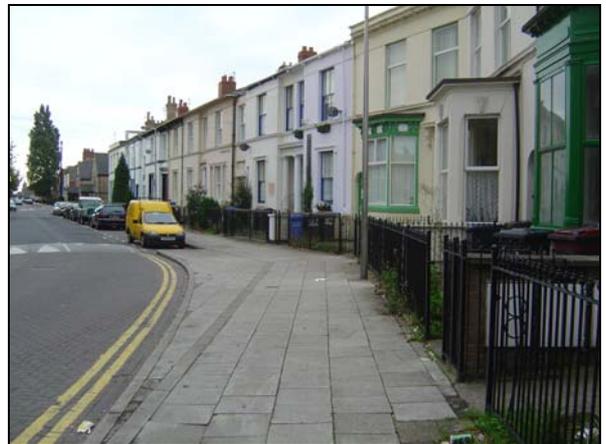
*Photo 48: 180-186 Coltman Street.*

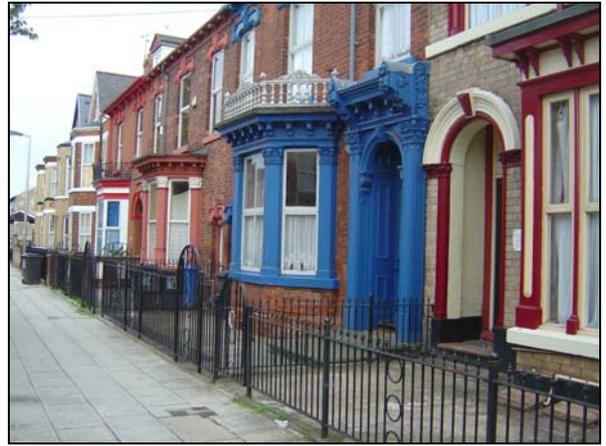
**44-47 Coltman Street** – Edwardian terrace of 4 (*Photo 50*).

Photo 50: 44-51 Coltman Street.
