**Spring Bank Conservation Area
Shop Front Design Guide
Published June 2024**

This document is designed to set out the principles of design that should be considered with any proposed works in the Conservation Area. This should be used to guide both the design process and the decision making process to enable a consistent approach to be established and maintained in the future.

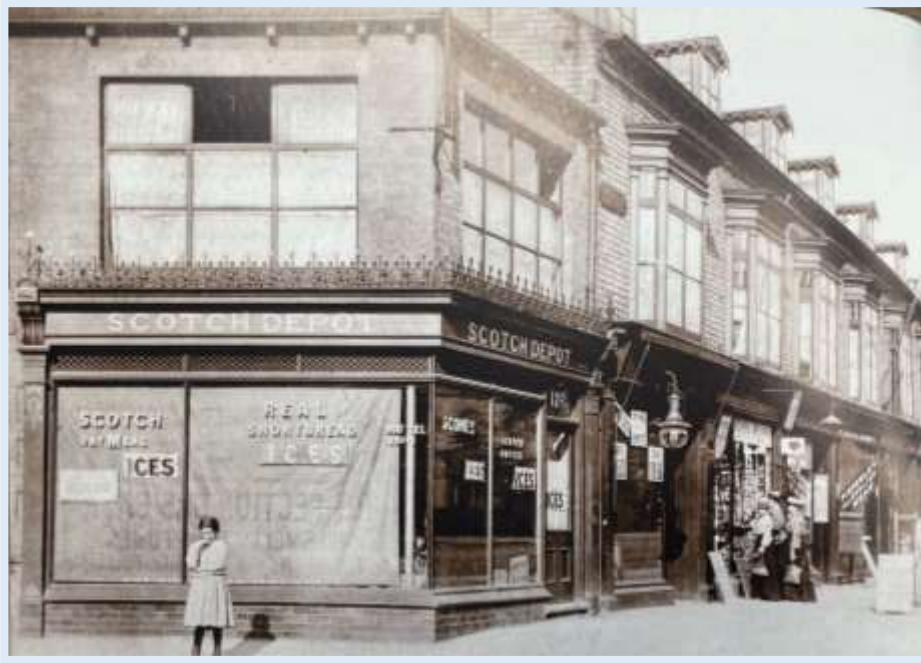
Figure 9 - Historical photograph from C1905 showing the styles of shopfronts installed on Spring Bank (Gibson, Hull Then and Now, Volume 2, 2010)

The majority of the traditional shopfronts along Spring Bank were installed in the mid-late 1800's after Spring Bank progressed from a "suburban 'promenade to the shopping 'centre' of the neighbourhood"¹ and many of the residential properties were converted to retail use on the ground floor level. This involved the wholesale adaption of the groups of buildings, each with a distinct style and detail that is visible in the historical photos from this time. Some of these details have been retained today.

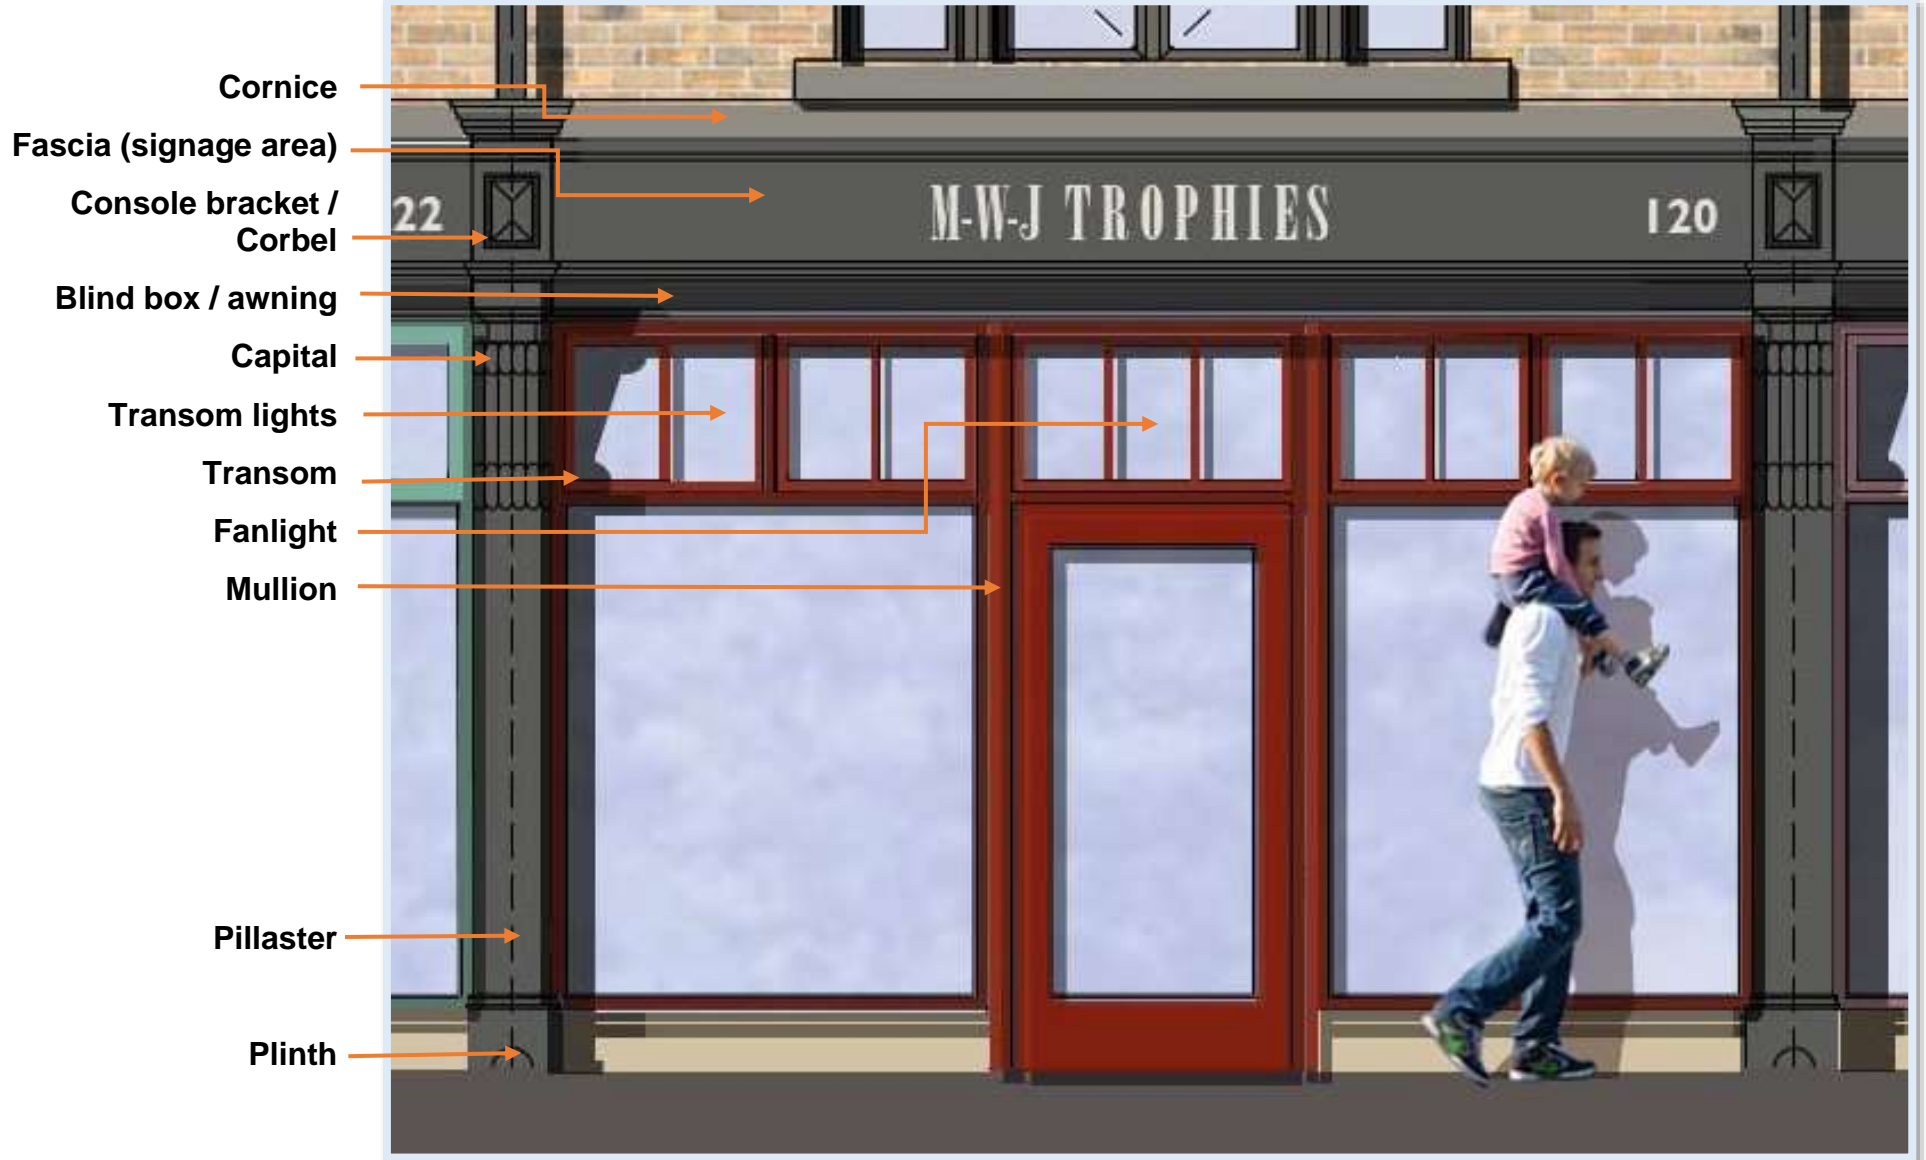
Figure 13 - Illustration showing the various parts of a shopfront design (Author, 2023)

Traditional Victorian shopfronts comprised of a number of different components, all designed to frame the goods on sale within, to provide maximum visibility of the goods on display and to respond to the architectural style and proportions of the building. The shopfronts were also designed to be highly functional, ensuring that rainfall is managed and shed from the building and that ventilation and protection from the sun through the use of blinds/awnings were all included in the shopfront design. A traditional shopfront design comprises of the following components :

Cornice - ensures that rainwater is thrown away from the building and protects the shop frontage from water damage

Fascia - provides the area where signage is applied (traditionally hand painted directly onto the fascia)

Blind boxes - These were positioned either above or below the fascia and conceal the blinds/awnings when not in use. The support brackets were often fixed to the pilaster.

Console brackets / corbels - a decorative element that sits at the top of the pilaster which frames the fascia and conceals/protects the edges of the fascia panel.

Stall risers - These provide a solid base to the shop front, protect the shopfront from passers-by kicking the glass and also prevent water damage to the timber shopfront.

Transom lights - These are windows at high level and were traditionally installed to conceal the gas lights behind. They are often used as a decorative feature using stained glass and translucent glass and were often created using leaded lights (small panes of glass connected together with lead cames).

Fanlight - These are positioned above the door and were often pivot opening fanlights to provide ventilation to the shop unit.

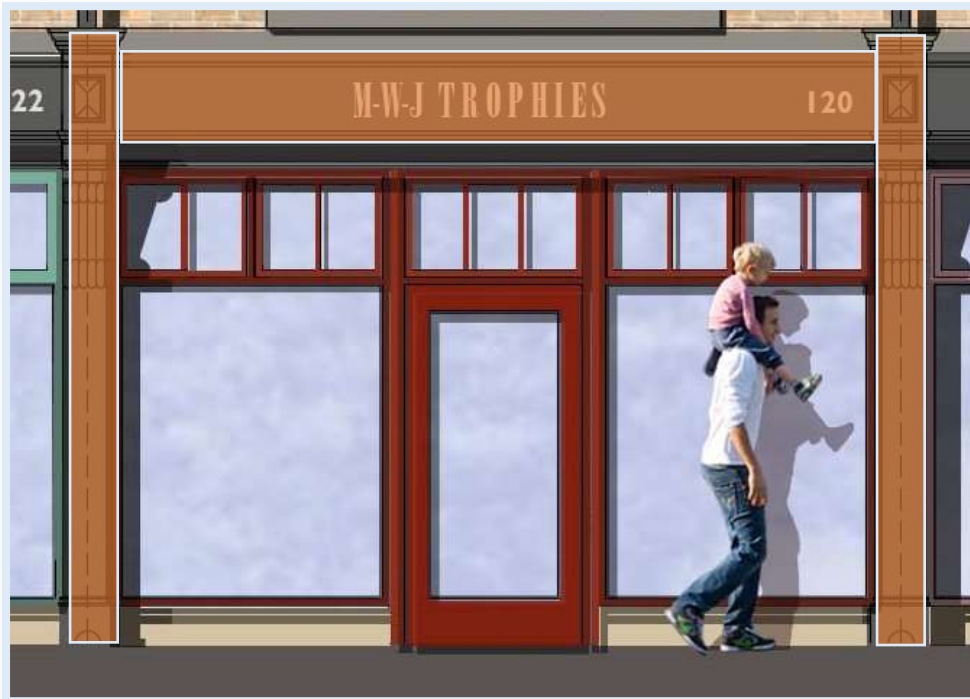
Figure 15 - Illustration showing how the pilasters and fascia frame the shopfront (Author, 2023)

The following diagram illustrates some key principles that can be applied to either traditional or modern shopfronts to ensure a successful design.

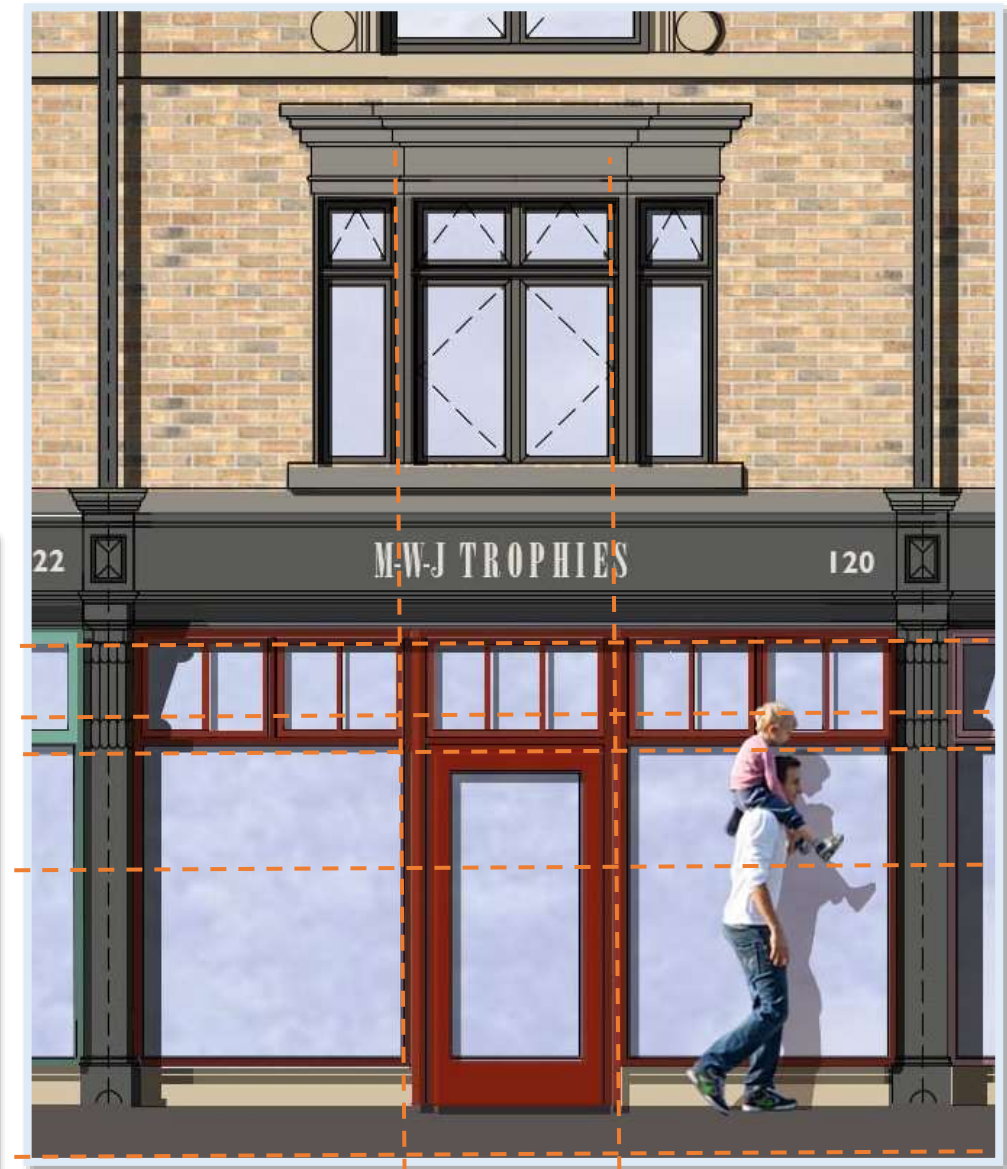
Figure 14 - Illustration showing how the proportions of the various elements of the shopfront should align to create a visually considered design (Author, 2023)

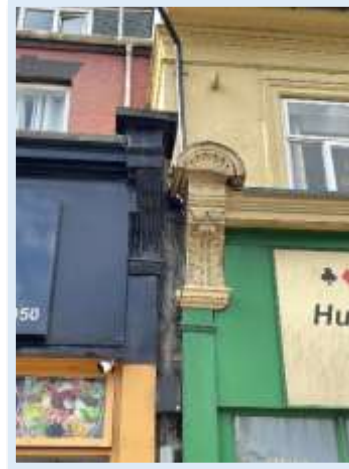
Figure 18 - Photograph of 117 Spring Bank (Author, 2023)

The lack of consistency in colour range and the use of bright colours also detracts from the retained historical details and character of the Conservation Area. A lack of cohesion in the font styles used for signage across the shopfronts also impacts negatively, with signs competing for the attention of passers-by.

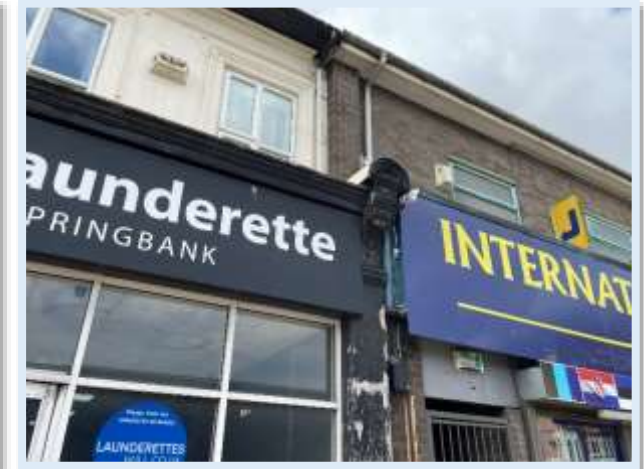
Figure 17 - Photograph of 121 Spring Bank (Author, 2023)

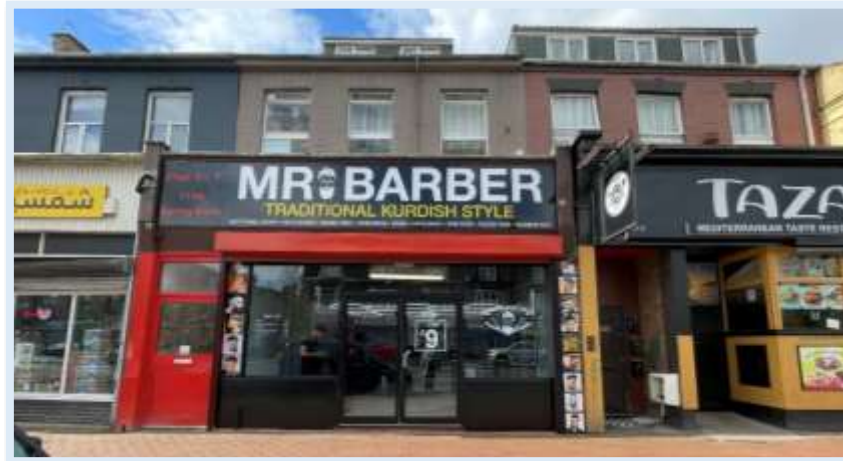
Figure 19 - Photograph of 113 Spring Bank (Author, 2023)

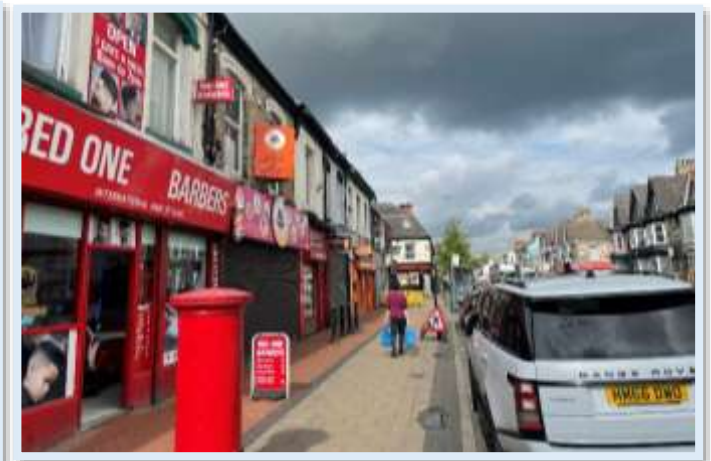
Figure 20 - Photograph of 153 Spring Bank (Author, 2023)

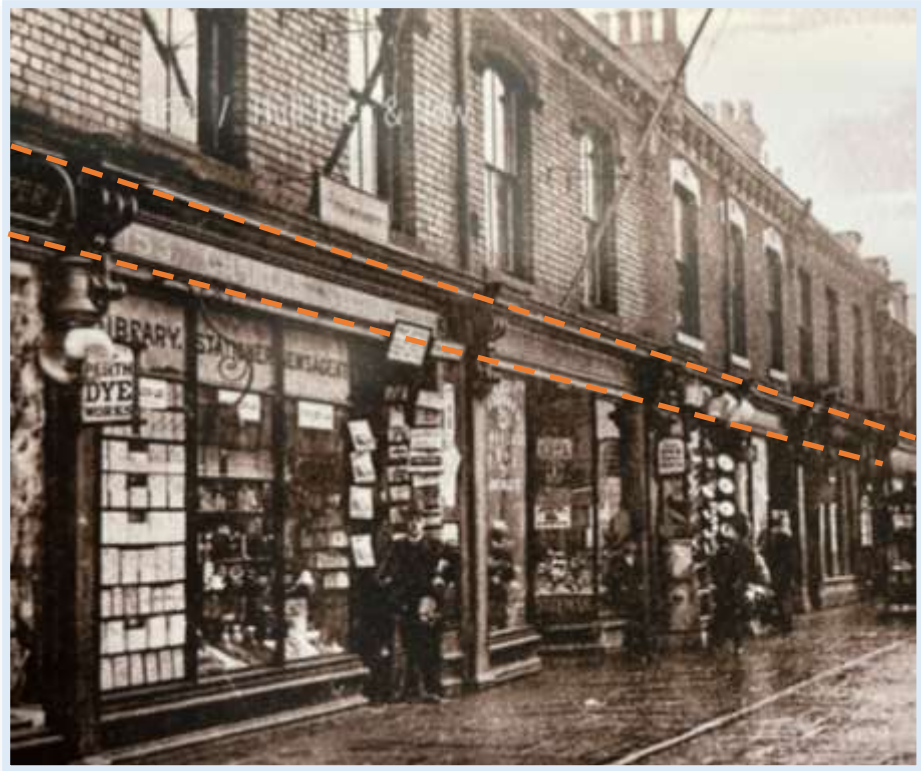
Figure 22 - Historical photograph from 1905 showing an example of the shopfronts on Spring Bank (Gibson, Hull Then and Now, Volume 1, 2008)

The historical photographs of Spring Bank show how traditional signage was incorporated into the shop front. The fascia panel, which was either vertical or sloping, provided the name and number of the shop. This would have been hand painted directly onto the fascia and repainted for each new tenant. The signage was limited to the fascia only and framed by the console brackets to each side. This provided a consistency across all units.

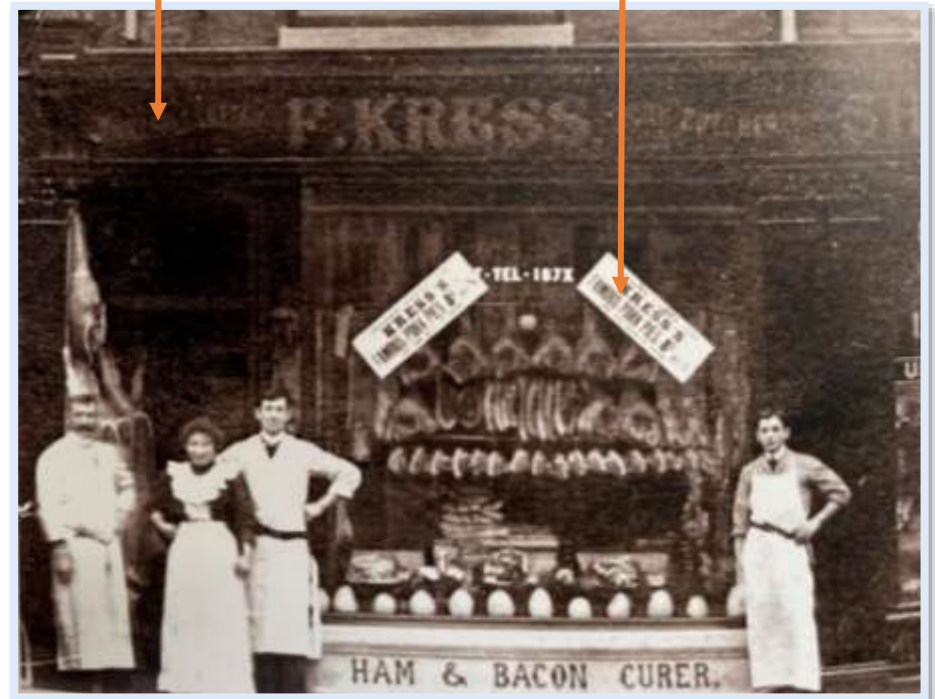
Figure 23 - Historical photograph from 1905 showing No 235 showing the signage (Gibson, Hull Then and Now, Volume 1, 2008)

Additional signage and advertisements were often incorporated into the shopfront and either hand painted directly onto the glass or printed onto paper and positioned behind the glass for extra impact.

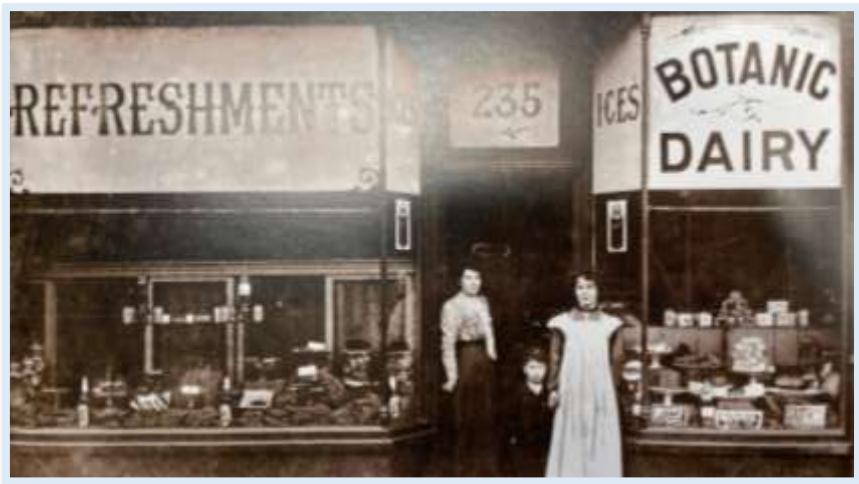
The below image of No 235 Spring Bank showing the use of Bohemia Font to 'REFRESHMENTS'.

Gill Sans bold to 'BOTANIC DAIRY'

Figure 28 - Historical photograph from 1905 showing No 235 showing the signage (Gibson, Hull Then and Now (5th Edition), 2015), p54.

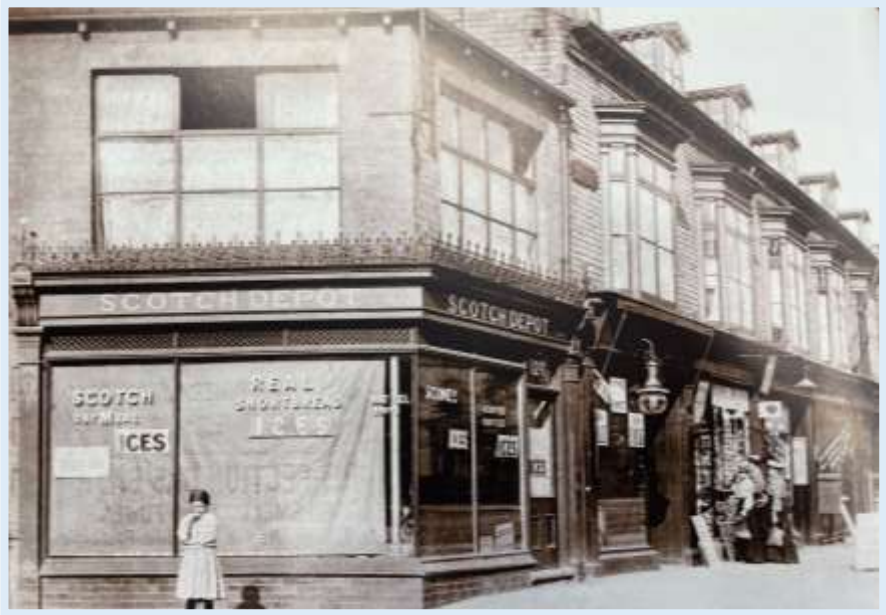
Wampum Font to 'SCOTCH DEPOT'

Figure 32 - Historical photograph from 1904 showing the signage to 129a Spring Bank (Gibson, Hull Then and Now, Volume 3, 2012)

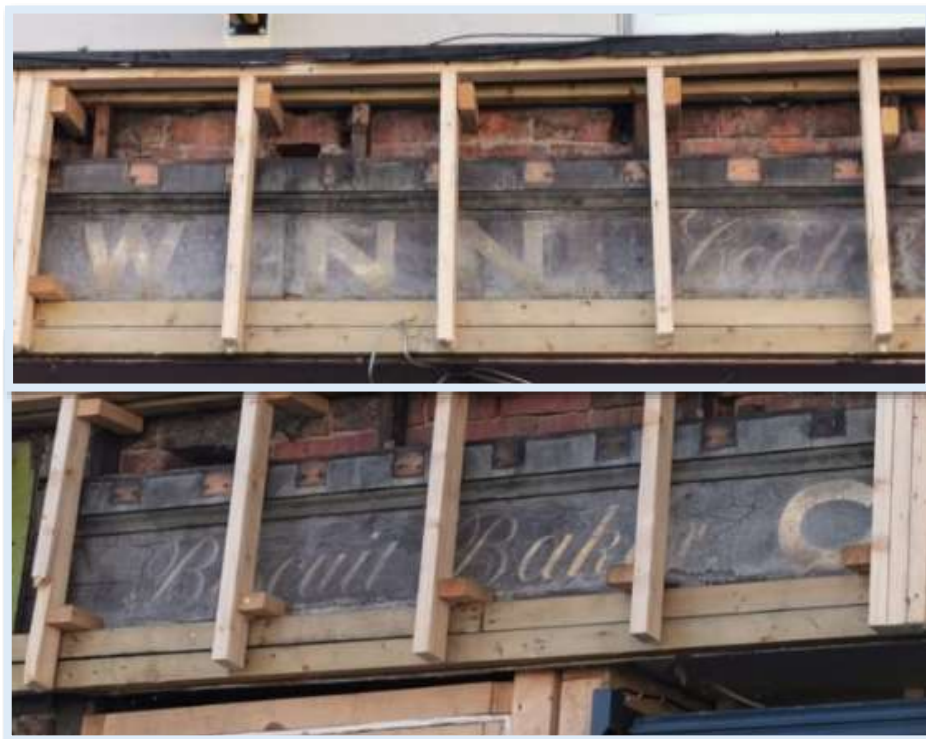
There is a possibility that some of the original signage fascias are concealed behind the later addition signage and could be uncovered. For example, the following photos were taken of 175 Spring Bank (south side) and show the original hand painted signage for a Bakery shop.

Gill Sans bold to 'OWNN').

Commercial Script to Cook, Confectioner and Biscuit Baker)

Figure 35 - Photographs of signage to 175 Spring Bank. (Author, 2023)

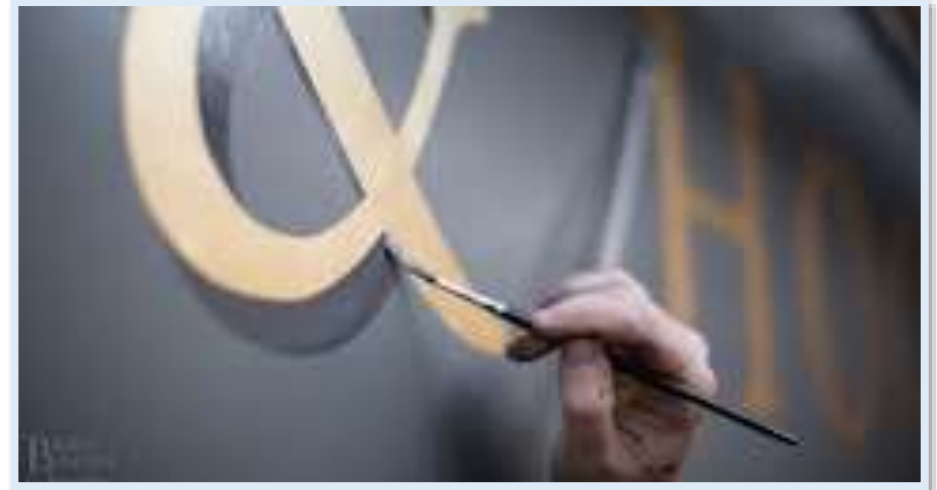
Figure 37-Hand painted signage (Boards, 2023)

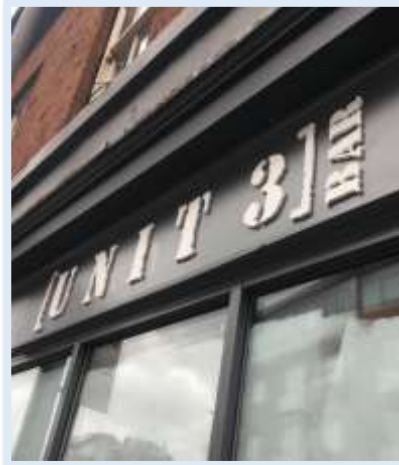
Figure 39 -Cut out letters on a traditional fascia can provide a more modern solution (SIGRAMCR., n.d.)

Where a more modern appearance is preferred, the use of cut out metal signage can be an affective solution that still respects the character of the historic shopfront design.

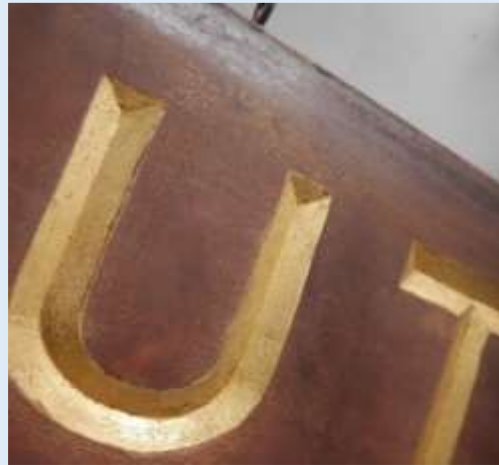
Figure 40 - V cut lettering on a traditional Victorian sign (Dibs, n.d.)

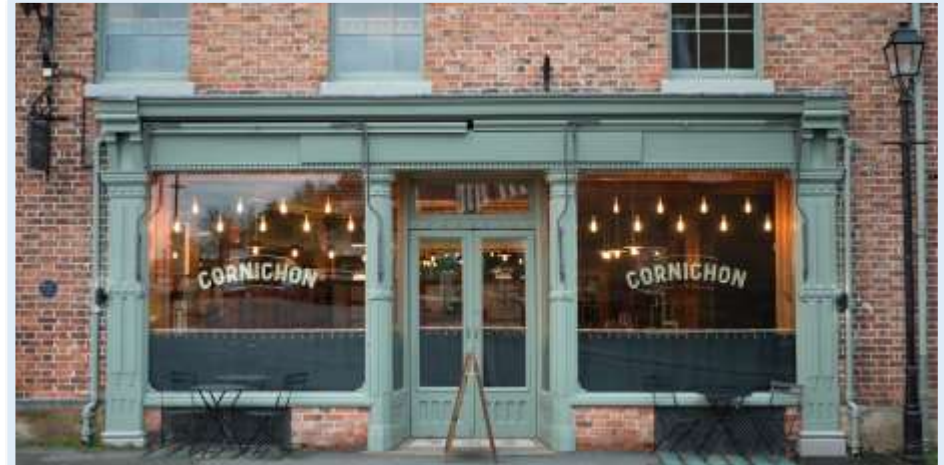
Figure 38 - Guided glass painted sign by Bravo Boards (Boards, 2023)

Signage can also be painted directly onto the glass frontage which allows the introduction of secondary signage at eye level, to the street.

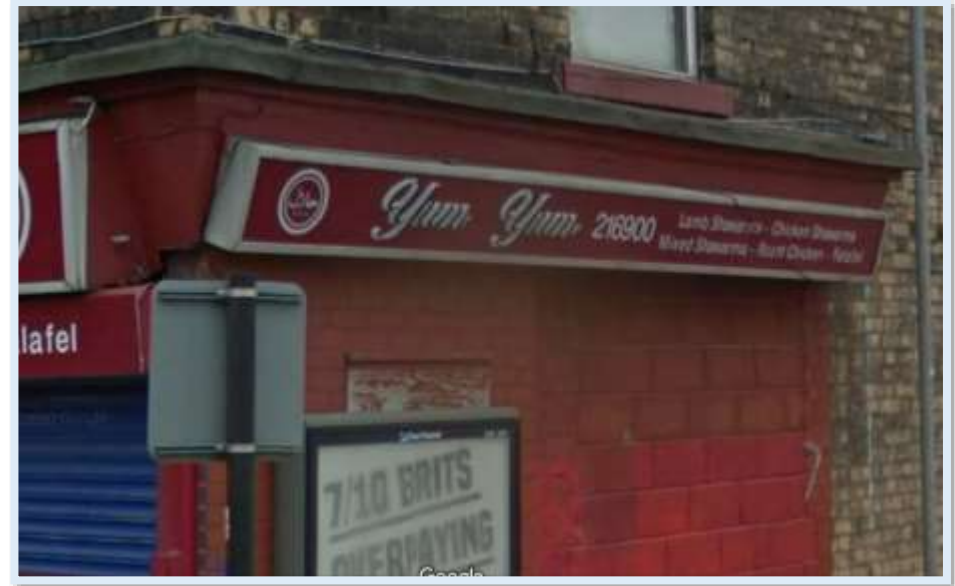
Figure 41 - Retained cornice detail to 141 Spring Bank (Author, 2023)

The cornice projects out over the fascia and the shopfront below and it serves to throw water away from the shopfront joinery work to prevent moisture getting into the end grain of the wood. The cornice would traditionally be topped with a lead flashing that was lapped 150mm into the brickwork above, provide a waterproof seal and preventing water from dripping into the timber work below.

Some cornice details have been retained along Spring Bank and should be used to establish the profile of cornice to be used to restore adjacent shopfronts within the group. Evidence of cornice details may also be found behind existing shop signage that can influence the design and proportions of a restored shopfront.

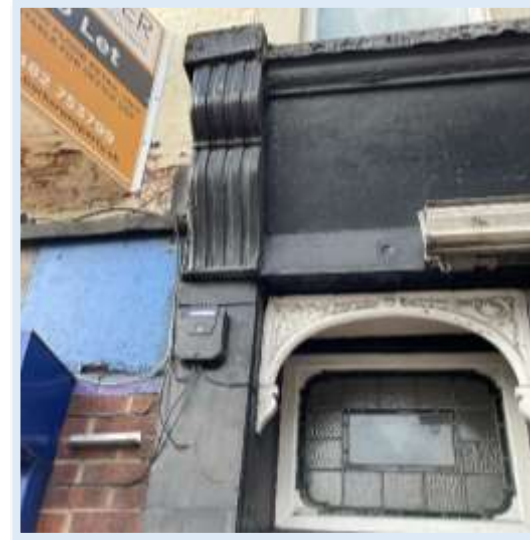
Figure 42 - Retained cornice detail to 45 Spring Bank (Author, 2023)

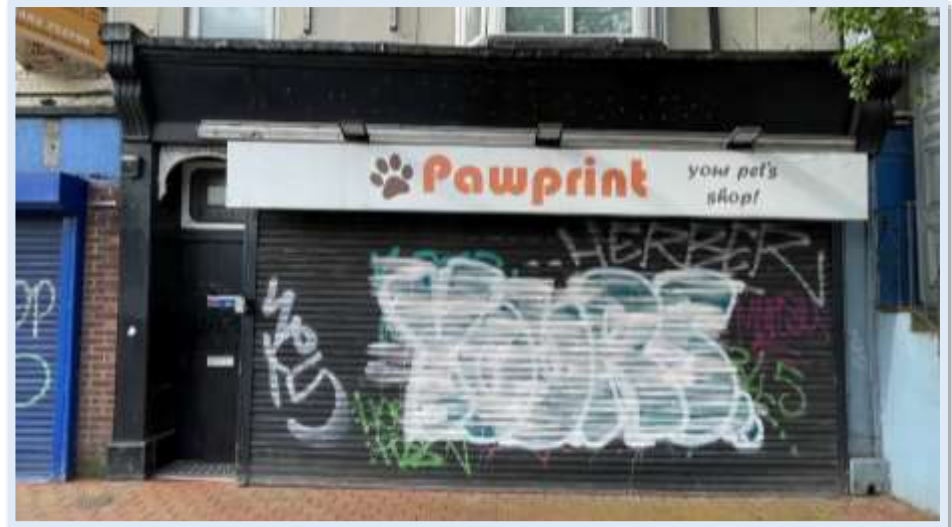
Figure 43 - No 45 Spring Bank showing the retained pilasters and console brackets dating from the late 1800's. (Author, 2023)

The following pages provide a record of the retained corbel details to both the south side (odd numbers) and north side (even numbers).

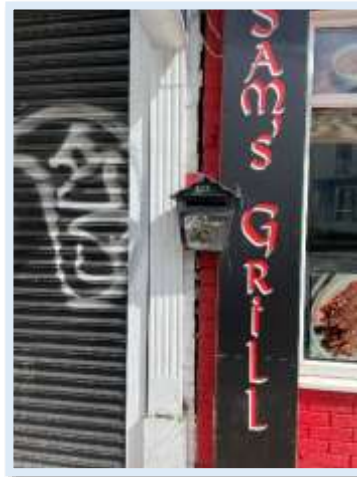
Figure 44 - No 104 Spring Bank showing the retained pilaster detail (Author, 2023)

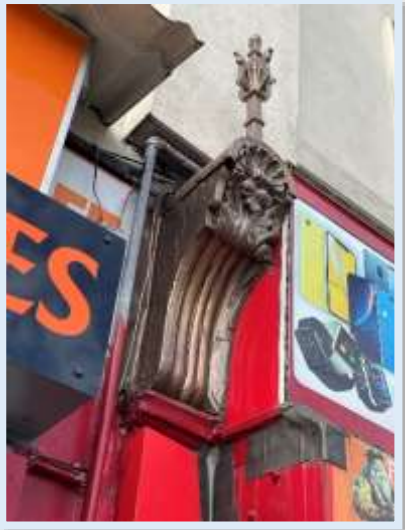
Figure 49 - Retained console bracket to No 19 Spring Bank (Author, 2023)

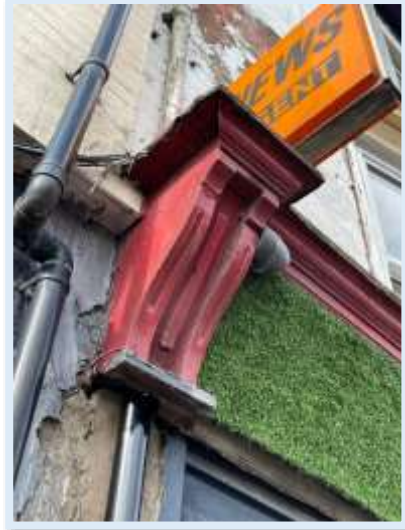
Figure 47 - Retained console bracket to No 21 Spring Bank (Author, 2023)

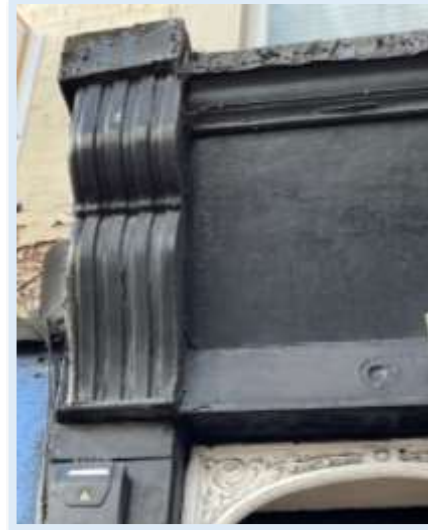
Figure 46 - Retained console bracket to No 21 Spring Bank (Author, 2023)

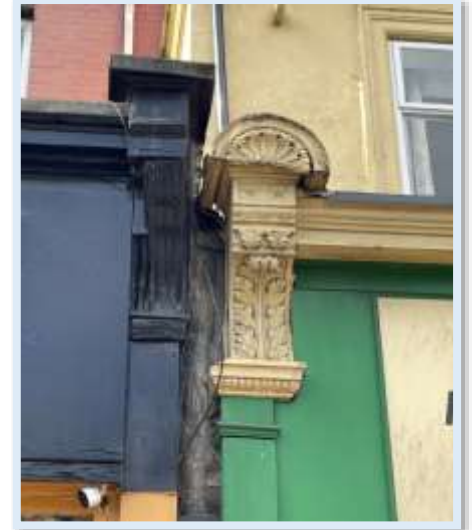
Figure 48 - Retained console brackets to No 45 and 47 Spring Bank (Author, 2023)

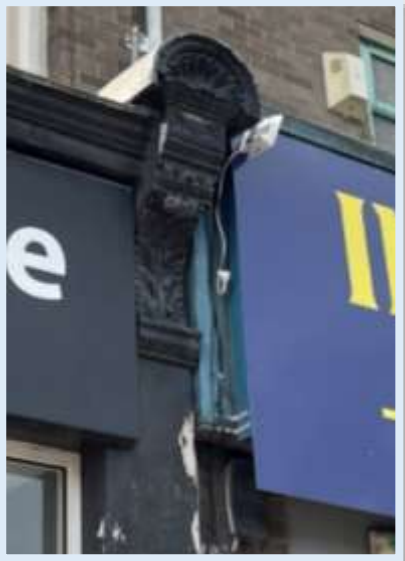
Figure 50 - Retained console brackets to No 121 Spring Bank (Author, 2023)

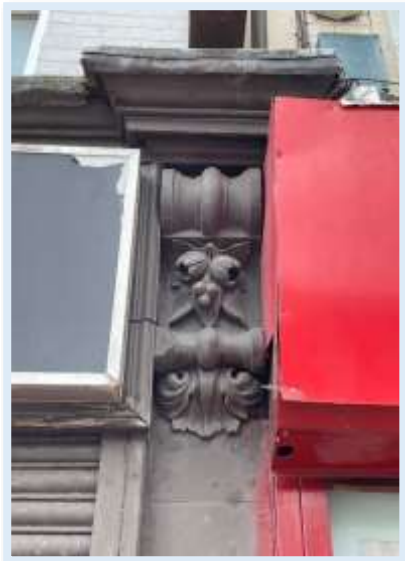
Figure 51 - Retained console brackets to No 151 Spring Bank (Author, 2023)

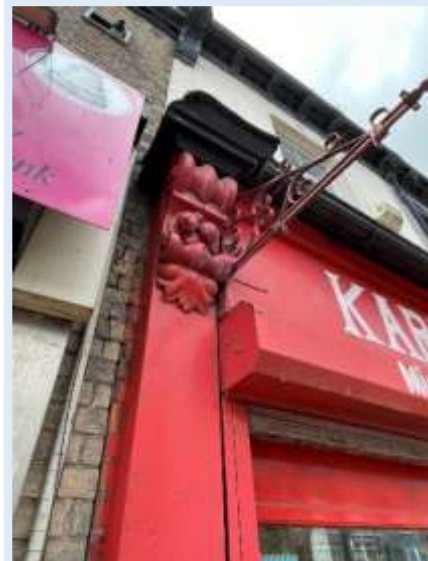
Figure 53 - Retained console bracket to No 157 Spring Bank (Author, 2023)

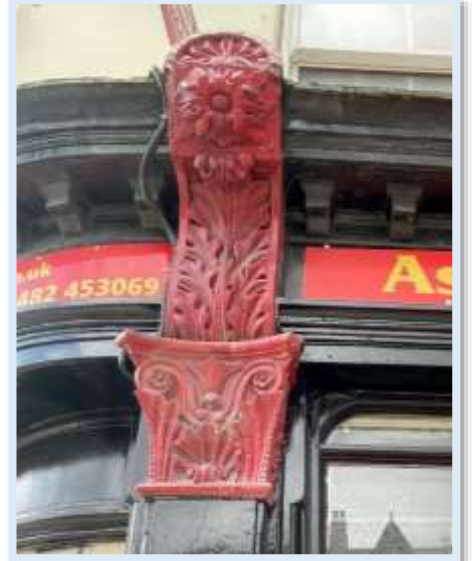
Figure 52 - Retained console brackets to No 169 & 121 Spring Bank (Author, 2023)

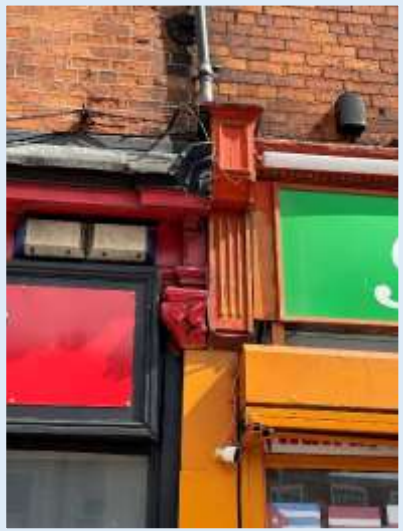
Figure 61 -Retained console bracket to No 98 Spring Bank (Author, 2023)

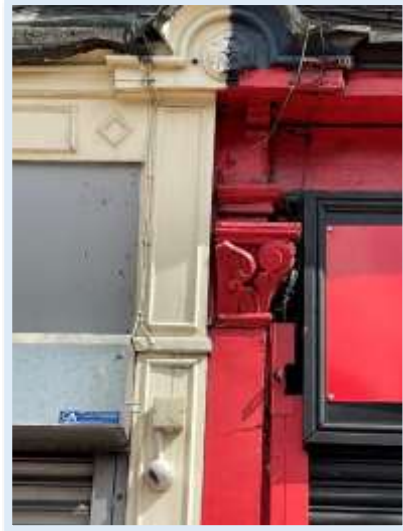
Figure 59 - Retained console bracket to No 96/98 Spring Bank (Author, 2023)

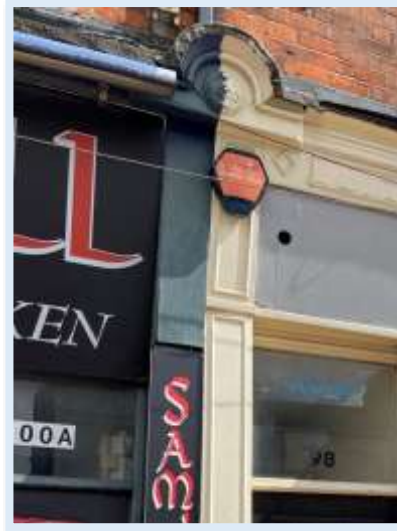
Figure 58 -Retained console head to No 94/98 Spring Bank (Author, 2023)

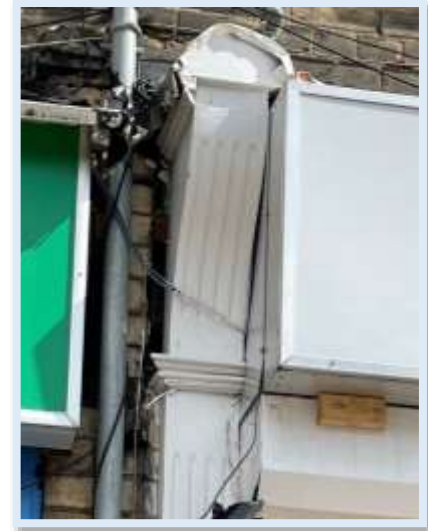
Figure 60 - Retained console brackets to No 102 Spring Bank (Author, 2023)

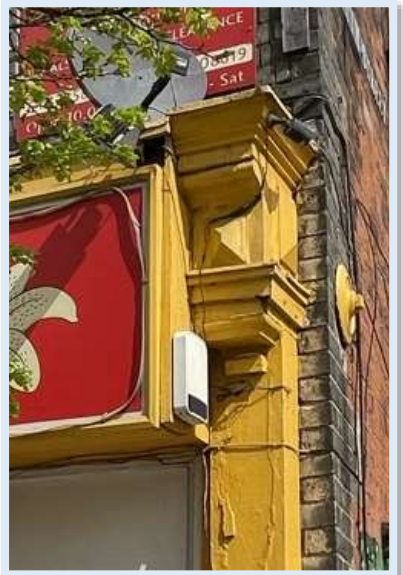
Figure 55 - Retained console brackets to No 121 Spring Bank (Author, 2023)

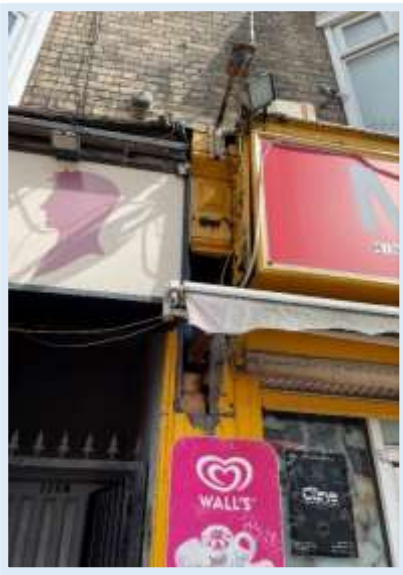
Figure 56 - Retained console brackets to No 114 Spring Bank (Author, 2023)

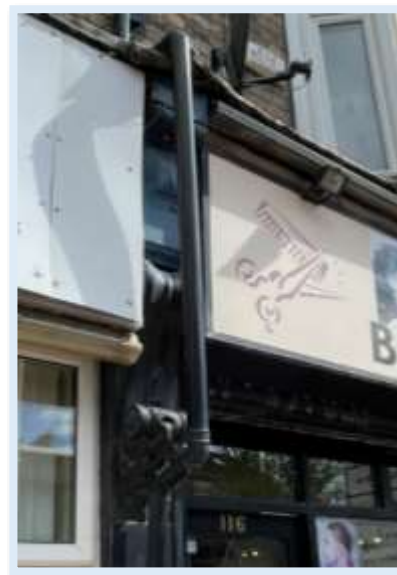
Figure 57 -Retained console bracket to No 118 Spring Bank (Author, 2023)

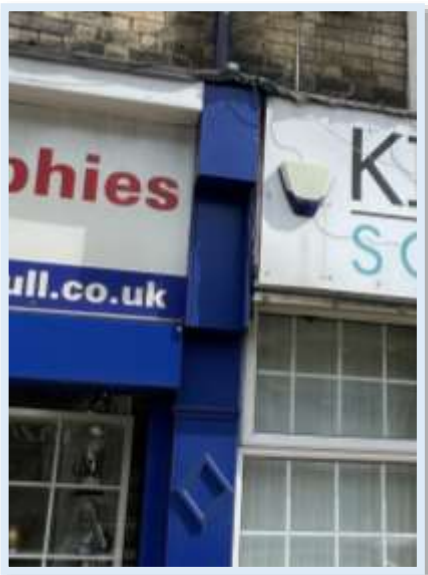
Figure 54 - Possible retained console brackets (behind box-out) to No 122 Spring Bank (Author, 2023)

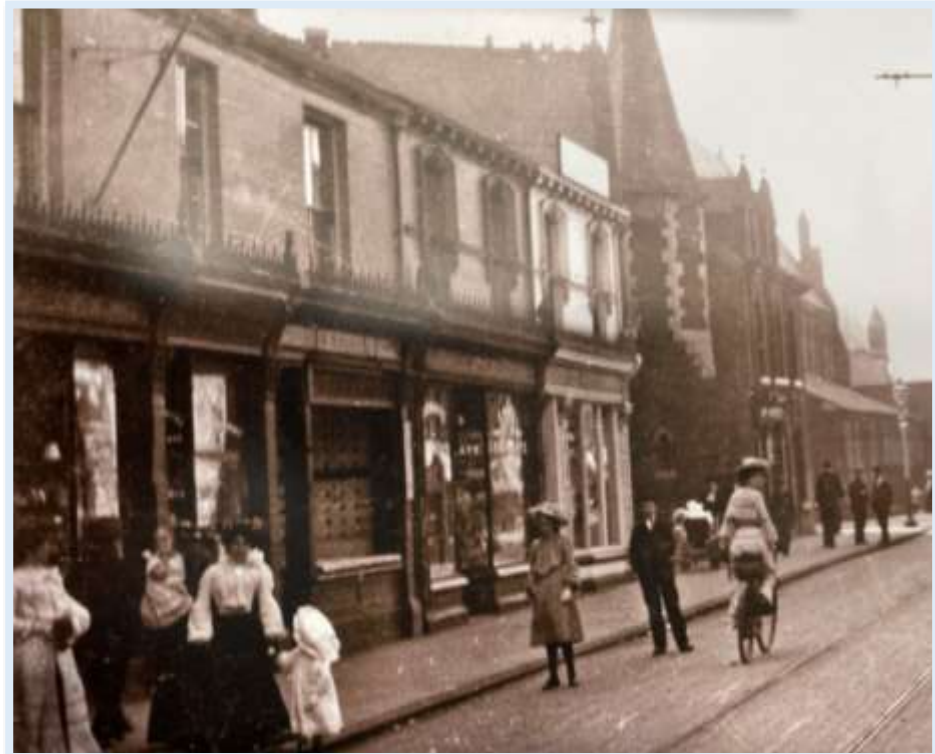
Figure 62 -Historical photograph from 1905 showing the south side of Spring Bank and the decorative corbels from No 169 – 175 (Gibson, Hull Then and Now, Volume 1, 2008)

The adjacent photographs show the extent of decorative corbels applied across the Victorian shopfronts when installed in the late 1800's. These corbels visually define the extent of the unit and provide an attractive detail to the head of the pilasters between units.

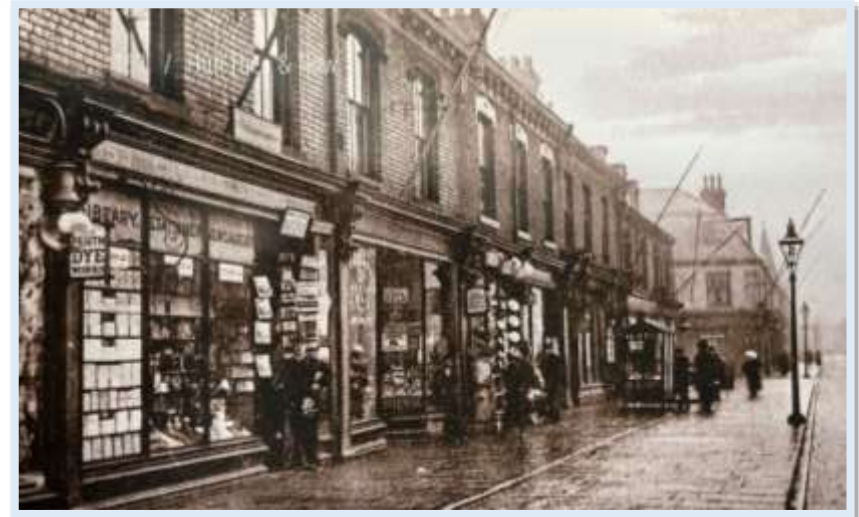
Figure 63 - Historical photograph from 1905 showing the south side of Spring Bank and the decorative corbels from No 153- 159 (Gibson, Hull Then and Now, Volume 1, 2008)

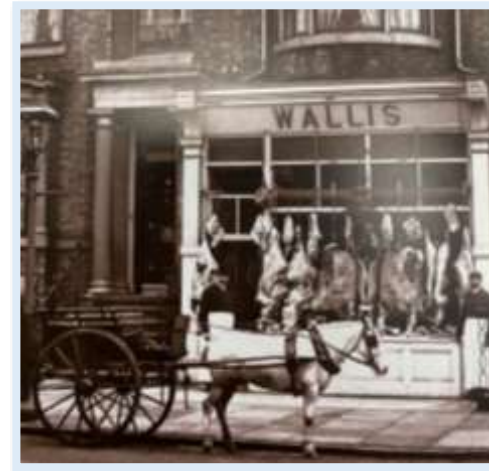
Figure 64 - Historical photograph from 1905 showing the south side of Spring Bank and the decorative corbels to No 109 (Gibson, Hull Then and Now, Volume 1, 2008)

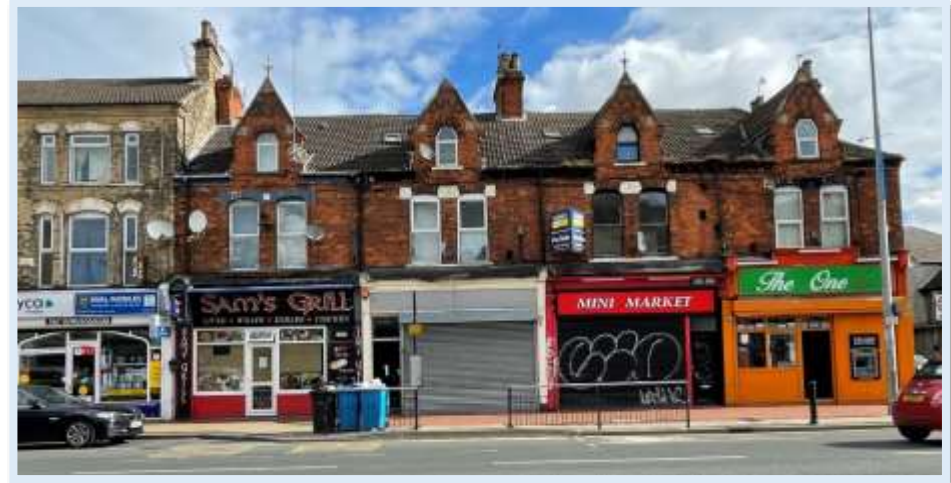
These roller shutters look unsightly, prevent views into the shop during the out of hours periods and are often subject to graffiti which further diminishes the quality and character of the Conservation Area.

Figure 65 - Examples of the extent of metal shutter installation to the shopfronts along Spring Bank (Author, 2023)

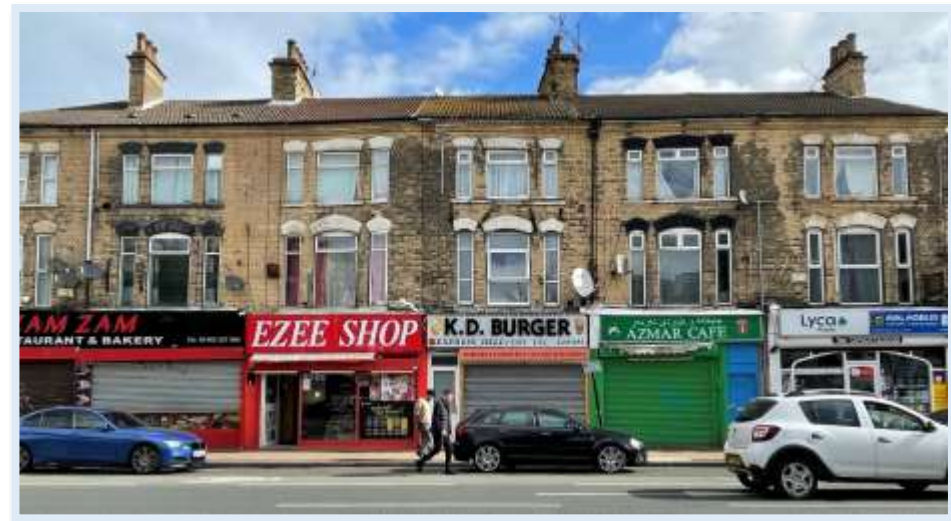
Figure 66 Examples of the extent of metal shutter installation to the shopfronts along Spring Bank (Author, 2023)

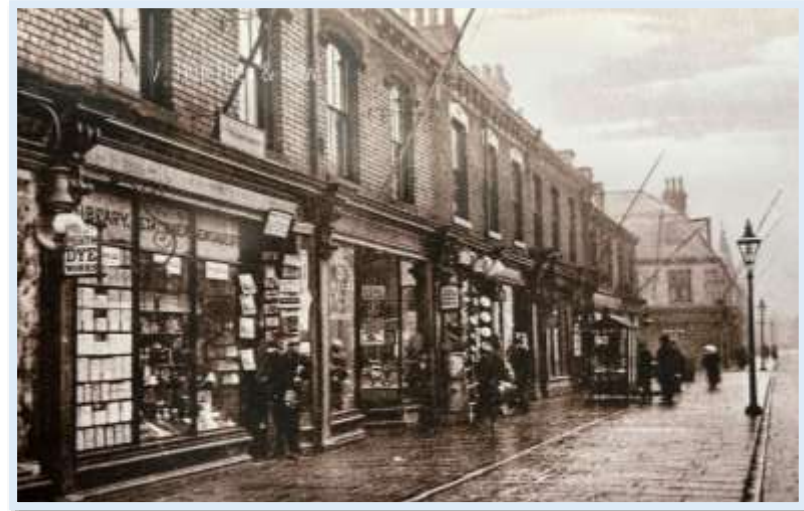
Historically shopfronts comprised of single glazed windows within a timber support frame. The shopfronts were often split horizontally and vertically to reduce the size of the glass as well as creating a more vertical emphasis and more elegant proportions. The reduced size of the glass provided more support to the glass, reduced the potential for damage and enabled the glass to be easily replaced.

Figure 67 -Historical photograph from 1905 showing the south side of Spring Bank from No 153- 159 showing the earlier shopfronts (Gibson, Hull Then and Now, Volume 1, 2008)

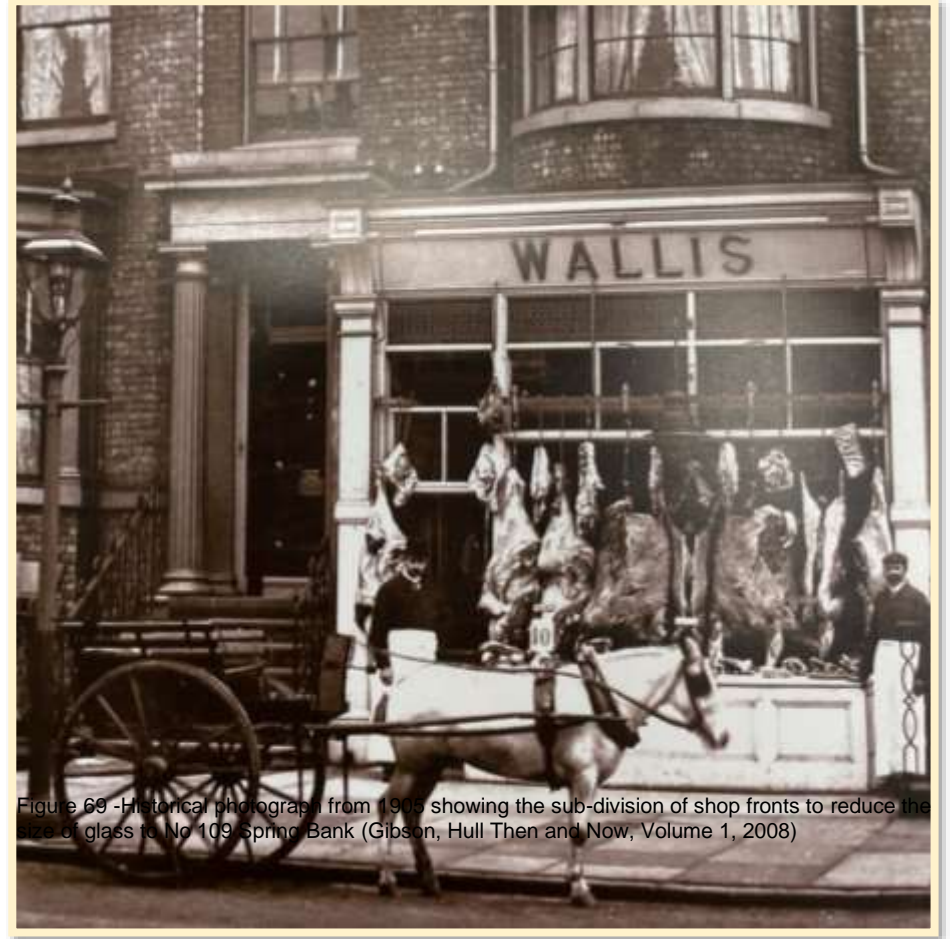
Figure 69 -Historical photograph from 1905 showing the sub-division of shop fronts to reduce the size of glass to No 109 Spring Bank (Gibson, Hull Then and Now, Volume 1, 2008)

Historical shopfronts utilised smaller areas of glass which were divided vertically and horizontally by decorative mullions. These helped to reduce the size of glazing units and therefore allowed for easier replacement. The use of stall risers at the base of the shopfront also reduced the risk of damage to the glass by raising the glass above floor level, making it less susceptible to damage.

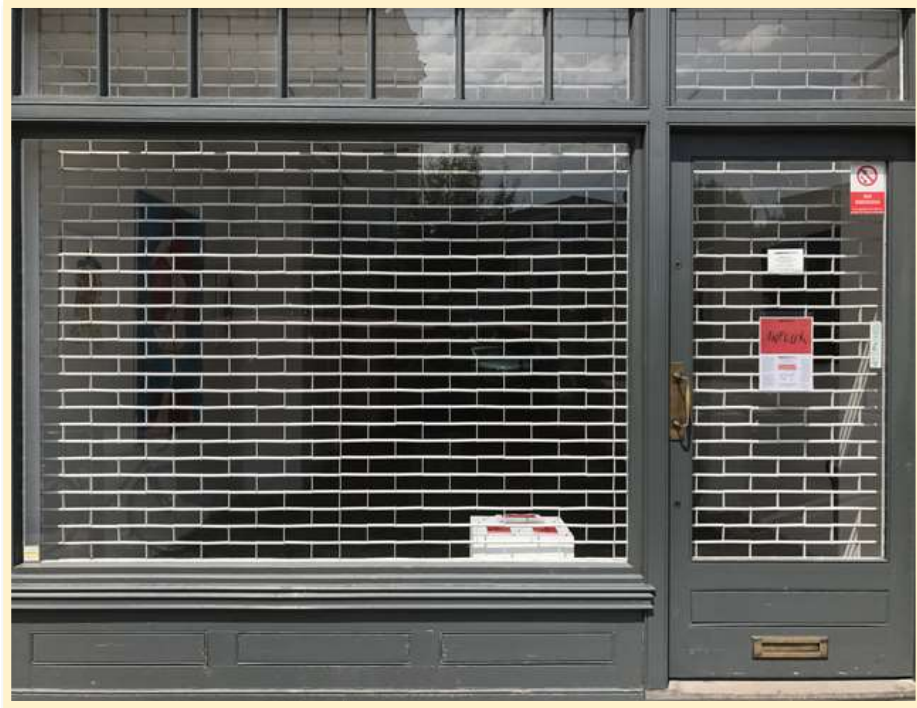
Figure 70 -Example of an internal lattice grill shutter to a restored shopfront (Shopfront, 2023)
