**Spring Bank Conservation Area
Shop Front Design Guide
Published June 2024**

This document is designed to set out the principles of design that should be considered with any proposed works in the Conservation Area. This should be used to guide both the design process and the decision making process to enable a consistent approach to be established and maintained in the future.

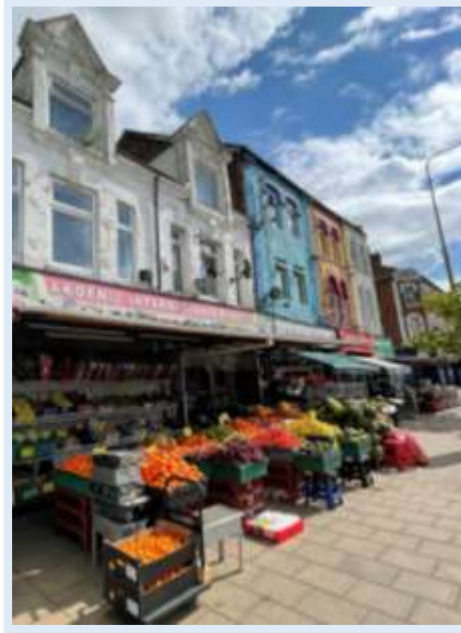
More recent development has resulted in the introduction of permanent covers to external areas constructed of low quality metal framed structures with profiles metal sheeting. The permanent nature of these covers requires the management of rainwater, resulting in exposed rain water pipes and outlets. This type of permanent covering has led to the loss of historic character to the street frontage.

Figure 73 - Existing permanent awnings (Author, 2023)

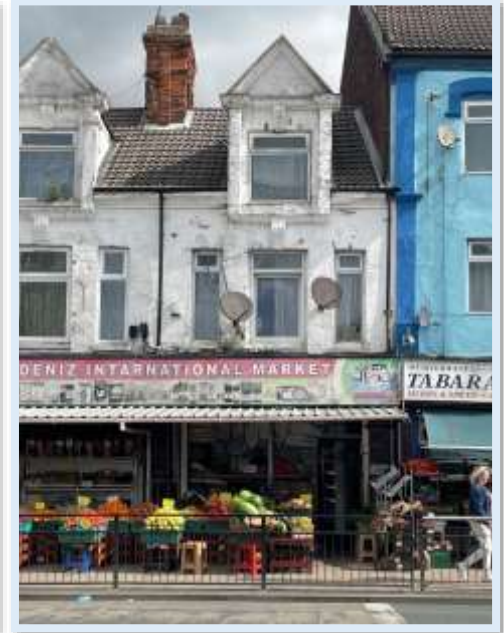
Figure 72 - Existing external display areas (Author, 2023)

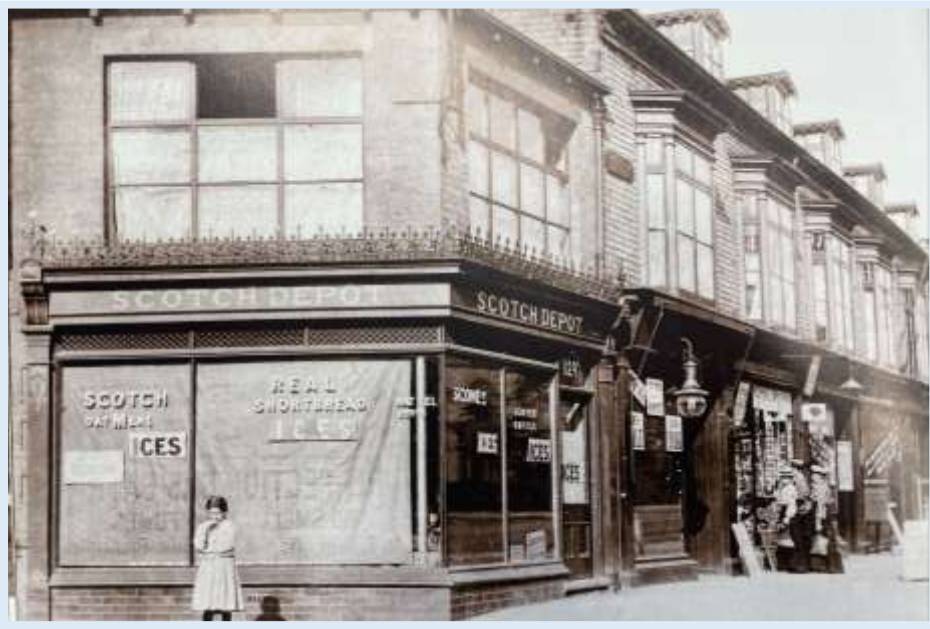
Figure 75 - Historical photograph from 1904 showing 129a and 129 adjacent on the south side of Spring Bank where the provision of an awning to the top of the fascia can be seen. (Gibson, Hull Then and Now, Volume 3, 2012)

The Victorian shop frontages would traditionally have incorporated a 'blind box' located at the top or base of the signage fascia with the metal stay bracket fixed vertically to the pilaster. This allowed awnings to be retracted out of hours and provided protection from damage.

Historical photographs of Spring Bank illustrate that many of the early Victorian shopfronts had awnings outside, sometimes along the full length of an urban block. These were predominantly located on the north side of the Spring Bank and would protect the south facing windows to this side of the street from excessive solar gain to the shop fronts as well as providing sheltered external display or seating areas.

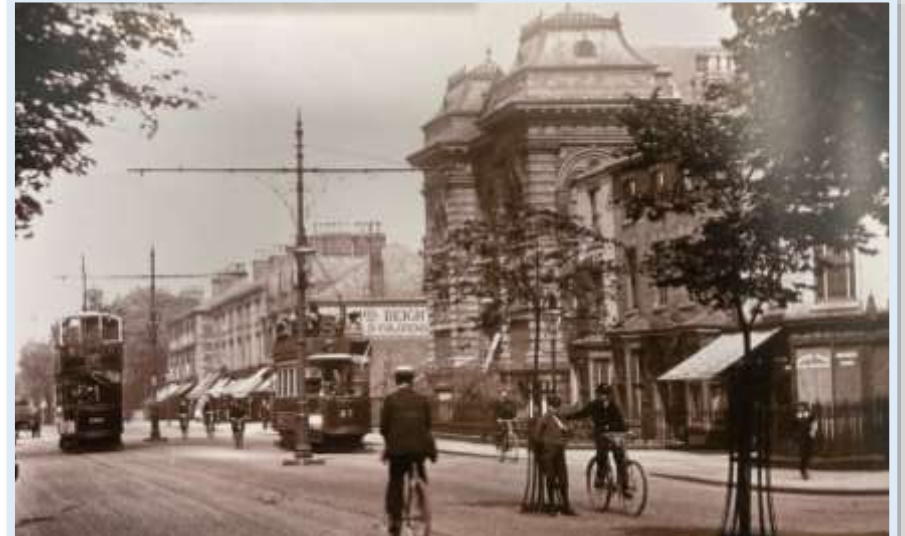
Figure 77 - Historical photograph from 1905 showing the north side of Spring Bank and the awning/blind to the outside the shop fronts. (Gibson, Hull Then and Now, Volume 1, 2008)

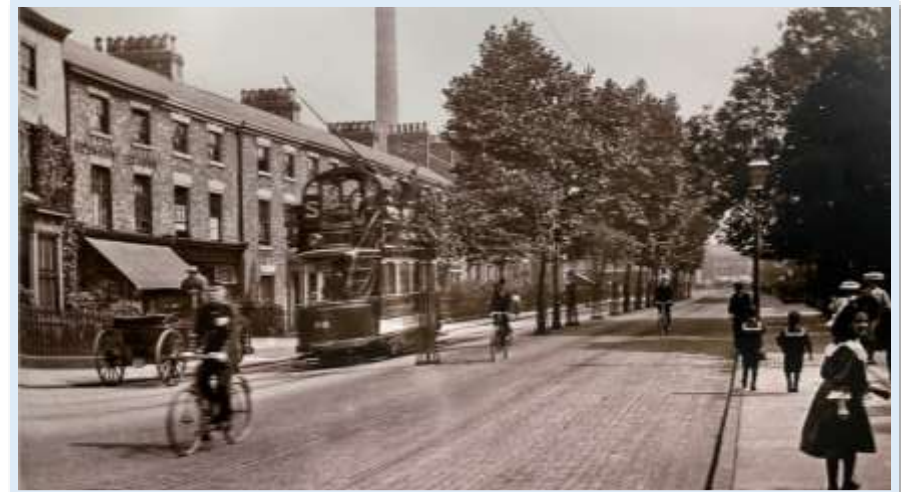
Figure 76 - Historical photograph from 1905 showing Brunswick Terrace to the north side of Spring Bank and the awning/blind to the Library. (Gibson, Hull Then and Now, Volume 1, 2008)

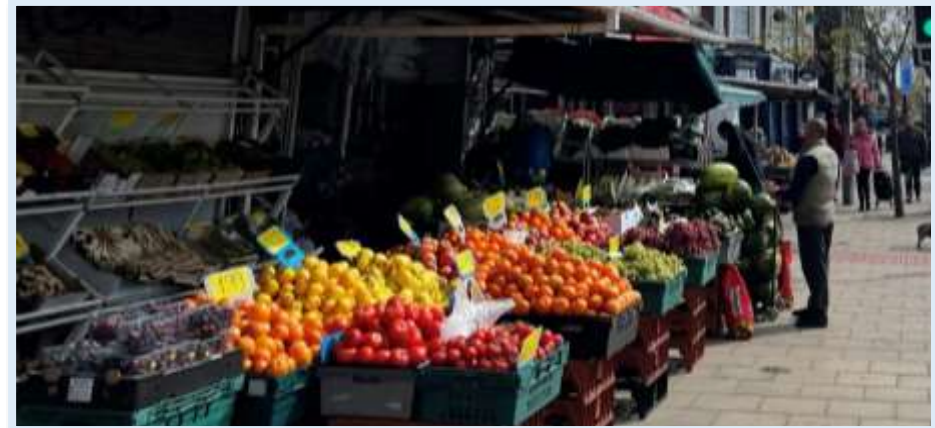
Figure 78 - Current photographs showing the use of external areas for the display of goods which is encouraged to enliven the street. (Author, 2023)

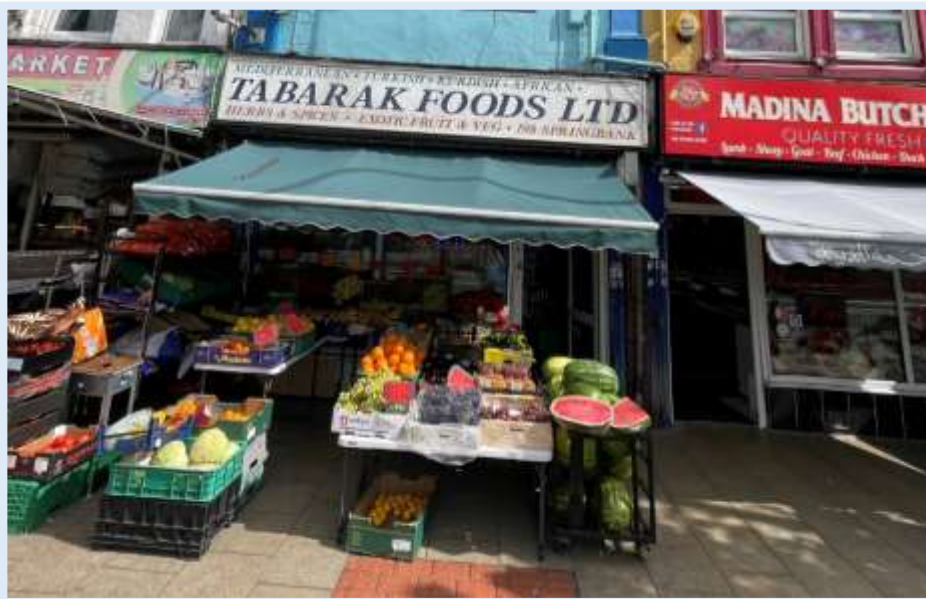
Where external cover/shade is required, traditional folding awnings should be provided to extend no further than the extent of land ownership.

Figure 80 - Current photograph showing the use of traditional retractable awnings which is encouraged. (Author, 2023)

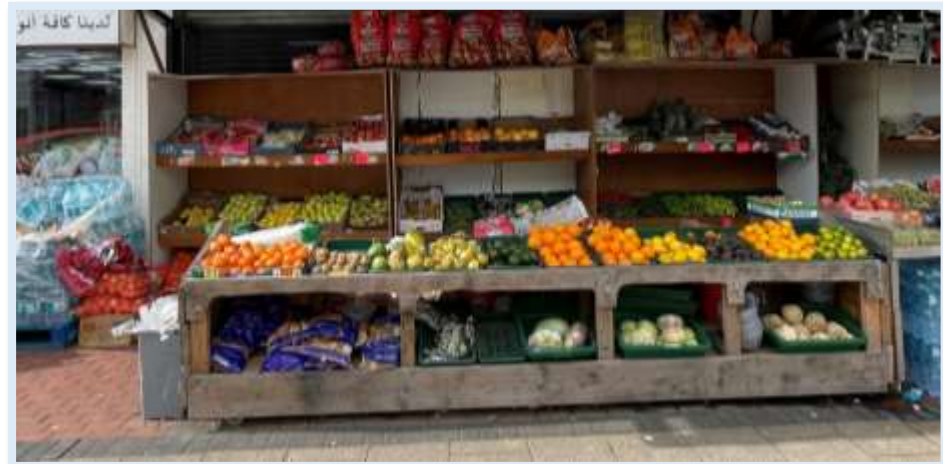
Figure 79 - Current photographs showing the use of external areas for the display of goods which is encouraged to enliven the street. (Author, 2023)

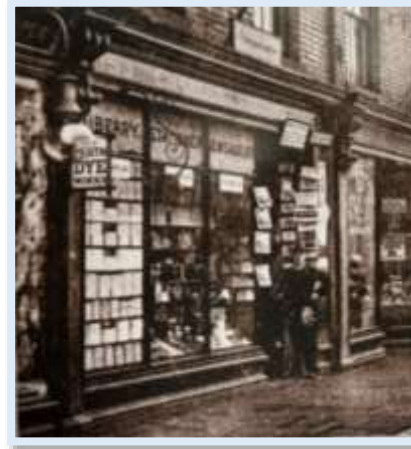
Figure 82 - Historical photograph from C1905 showing the carved stone stall riser (Gibson, Hull Then and Now, Volume 1, 2008)

Stall risers form the base to the shopfront and would be built from either stonework, brickwork or hardwood timber.

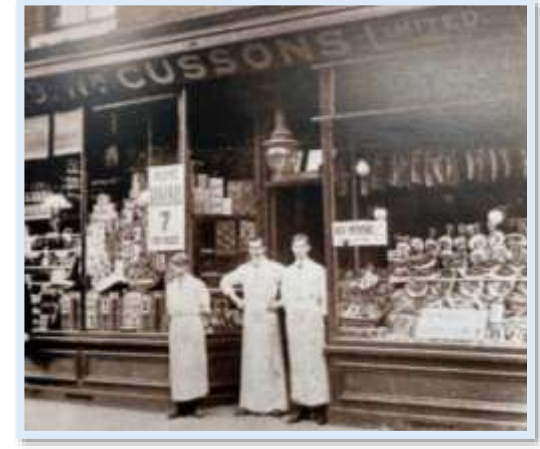
Figure 81 - Historic photograph of Spring from C1950 showing the timber panelled stall riser. (Gibson, Hull Then and Now, Volume 1, 2008)

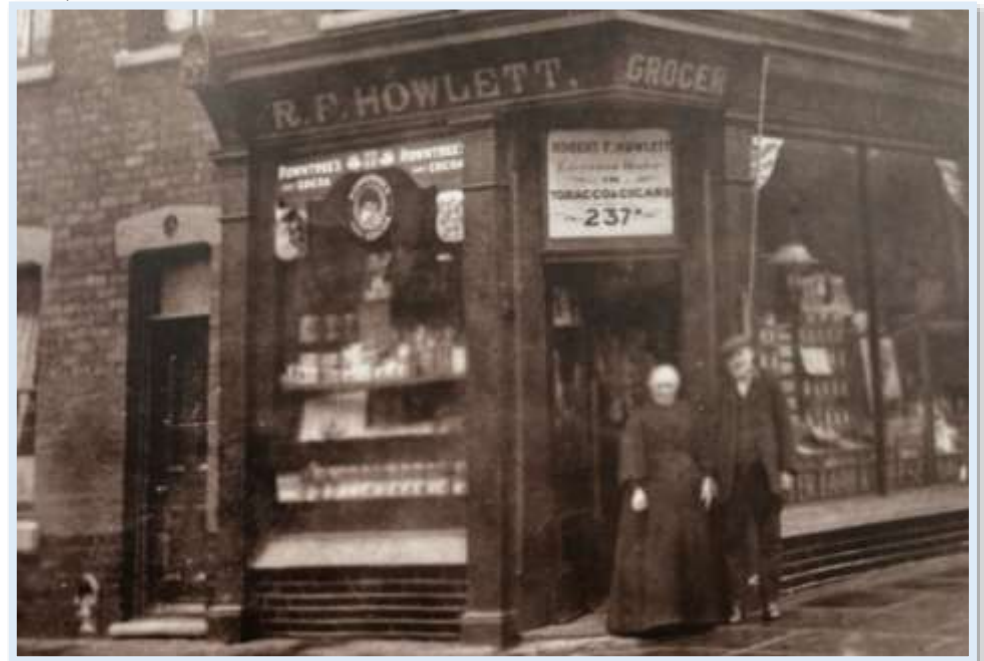
Figure 83 - Historic photograph from c1905 showing a brick stall riser. (Gibson, Hull Then and Now, Volume 1, 2008)

Stall risers are an important feature on a shopfront design and should not be overlooked in the shopfront design. Stall risers have a number of functions. They raise the shopfront off the ground, preventing moisture and rainfall to cause damp to the timber shopfront.

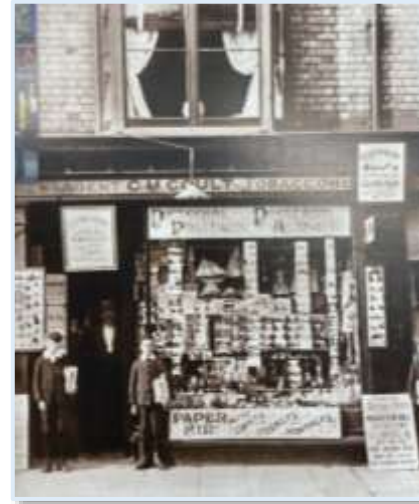
Figure 84 -Historical photograph from 1904/1905 showing the use of transom lights shopfronts on Spring Bank (Gibson, Hull Then and Now, Volume 1, 2008)

Transom lights are the high level windows above the main shop front. These were often decorative elements and incorporated leaded lights, often with translucent glass or decorative stained glass that provided dappled diffused light from within and were designed to conceal the gas light fittings when viewed externally.

Ventilation grills were located above the transom light and provided background ventilation into the shopfront to prevent a build-up of moisture and heat within the shop.

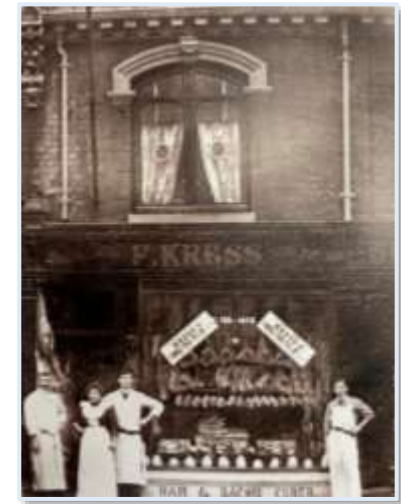
Figure 85- Historical photographs from 1904/1905 showing the use of ventilation grills in shopfronts on Spring Bank (Gibson, Hull Then and Now, Volume 1, 2008)

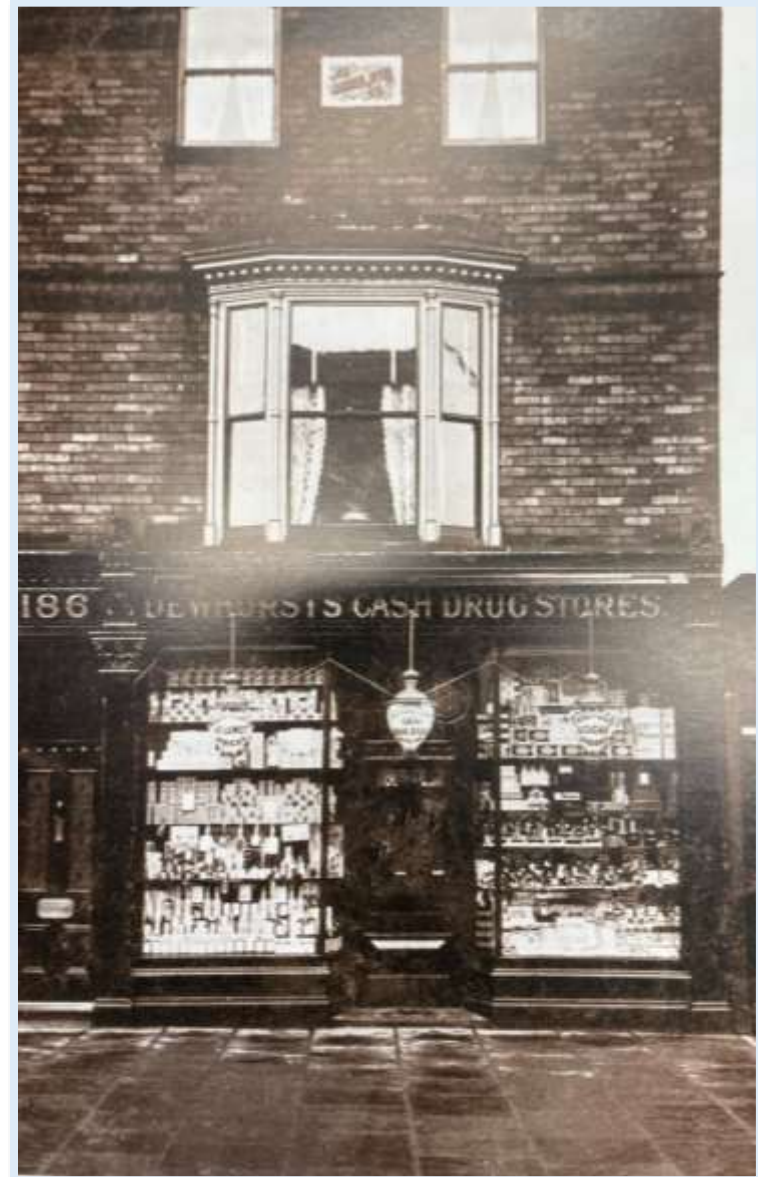
Figure 91 -Historical photographs from 1905 showing an example of the doorway designs on Spring Bank (Gibson, Hull Then and Now, Volume 1, 2008)

More recent development of the units along Spring Bank has led to the loss of most historic shopfronts with only remnants of a few remaining. Very few of the modern shopfronts have incorporated the recessed doorway into the new designs. This has led to a loss in the depth and visual interest of the shopfronts along the street.

Accessibility and providing level door thresholds to comply with the Equality Act 2010 has also contributed to the loss of historic entrance ways and recessed doors. Recessed doorways, however, can be used to create a gentle ramp into the unit from the street.

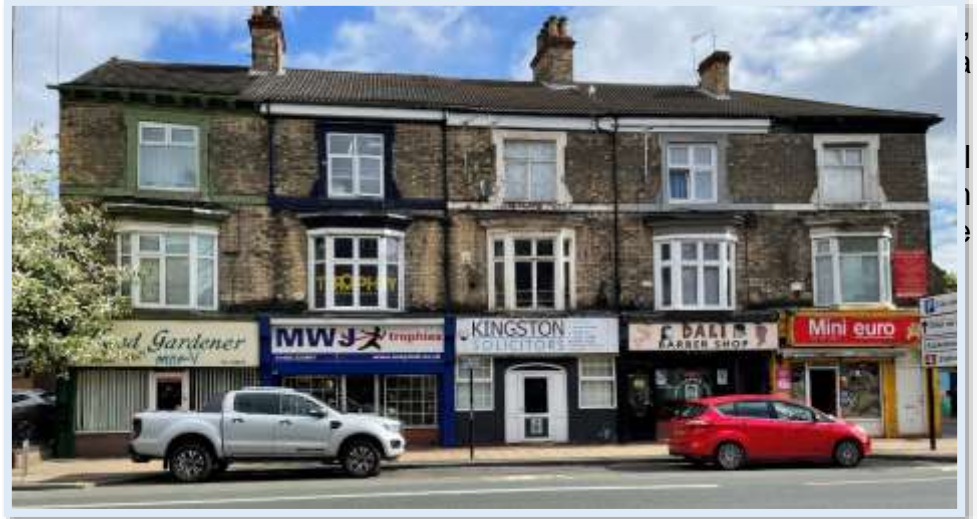
Figure 92 - Existing photograph of the group of buildings (Author, 2023)

The following pages provide an example of how to approach a group of shopfronts and is based on No 114, 116, 118, 120 and 122, a group of buildings designed and built at the same period of time.

The existing photograph shows how the shopfronts vary considerably across the group. The signage fascia varies in

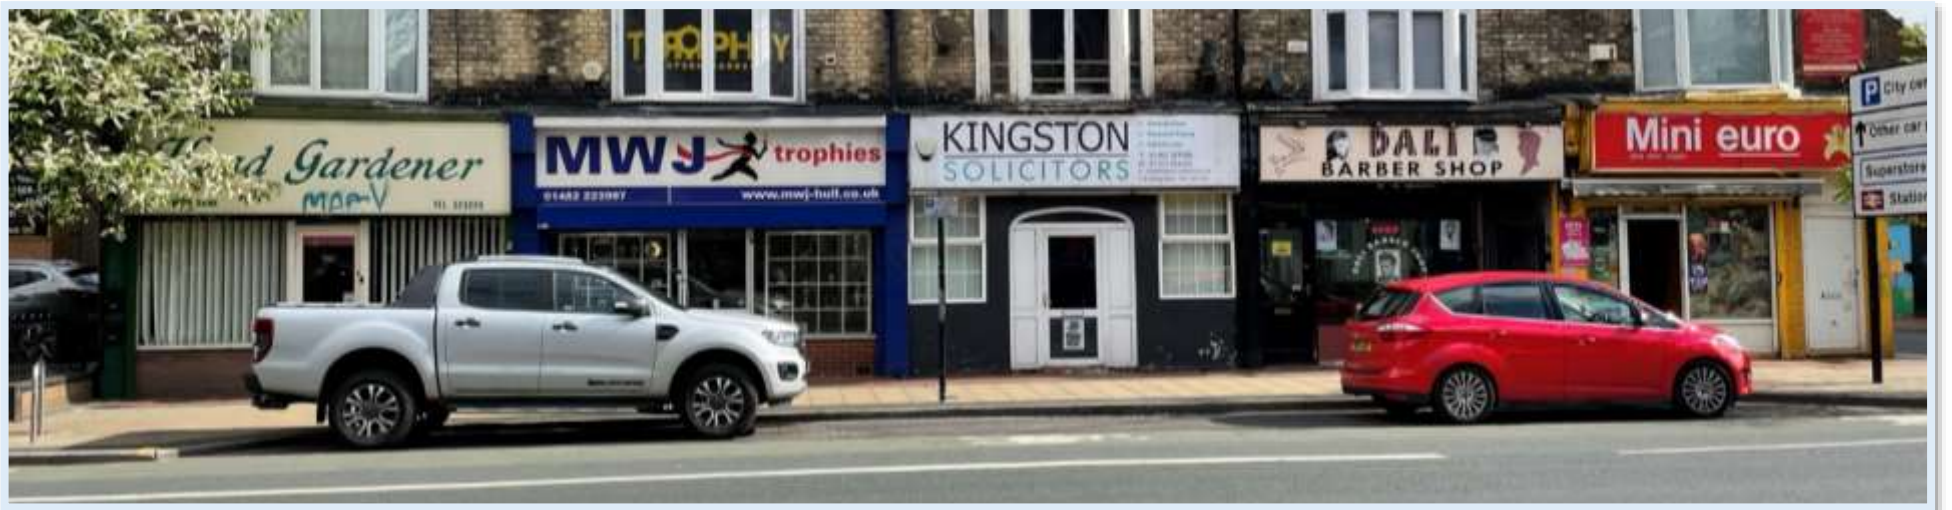
Figure 93 - Existing photograph showing the shopfronts and the variety in style, detail, signage area and quality. (Author, 2023)

The pilasters, fascia, corbel detail, cornice and blind box should be a consistent design throughout to create a cohesive group of units. The blow image shows how variations can be achieved for different uses whilst creating a 'family' of units across the group.

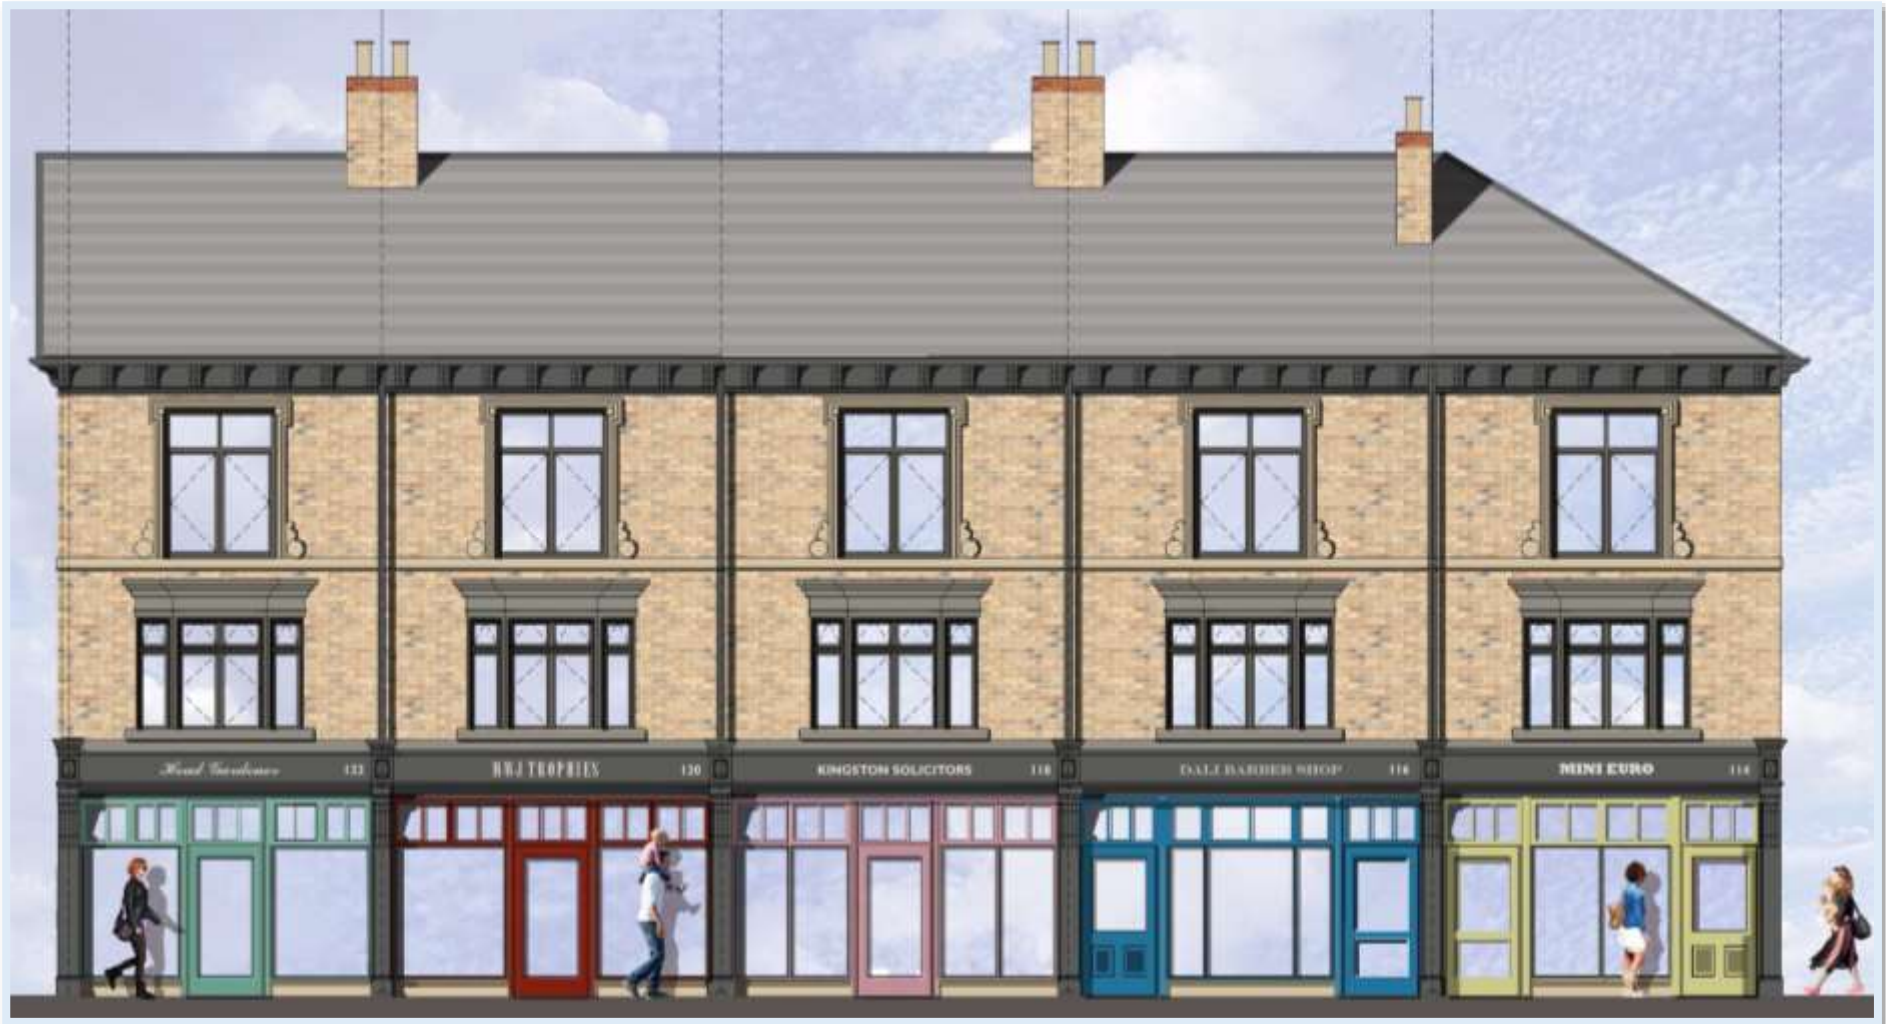
Figure 94 - Illustration showing how the various uses can be accommodated in the design whilst creating a cohesive design. (Author, 2023)

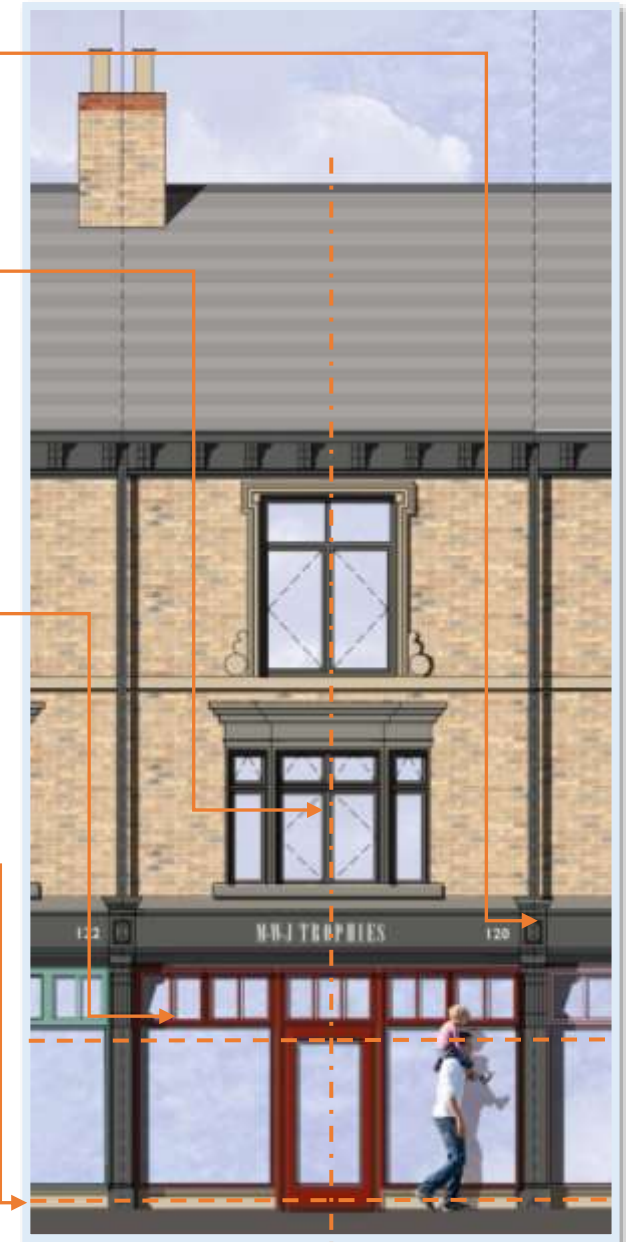
Figure 95 - Illustration showing a typical shopfront with a central door. (Author, 2023)

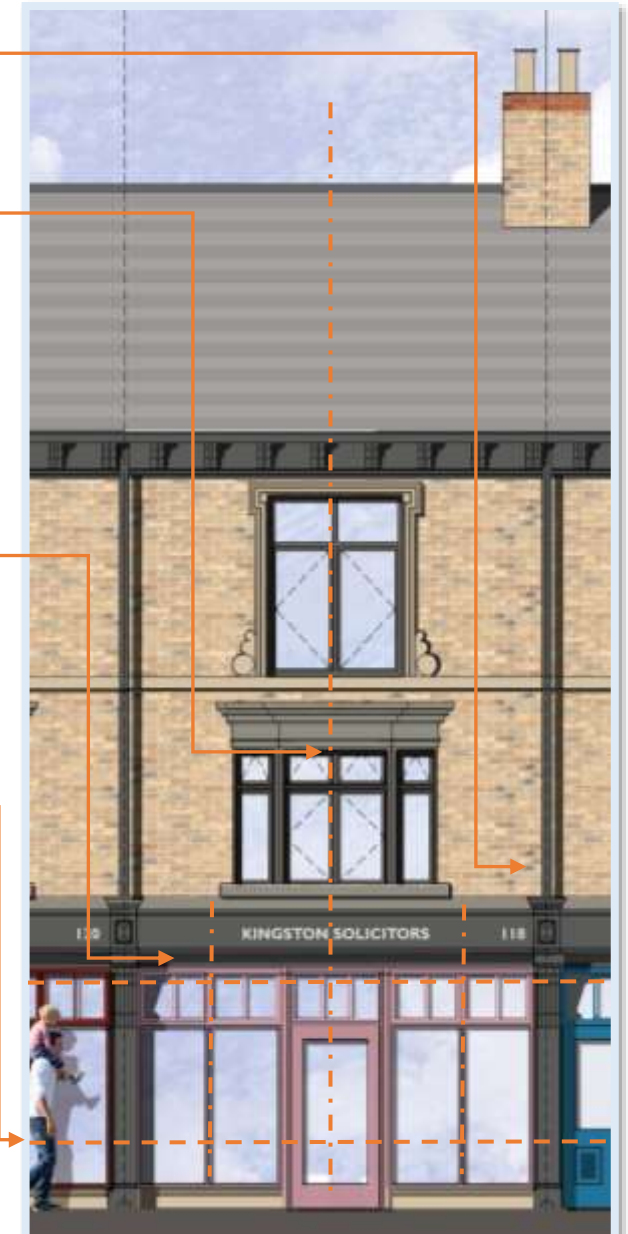
Figure 96 - Illustration showing a typical office frontage with a central door. v (Author, 2023)

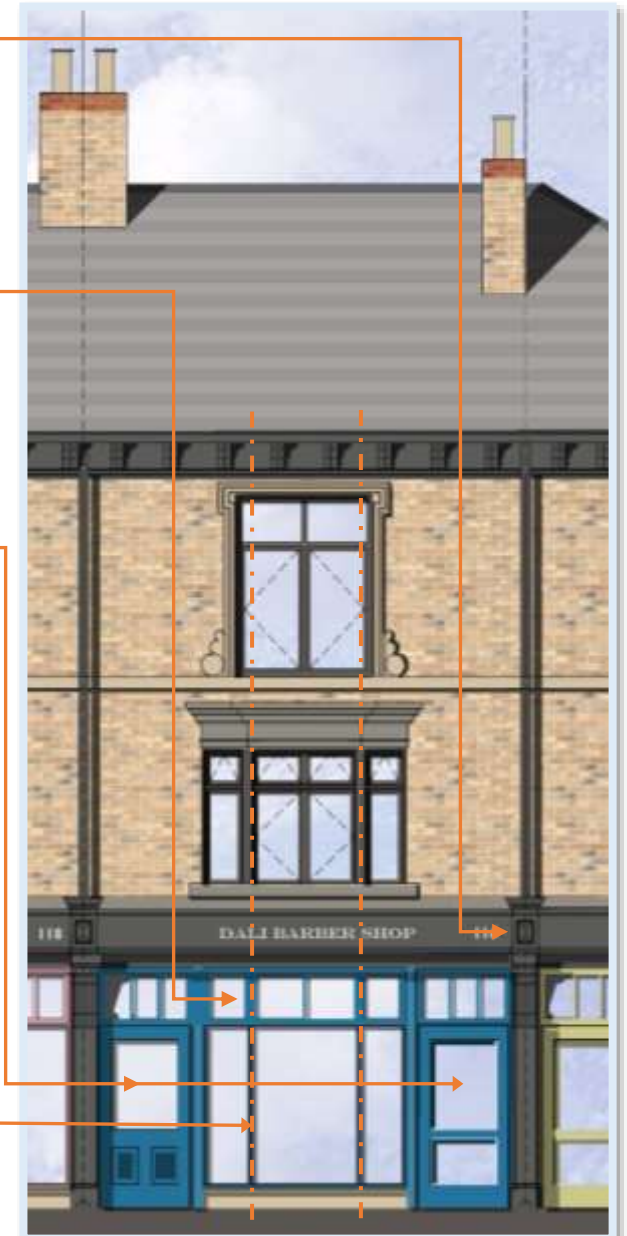
Figure 97 - Illustration showing a shopfront with two doors incorporated. (Author, 2023)

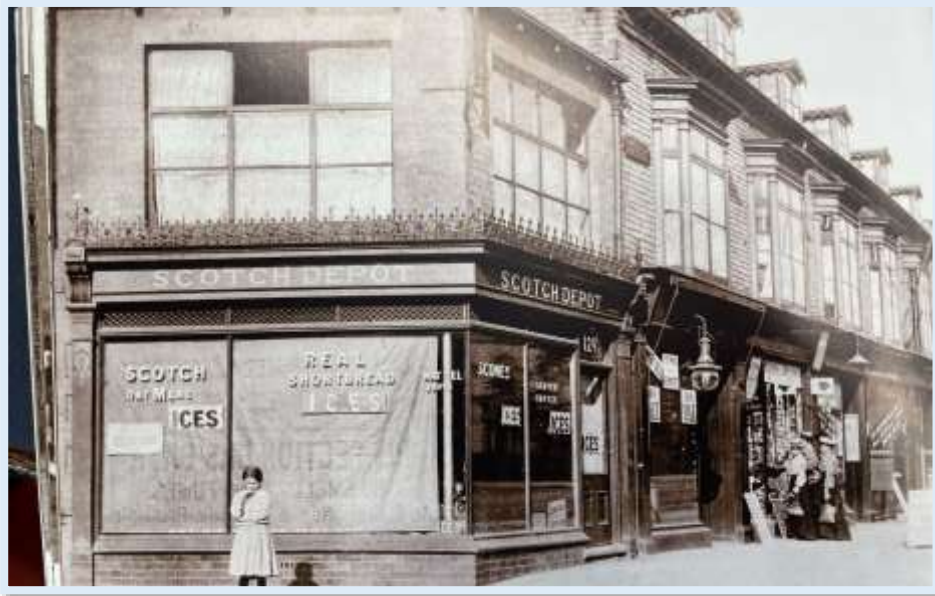
Figure 99 - Photograph dating from 1905 showing the consistent colour scheme across a group of shopfronts on Spring Bank (Gibson, Hull Then and Now, Volume 2, 2010)

The historical photographs, although in black and white, show that the original shopfronts were dark in colour and likely to be black/dark brown or burgundy.

As many of the shopfronts were designed as a group of shopfronts with a consistent design approach, the fascias, cornice, pillasters and corbel details would have been painted a consistent colour. This avoided visual clutter and created a calm street scene.

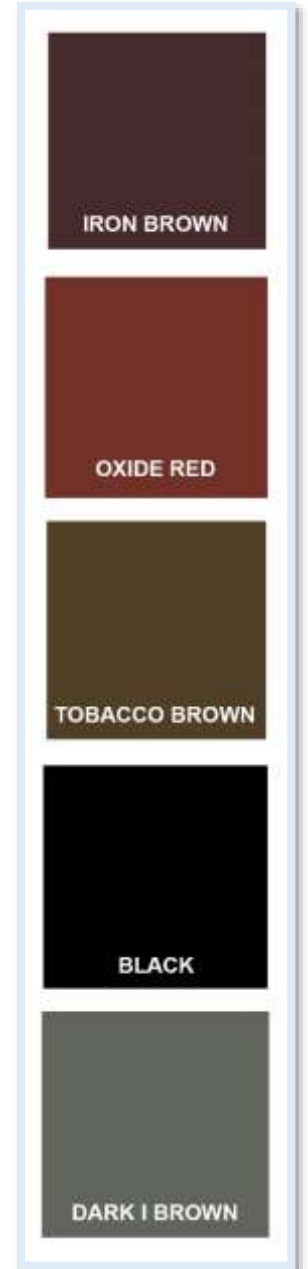
Figure 98 - Traditional Victorian colour palette (Author, 2023)

During the Victorian era the traditional colour palette was dark and consisted of rich, deep shades including black, maroon, red, burgundy, chestnut, dark green brown and blues. The limited colour range was due to the limitations in natural pigments available at the time, prior to the introduction of a more extensive colour pigment range.

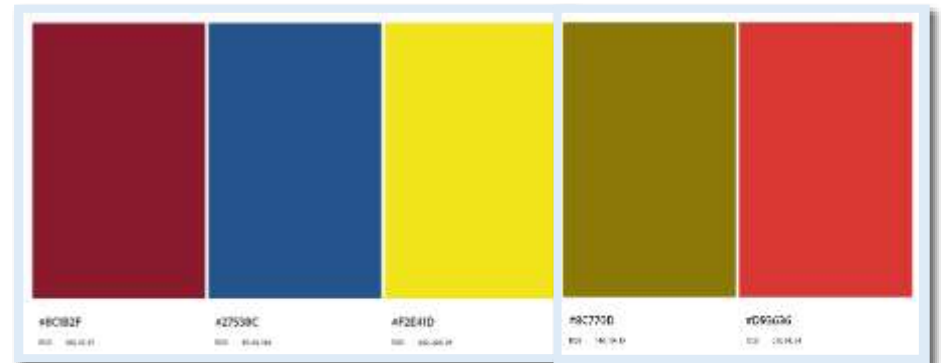
Figure 100 - Bright complimentary colour palette for shopfront frames (Adobe Colour, 2023)

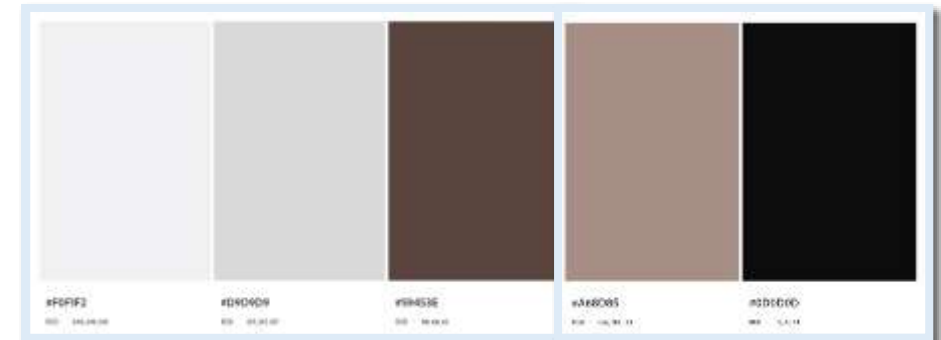
Figure 103 - Muted complimentary colour palette for shopfront frames (Adobe Colour, 2023)

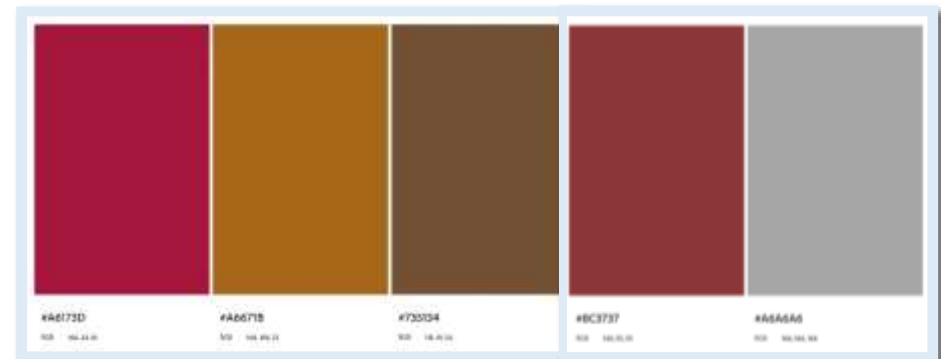
Figure 102 - Muted bright complimentary colour palette for shopfront frames (Adobe Colour, 2023)

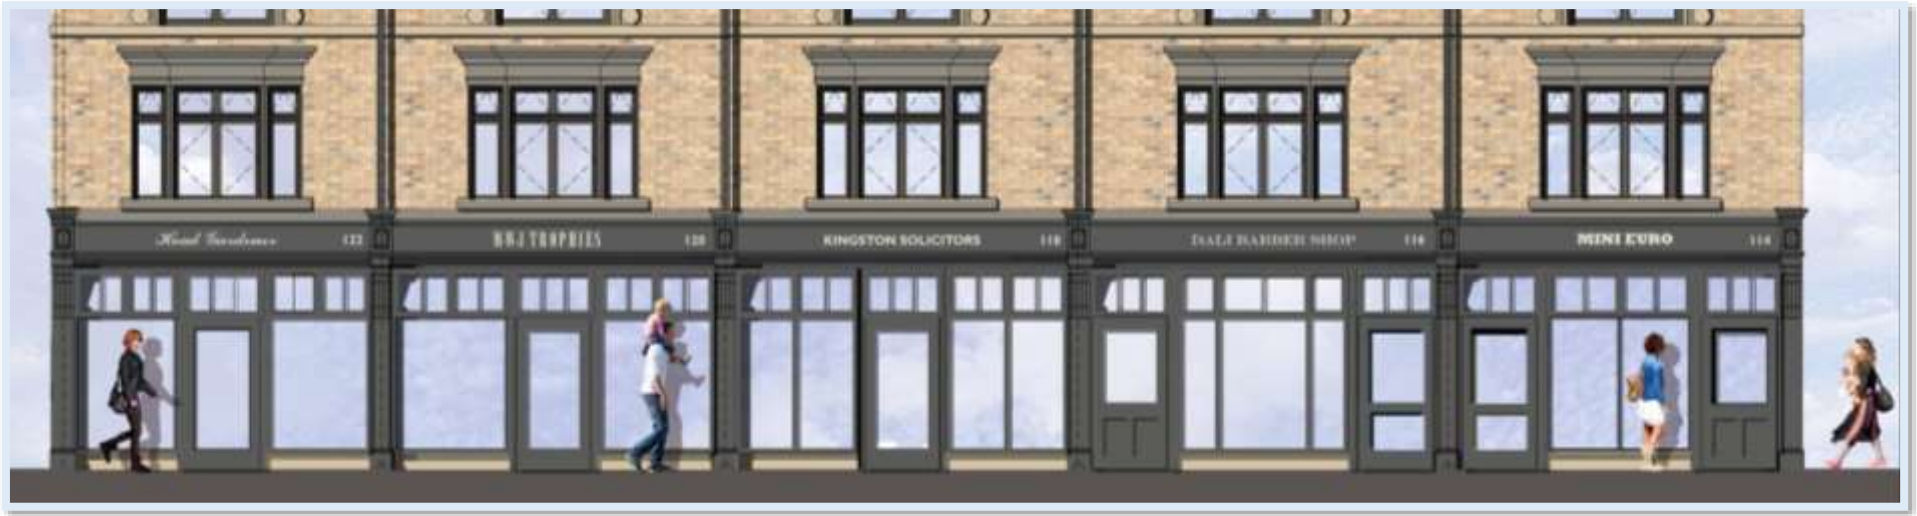
Figure 104 - Proposed elevation showing a consistent neutral colour scheme across all units (Author, 2023)

It is therefore recommended that a consistent colour palette is created to the whole group which could be based on a neutral colour such as black or mid grey/dark brown colour, providing flexibility to respond to the branding of each unit.

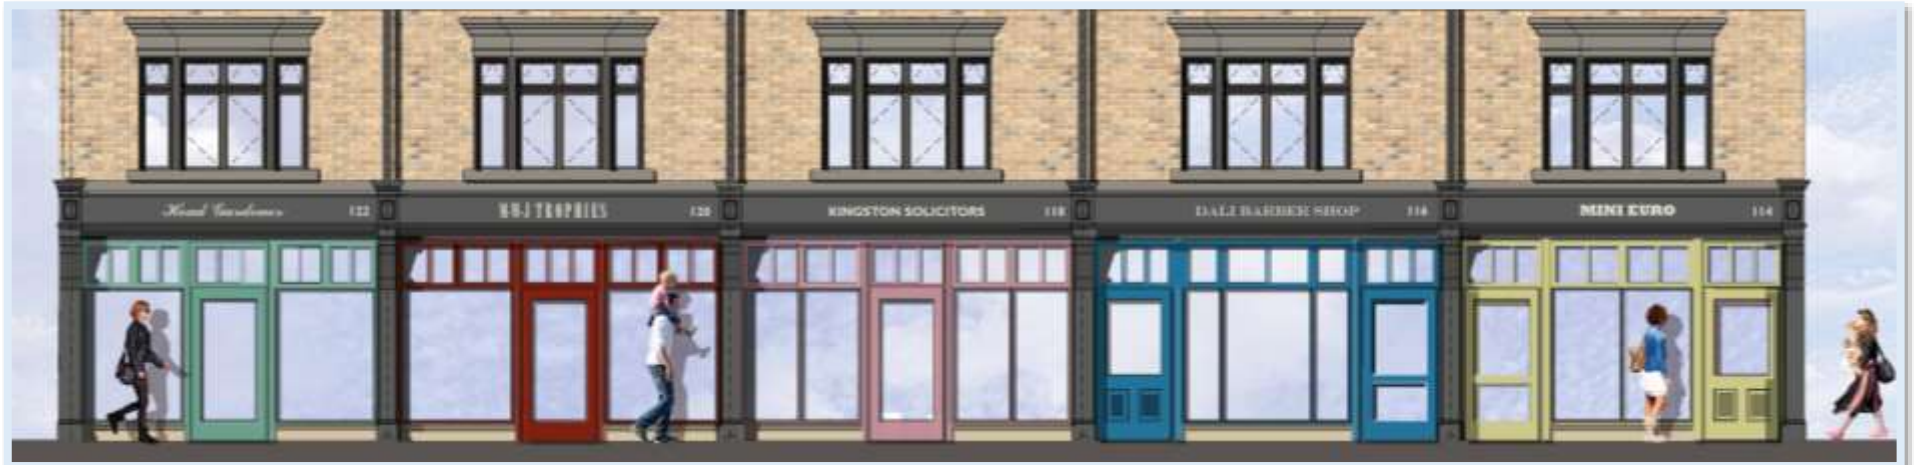
Figure 105 - Proposed elevation showing variation in colour to the individual shopfronts with a consistent neutral colour to the fascia's and pilasters and different colours to the shopfront frame (Author, 2023)

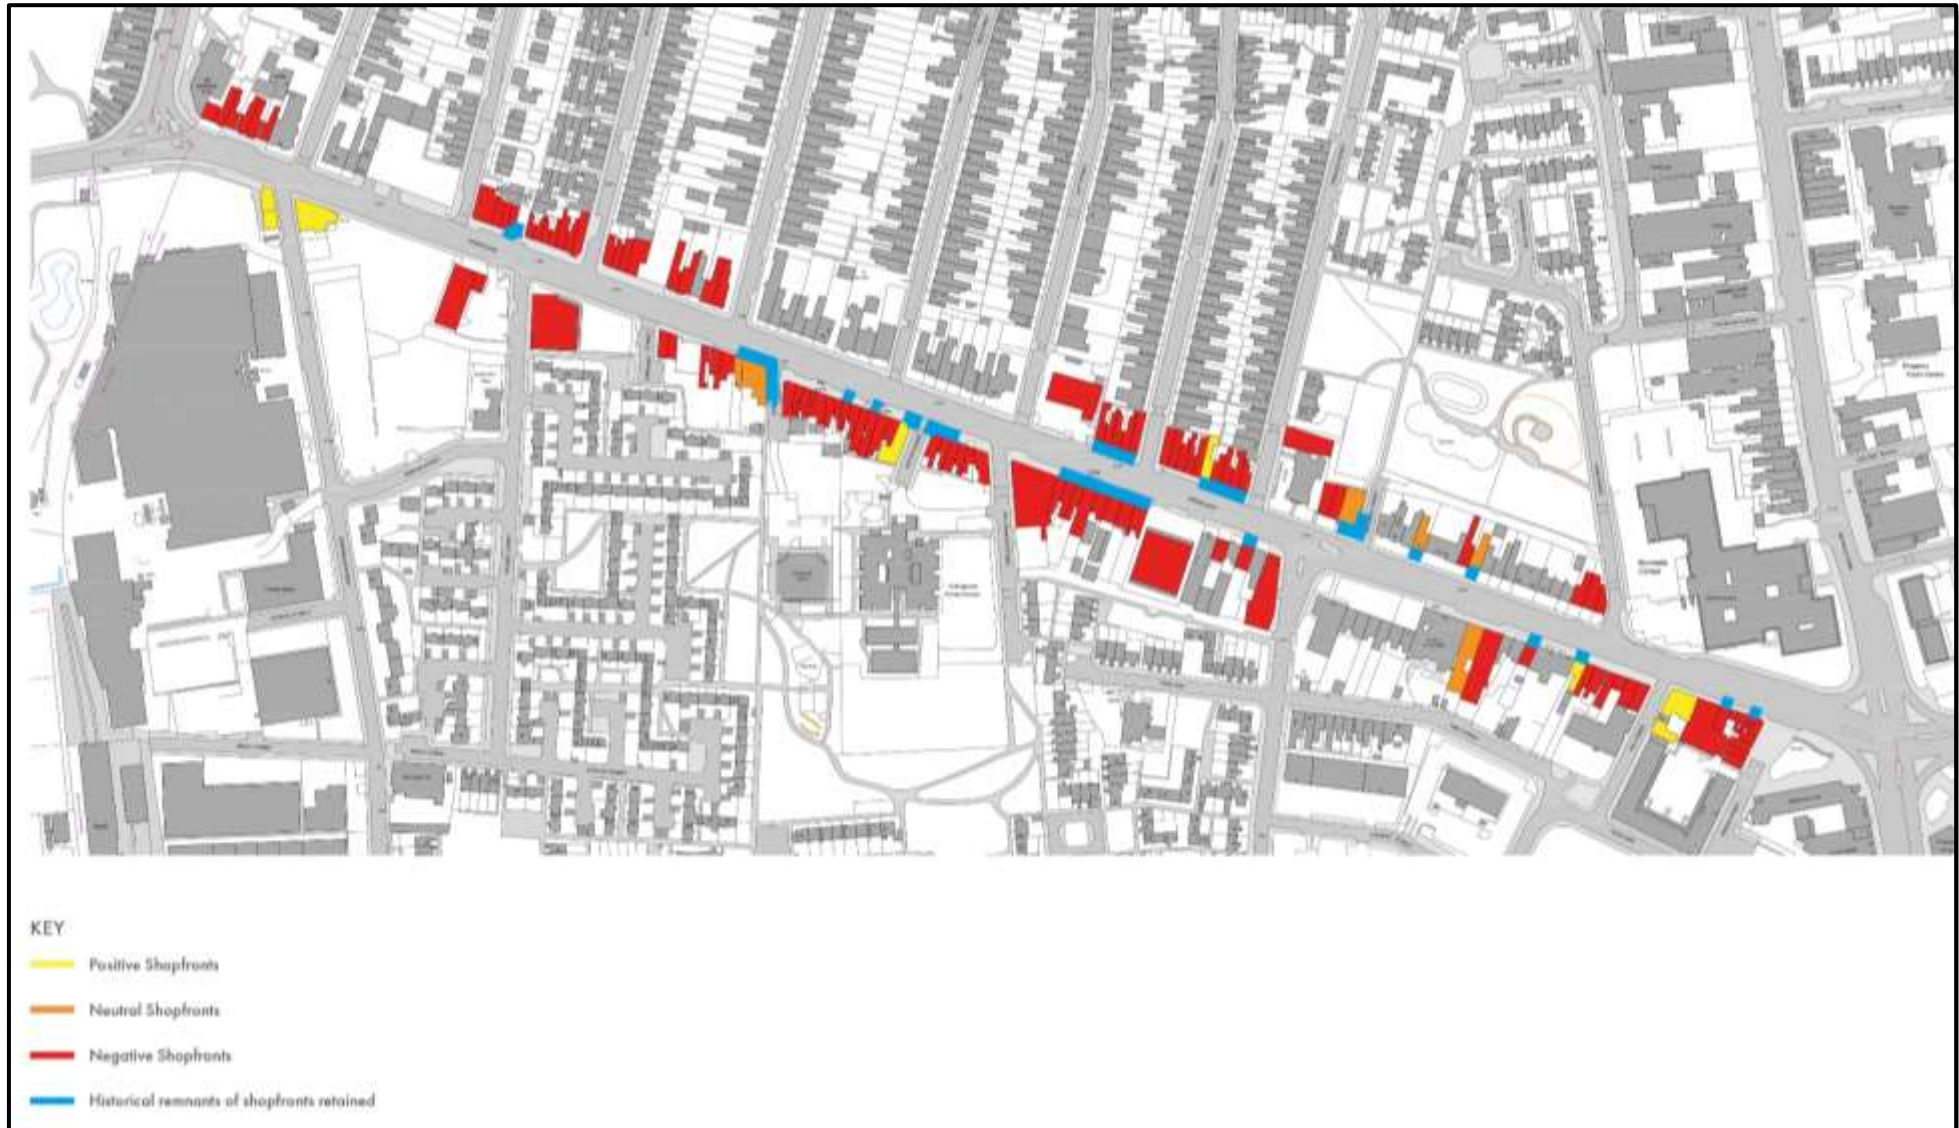
Figure 106 - Plan showing positive/neutral/negative shopfronts on Spring Bank Prepared by Seven based on Ordnance Survey © Crown Copyright 2023. All rights reserved. Licence number 100022432 (Author, 2023)

Positive	Neutral	Negative
Considered design that responds to the proportions of the building above and creates proportions with consistent horizontal and vertical lines.	Has the potential to have a positive shopfront design but lacks consideration of overall proportions with the building.	Design that does not respond to the proportions of the building above.
Use of high quality natural materials to a high standard of finish (hardwood timber, stonework, brickwork).	Some consideration to the quality of materials but fails to create a high quality finish.	Low quality materials (UPVC, low quality metal frames, shopfronts that have been adapted).
High level of detail (corbel details, cornice)	Low level of detail and limited consideration to the overall appearance of the shopfront.	No detailing or consideration to the overall appearance of the shopfront.
Signage that respects the historical shopfront design and proportions.	Historical signage details retained (such as fascia, cornice, corbel details, pilasters) but has suffered from adaption.	Large scale signage applied over the top of existing signage fascias with no regard to the historical proportions of the shopfront.
