# VERIFICATION REQUIREMENTS FOR COVER SYSTEMS

Technical Guidance for  
Developers,  
Landowners and  
Consultants

**Yorkshire and Lincolnshire  
Pollution Advisory Group**

Version 4.1 – June 2021

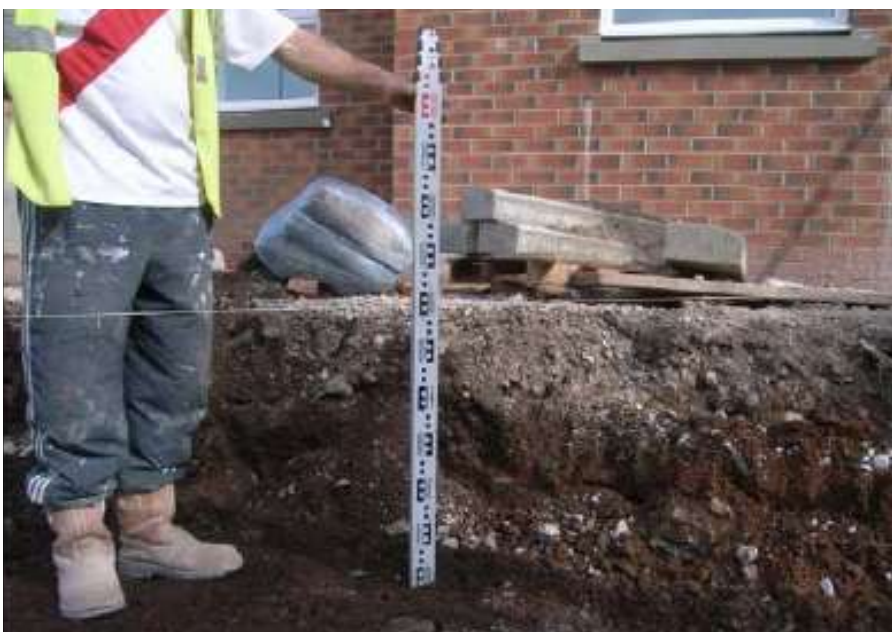
Photograph 5:  
Depth check of inert cover within rear gardens. Taut string line spans across excavation.

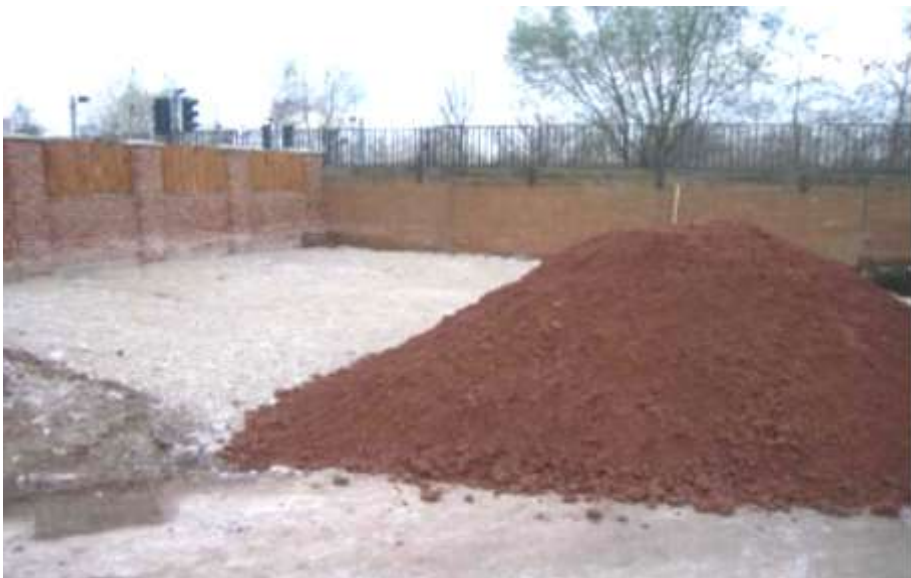
Photograph 10: Inert crushed sandstone being delivered with visible remediation break layer. The spatial area of the remediation can be observed from these photographs (traffic lights).
