**Avenues and  
Pearson Park  
Conservation Area  
Character  
Appraisals**

# Character Appraisal 2: Pearson Park

Published 2015

Published by Hull City Council, Kingston upon Hull, UK

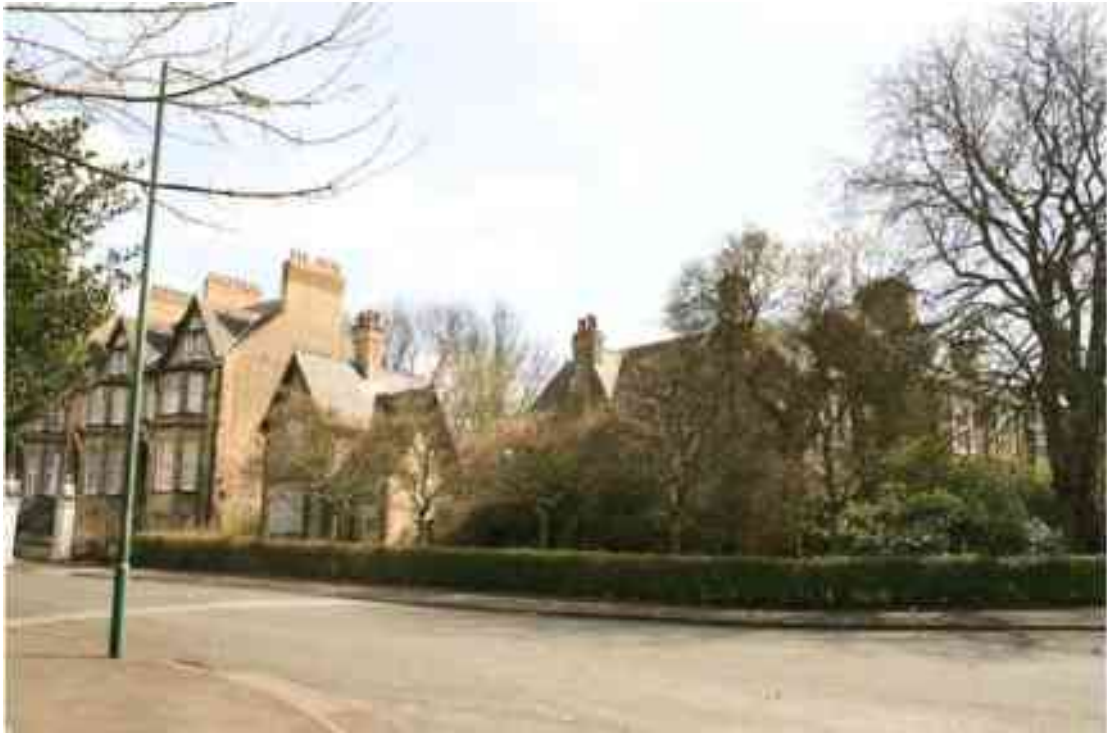
**Figure46 No. 1 including garden**

- 7.1.4.1 Designed by R. G. Smith, the lodge was finished in 1862 (Gibson) and is a Grade Two Listed Building. It exists today in a very sad state. Set within a long garden on the southern corner of Pearson Avenue and Pearson Park, the property is empty. Steps have been taken to secure the property from intruders and the weather. A design for this gate lodge, although not identical, bears similarities and gives an impression of what it would have looked like when new.

- 7.1.4.2 The ornate ridge tiles are mostly damaged or missing and the state of the windows cannot be seen due to the anti-vandalism screens. However, the decorative barge-boards are still in place, as is the patterned slate roof and contrasting black brick quoins. The lodge is Victorian Gothic, as the top window suggests, with patterned brickwork creating the high arch, and a ground floor bay window in stone. The garden is important to this house and, if restored, the house would be a fitting balance to the open corner. Entering the park through the gates, this openness is a gentle introduction, enabling an appreciation of the size of the park and scale of the trees.

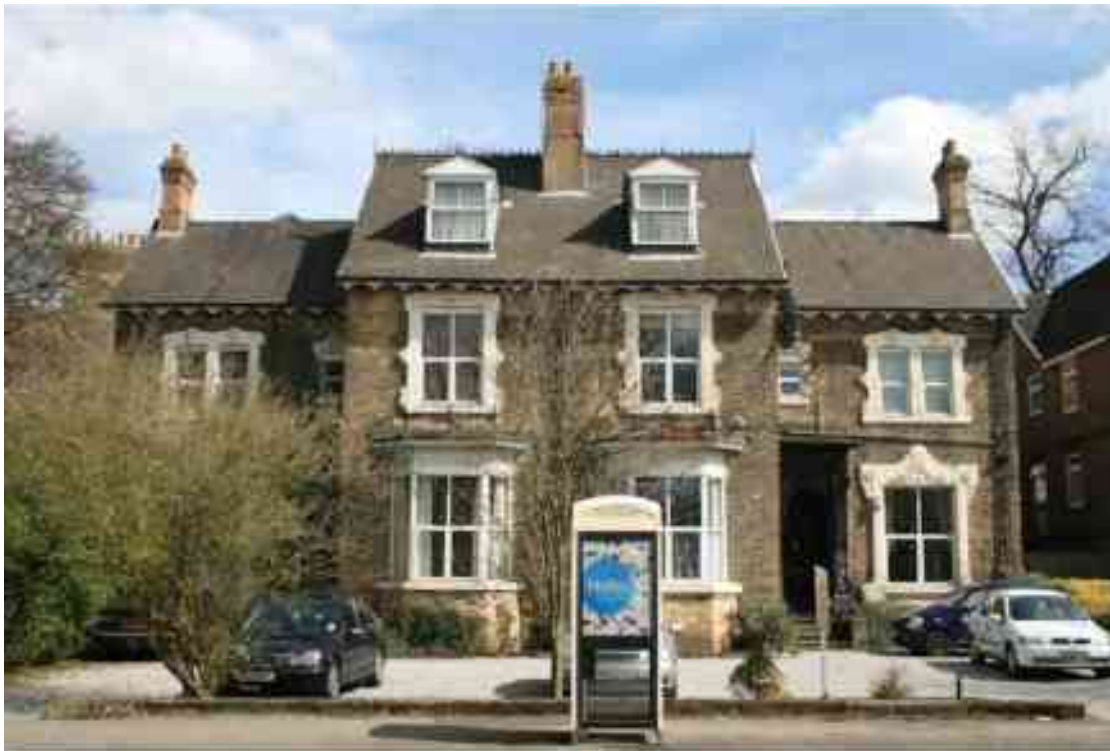
**Figure 47 Nos. 2 & 3, or *Leicester Cottage*, front view**

7.1.5.1 Pre-1890, the villa has been restored in recent years, and is on the Local Heritage List. The placing of the telephone box is unfortunate as it blocks the view of the property. The ironwork decoration above the bay windows is of particular note, as are the intricate window surrounds. The ridge tiles and carved barge-board are interesting features.

7.1.5.2 The choice of double-glazing has tried to be in keeping with the style; unfortunately it does look out of place. Six satellite dishes are placed on the front elevation, in contravention of national guidelines for conservation areas, and break up the symmetrical form of the houses, as does the dormer window to the rear. The reinstatement of a boundary hedge at the front, as originally intended for the properties, could help to unify the property and provide a place to put the wheelie bins.

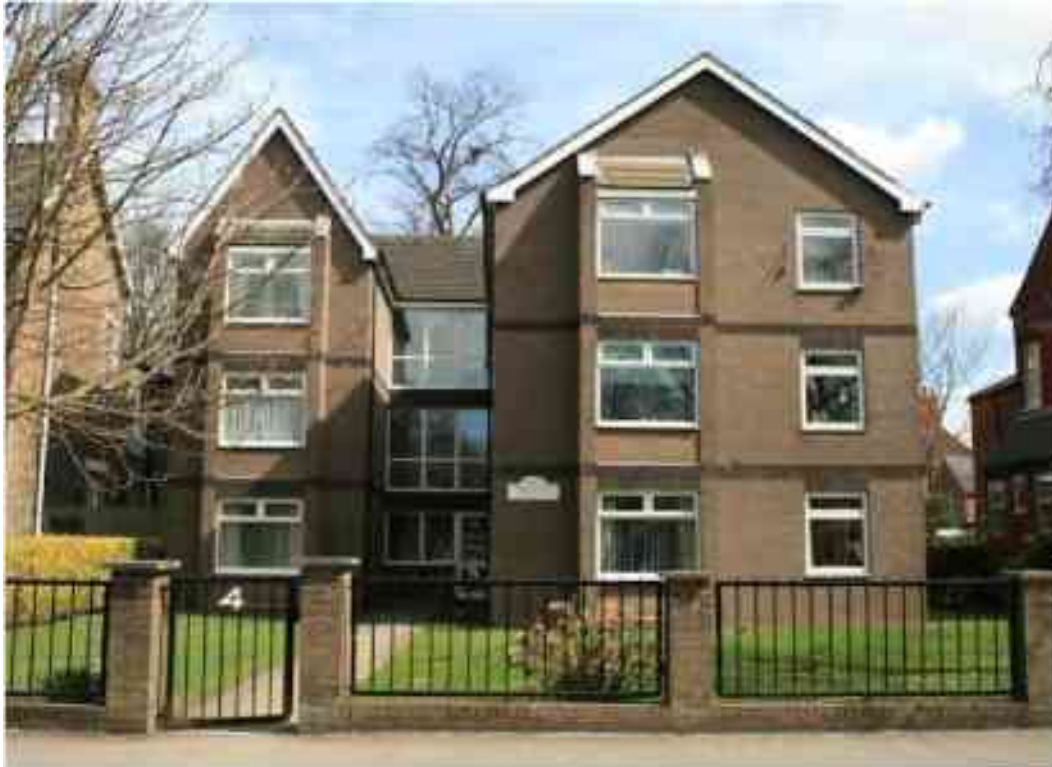
**Figure 48** No. 4 front

- 7.1.6.1 No. 4, Pearson Park, a 1970s block of flats on an infill site, is owned by Sanctuary Housing and provides sheltered accommodation for the elderly.

- 7.1.6.3 An attempt has been made to capture the essence of the villa form in its scale and massing and its references to gables. Nonetheless, it lacks character and fails to integrate successfully within the park, as the pitched roofs are covered with modern concrete tiles which lack the aesthetic value of their traditional counterparts; the fascia and barge-boards are narrow and lack moulding detail; the window casements are of modern proportions and styling; and the colour of the brick, although muted, is not in keeping with the traditional palette of colours. The building does not succeed as a pastiche, but neither does it succeed as a modern housing block as it does not have its own integrity or style.

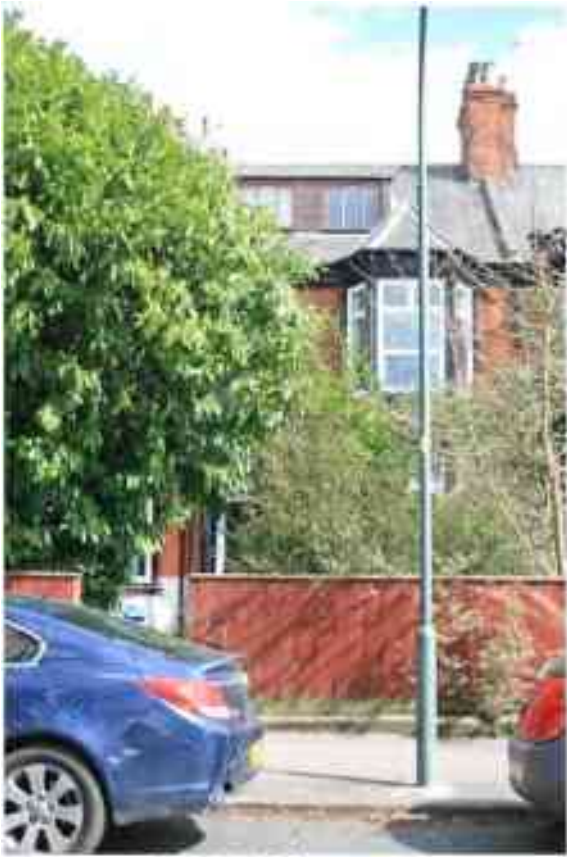
**Figure 51 No. 8 front**

7.1.10.1 Although obscured by foliage and a high fence, neither traditional nor in unity with neighbouring property boundaries, No. 8 still offers some of its original grandeur. The canopied, ornately pillared entrance, original front doors, capped columns on all of the double bays, dentil moulding above the lower bays, decorative fascia and gutter blocks, slated conical roofs above the bays and original chimney pots are worthy features, adding considerable value to the over-all appearance.

7.1.10.2 However, the original front elevation has been spoilt by three of the front facing bay windows having UPVC replacements installed, with hinged storm-proof openings, which detract from the remaining timber casement windows of a differing design. The addition of a plank-faced dormer window does not bring any harmony to the building, disrupting the roofline.

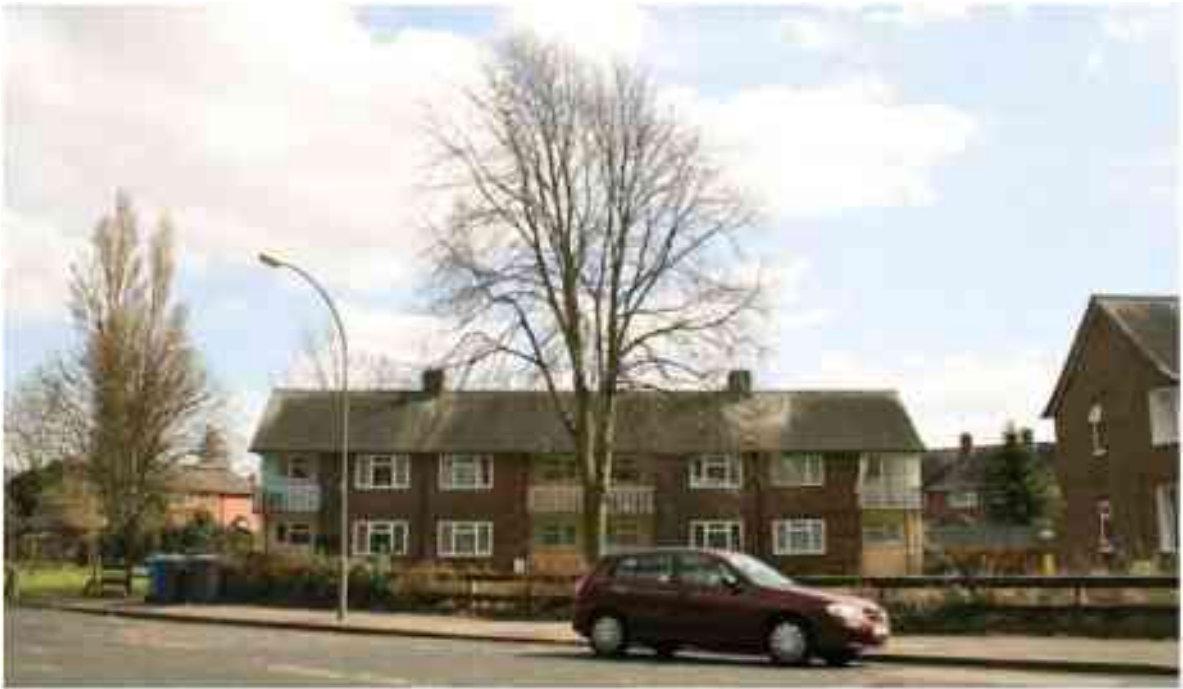
**Figure 55** *Henson Villas front*

7.1.13.1 The red-brick villas sit between Numbers 9 and 18 Pearson Park, originally occupied by Lime Villa at the west side and Malvern House on the east side taking up 4 of the original Pearson Park villa plots. It seems from the Hull bomb map that Malvern Villa and the Park Lane area was severely damaged by bombs in May 1941 necessitating demolition and clearance. Henson Villas was built in 1950 on the plots as part of the areas regeneration and are typical of their time. A much worn foundation stone can still be seen on the middle block. They currently offer a secure environment of 24 flats for single women and men, but were originally built for just single women. The Villas are built diagonally across the original plots in three blocks and have a low 2 storey profile set in open lawns with some trees around the periphery. They do adhere to the building line as the northwest corner of each block lies on it, but the diagonal alignment deflects the viewer off line. Wheelie bins are stored on the street, contributing to visual clutter. Each flat has its own outdoor porch or balcony surrounded by white metal railings with white support pole. The double-glazed windows are mostly similar to the originals, maintaining the rectangular, unimposing symmetry.

7.1.13.2 The view of the 6ft steel fence and housing beyond the park does not add value to this corner; and an attractive planting scheme could draw the eye away from this, whilst not causing an obstruction for the residents of the aforementioned housing. The low wooden fence, separating the spacious grassed area surrounding the properties from the broad carriageway, befits the properties and does not hem them in, but allows their view of the park to be uninterrupted and vice versa. The Bowling Pavilion nearby, of a similar era and material construction, helps to tie the villas in with the main park.

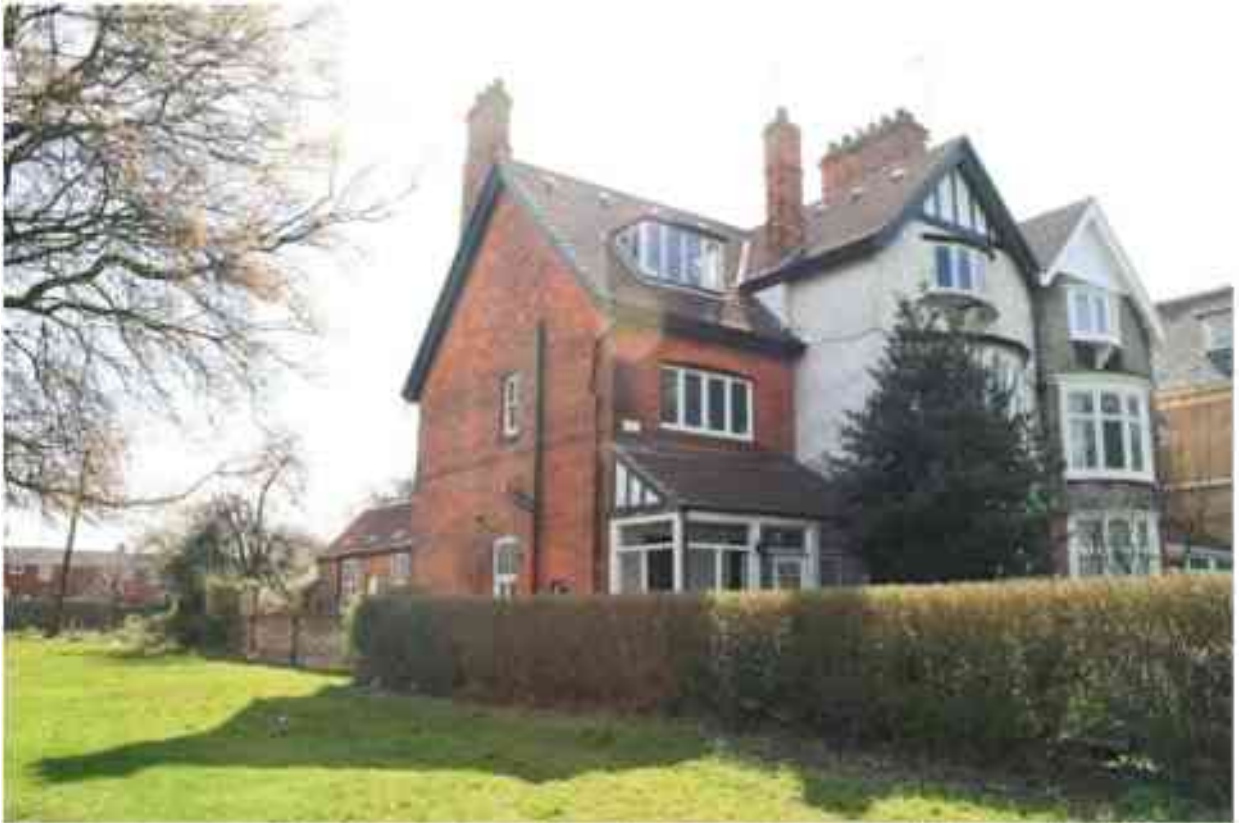
**Figure 57** Nos. 15 & 16 angle

7.1.14.1 These are semi-detached houses, possibly late Edwardian. No. 15 is partially obscured by a tree in front of the doorway. This residence has retained the black and white paintwork on the mock-timbered gable, but other timber windows are in need of attention. The projecting porches of both houses have been enclosed in glazed timber frames. They each retain the pebbledash facade to the proud frontage, original windows, tall chimneys and boundary treatment in the form of low stone kerb and hedging. Previously, iron railings would have risen from the stone edging.

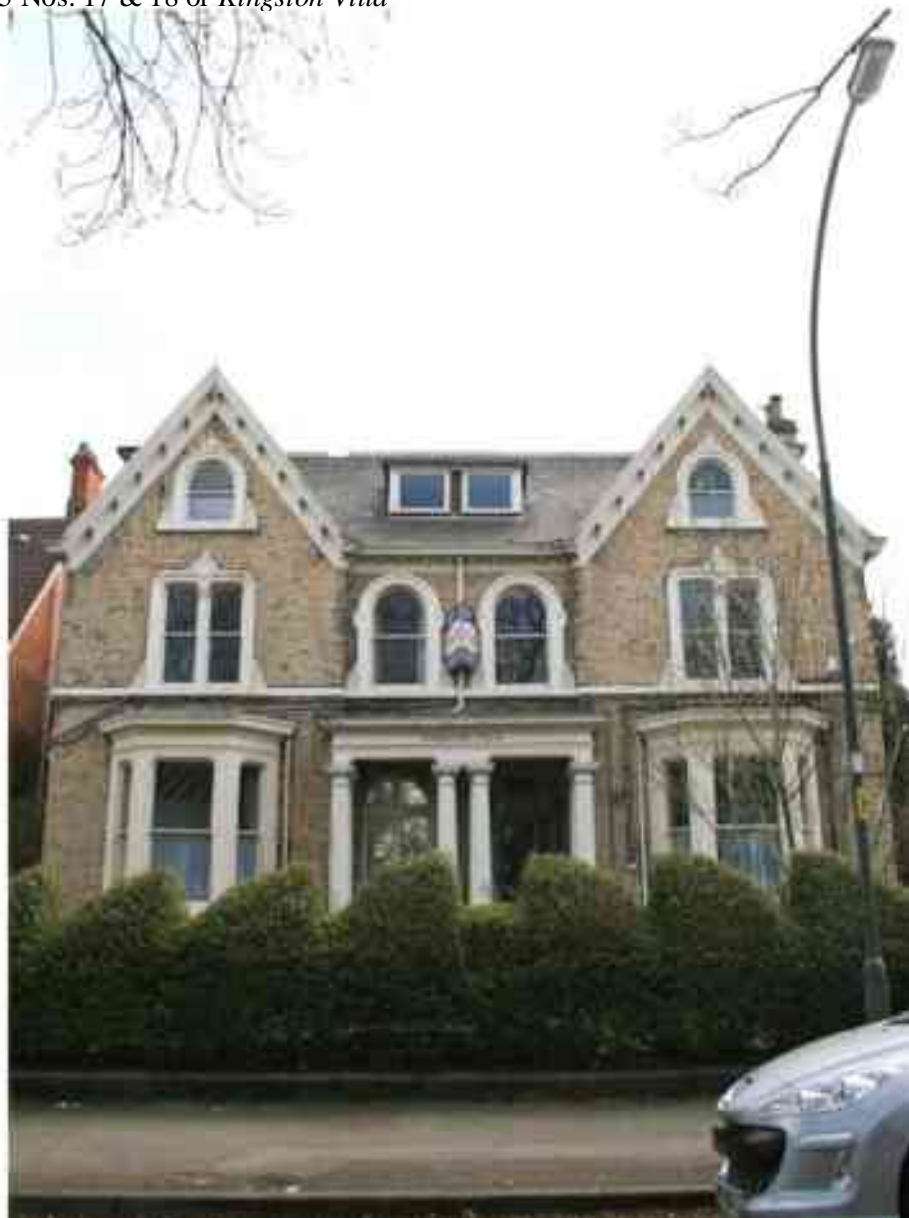
**Figure 59**      **Nos. 17 & 18**

- 7.1.15.2 The Fleur de Lys crested ridge tiles are almost complete and, along with the slate tiles and chimney pots, create an imposing roof. The Villa is constructed in smooth buff-cream brick, has two front doors, which are impressive with a double porch. Unfortunately, a replacement door on the left-hand side and cumbersome modern appendages to provide ease of access spoil the grand entrance through addressing solely practical concerns. The boundary hedge has been given a topiarian treatment. Although a plainer hedge may display the architectural style of the building to greater advantage, it is good to see a boundary treatment, close to the original style, continuing from Nos. 15 and 16. Round the side - on Park Road - grand, arched windows lighting a stairwell, together with a Gothic-style window in the eaves, create a composition similar to the front of a house. This carefully ordered design is disturbed by a plethora of wires, cameras and extractor fan outlets, as is also the case with the front of the house.

7.1.15.3 A planning application to install vehicular access across the pavement, remove the front boundary treatment and create front garden parking was refused by the Council in April 2014.

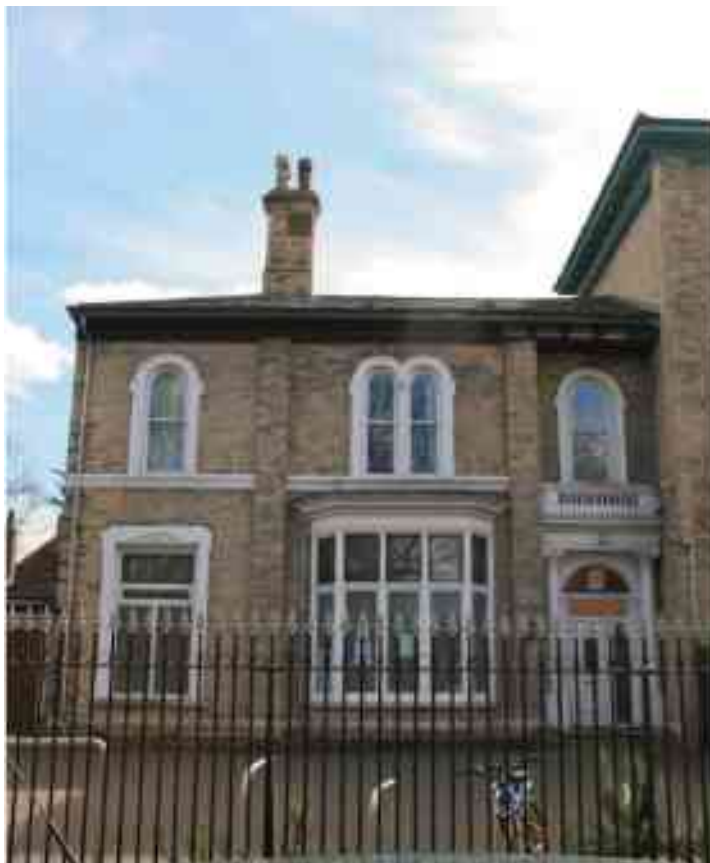
**Figure 65 No. 20 Mosque**

7.2.4.2 The most obvious and interesting features are the Ionic doorcase with balcony above; and the simple, elegant windows with Georgian-inspired arches. One window to the first floor has a mullion with a detailed capital. The original door space has been in-filled with a UPVC replacement of inappropriate dimensions, losing the balance and solidity of the original design. The large, ground floor bay window and adjacent rectangular window, with splendid frieze detailing above, have also been replaced with timber frames in an untraditional layout that is not sympathetic to the overall design. Plastic drainpipes and signs, similar to the Police Station's next door, detract from the building's unified atmosphere. The frontage has a black and gold 6ft high steel fence, 'Sheffield' style bicycle stands, and bricks in a herringbone pattern are laid where the front garden would once have been. Number 20 has been a mosque since 1990 and in Spring 2011 Hull City Council approved planning permission for an extension to this building.

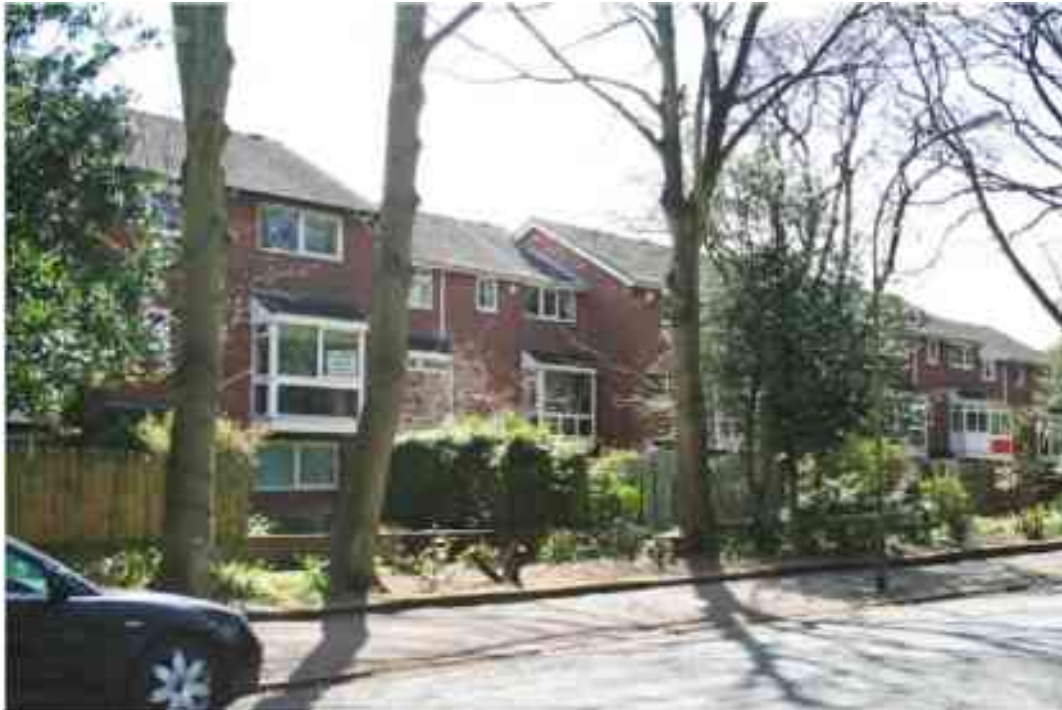
**Figure 70** Nos. 23 to 28 *The Parade* street view

7.2.6.1 This space would have originally been plot Nos. 23 to 28. This area of land used to be a convent. The land now contains three-storey town-houses, twenty in all. These are numbered in the opposite direction to the rest of the houses in the park. Built in the 1970s, they are behind trees and shrubbery, helping them blend into the parkscape. So as not to create a wall-like appearance, they are differing distances away from the kerb, in a staggered arrangement. The dimensions and composition of these town-houses, with projecting first floor living room windows, have been built to capitalise on the land available. Unlike Henson Villas, these properties do not have space to sit comfortably, disregarding the character of the park. A pathway leads between Nos. 9 and 10 through to Park Grove.

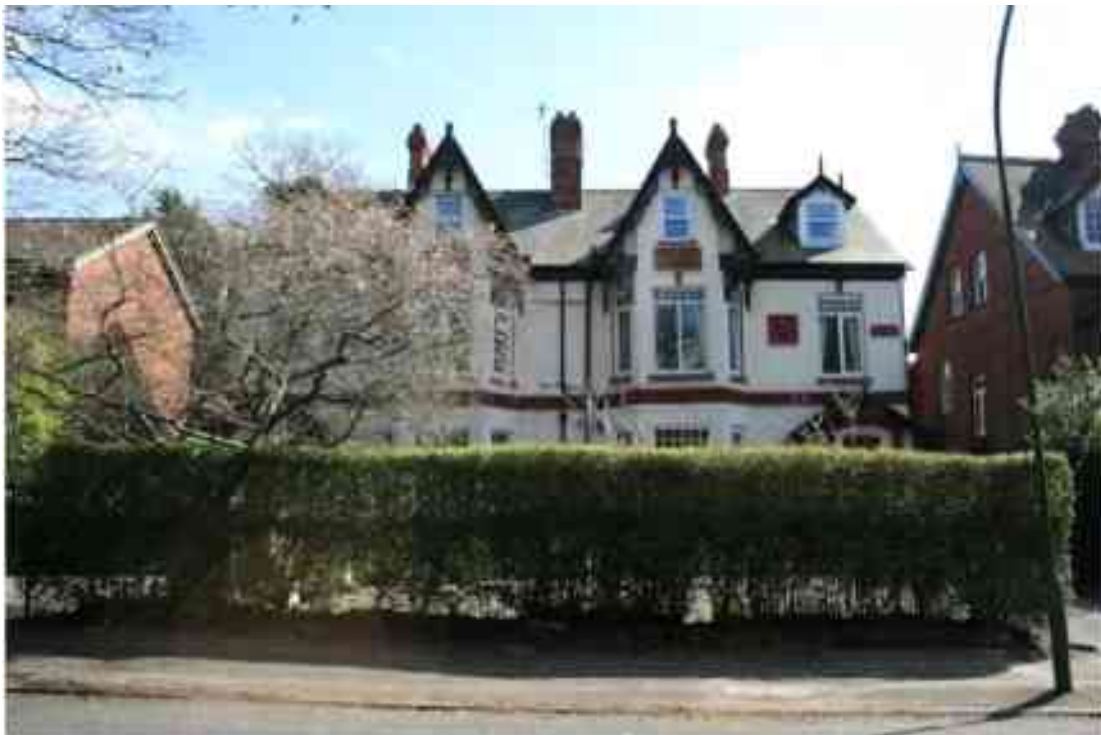
**Figure 73** Nos. 29 & 30 or *Lake View Manor*

7.2.7.1 Formerly known as *Saxby House*, this property was built in 1891. The two-into-one property is currently a residential home. ‘The original brick has been painted over but the porch and terracotta relief and owl medallions survive’ (Ketchell). Windows have been replaced with UPVC substitutes but the roof remains slate with decorative barge-boards and finials mainly still intact. The door internal front door of No. 29 is an inappropriate modern replacement. The plethora of wires, guttering and tall metal chimneys interrupt the composition and detract from the original workmanship. The front garden is now deteriorating tarmac.

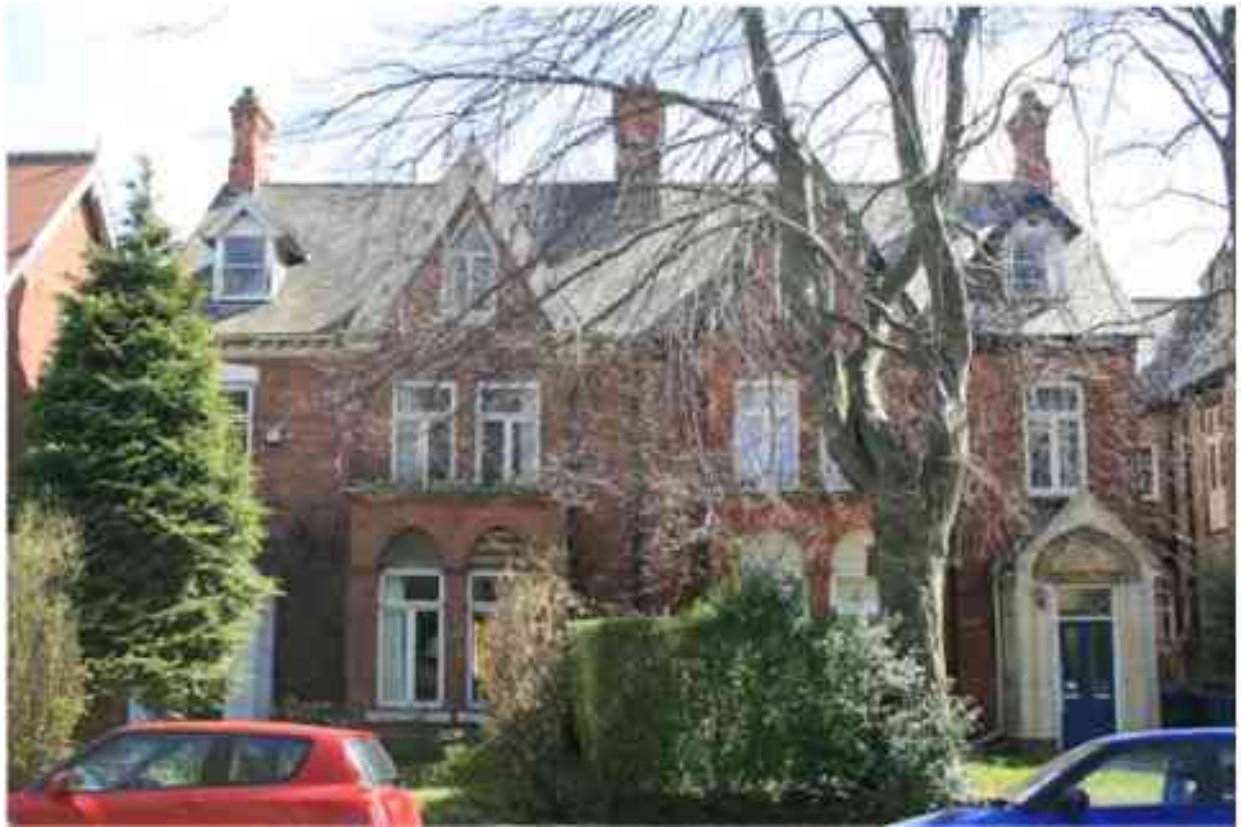
**Figure 77** Nos. 33 & 34

- 7.2.9.1 In Victorian Gothic style and emphasised by the tall windows, these semi-detached villas have fine examples of Early English arches on the ground floor rectangular bay windows with Perpendicular-arched side windows. These are topped with the original ornate iron balcony railings. No. 33 has some of the original tiling above the right-hand window of the pair. The porches are made from brick with pitched slate roofs. No. 33 has an open porch with Perpendicular arch and finial. Side windows on both porches provide for maximum light. On No. 34 the porch has been in-filled with a storm door. The porch has an arched lintel, which is a later addition. The timber frames of the windows on both houses are matching, although it is unlikely these are the original windows. As with Kingston Villa (Nos. 17 and 18), but of smaller proportions, the well-detailed timberwork of the modillion type gutter blocks and fascias is carried on through to the rake of the gable ends. This is a particularly fine functional design detail. However, the modillion-style gutter blocks have not been replicated when replacing those at No. 34.

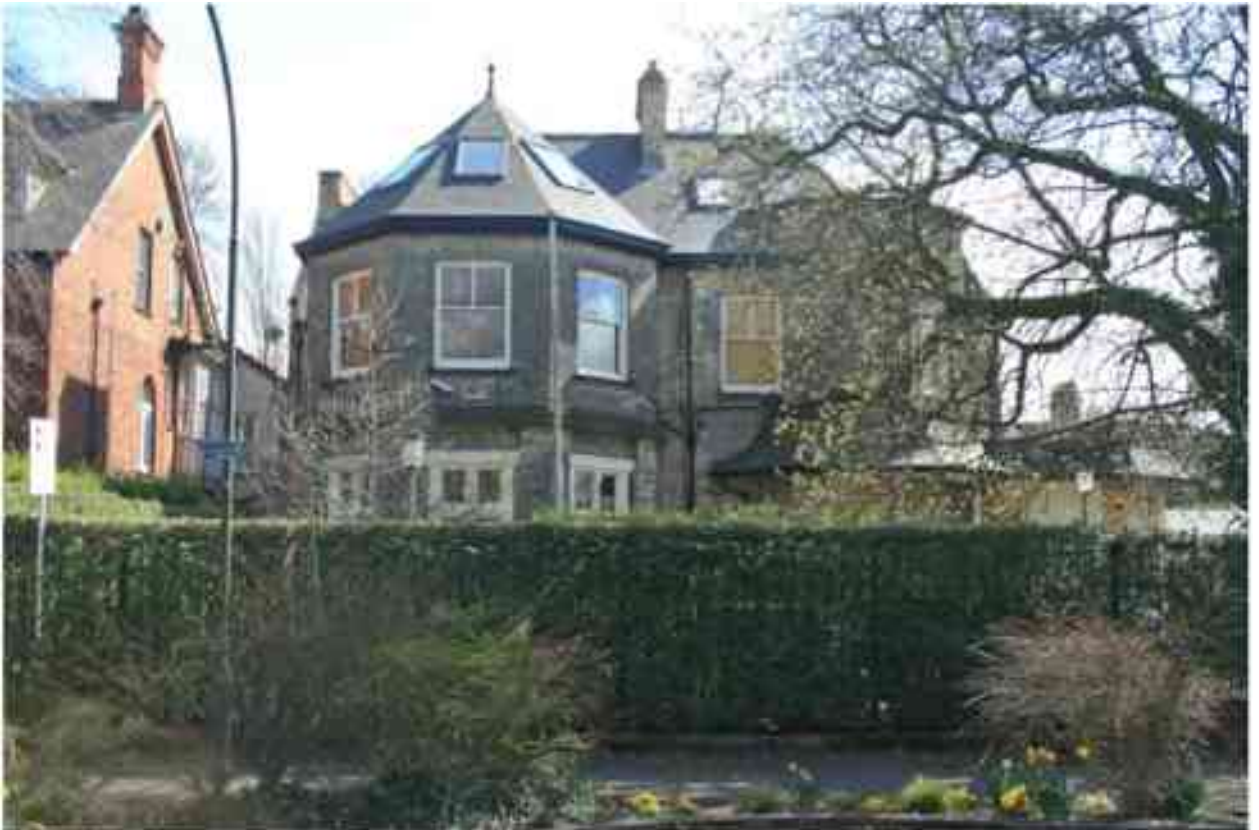
**Figure 80** No. 35 or *Rosemount* front

7.2.10.1 Made from smooth buff-grey brick with a slate roof and timber windows. The projecting left-hand side of the building is a strong semi-hexagonal design with simple three-pane sash windows to the first floor. The ground floor windows are particularly noteworthy: they have kept their unusual frames with carved mullions and curved corners. The hexagonal design is repeated on the corner facing the entrance to the house, with the downstairs bay emphasising this with sprocketed eaves and slate tiling. In creating an extension, protruding from the bay and reaching to the front door, care has been taken to recreate the hexagonal shape but the result disrupts the form of the original design and appears confusing.

7.2.10.2 Velux windows punctuating the slate roof, blocked-up windows, appendages to the front door for accessibility, the modern extension to the rear – but visible from the entrance - and the car park which replaces the original landscaping all detract from the original character. Worthy of note are the timber fascias with dentil detailing in places, the window frames, original chimneys with dentilated brickwork and traditional-style downpipes.

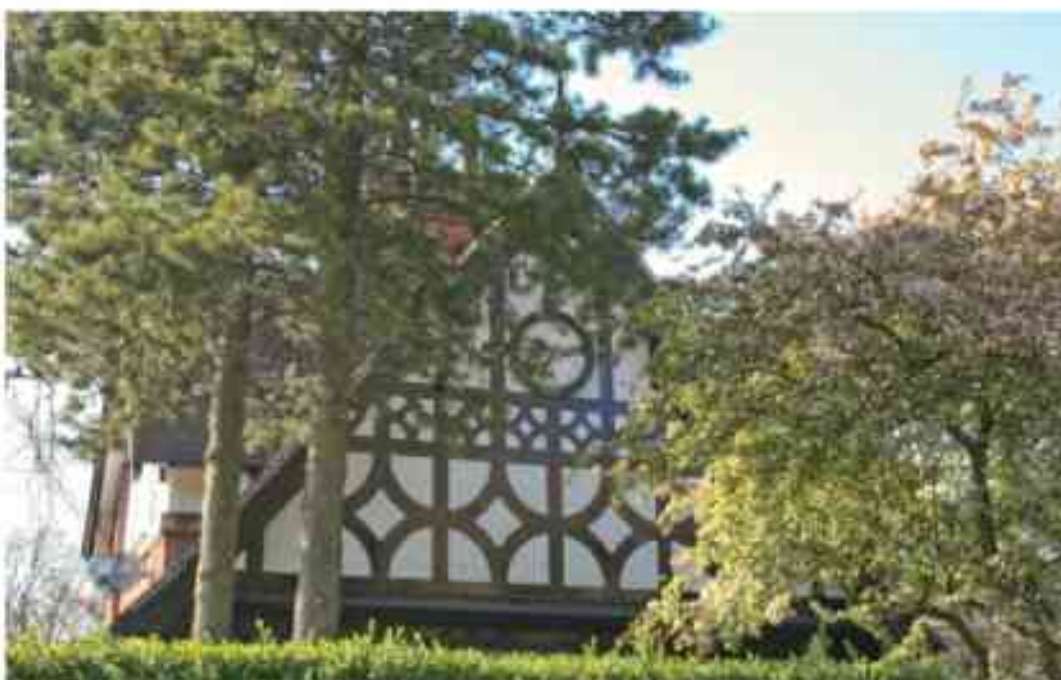
**e 85 38 West Entrance Lodge**

7.2.13.1 The lodge is complete with stately chimney, ornate ridge tiles, roof finials, jettied gable in Elizabethan-inspired timbering with ornately carved supports to the east and tile-hung gable wall to the north. The fascia boards are timber and the exposed rafters under the eaves are an unusual feature. String courses of contrasting brick encircle the dwelling. UPVC glazing has replaced original timber frames and there is a blocked-up window to the east. An extractor fan or flue on the east wall is disruptive to the overall design. Unfortunately, the clock on the jettied gable appears to be damaged. The garden is surrounded by a metre-high bow-topped fence.

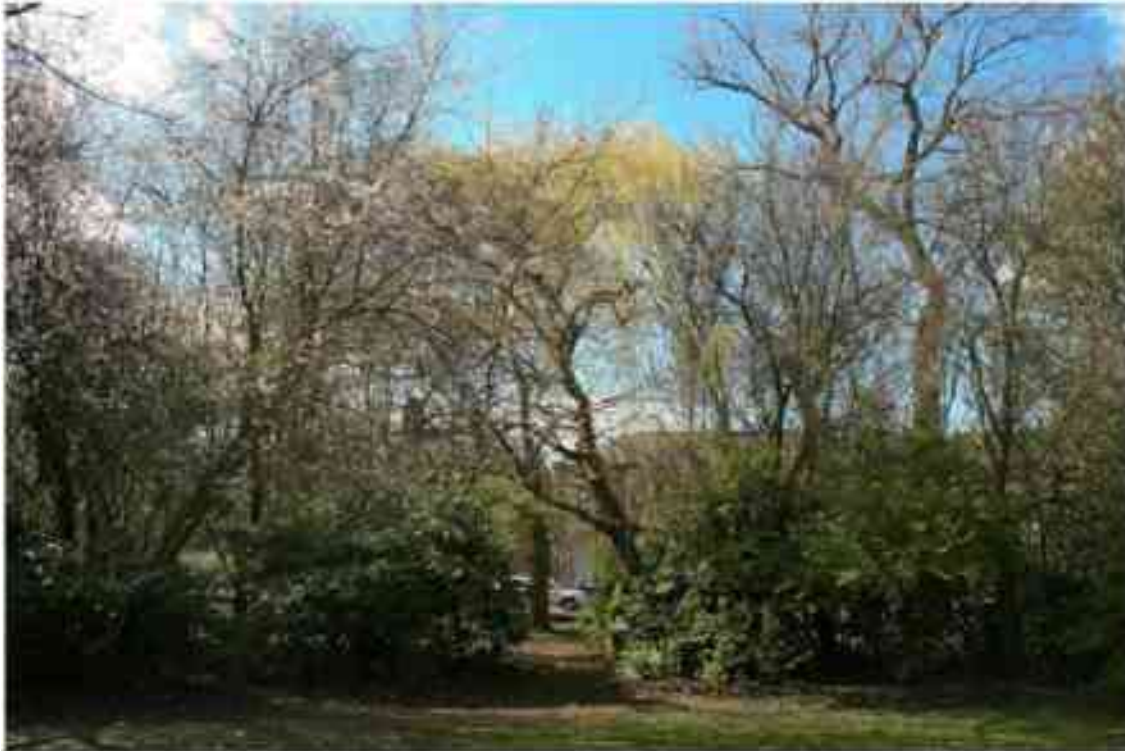
**Figure 90** View of planting on west perimeter through to Princes Avenue

7.3.6 The planting on the west perimeter is dense. The planting offers interest but does not afford an opportunity to view the vistas from the park and into the park.

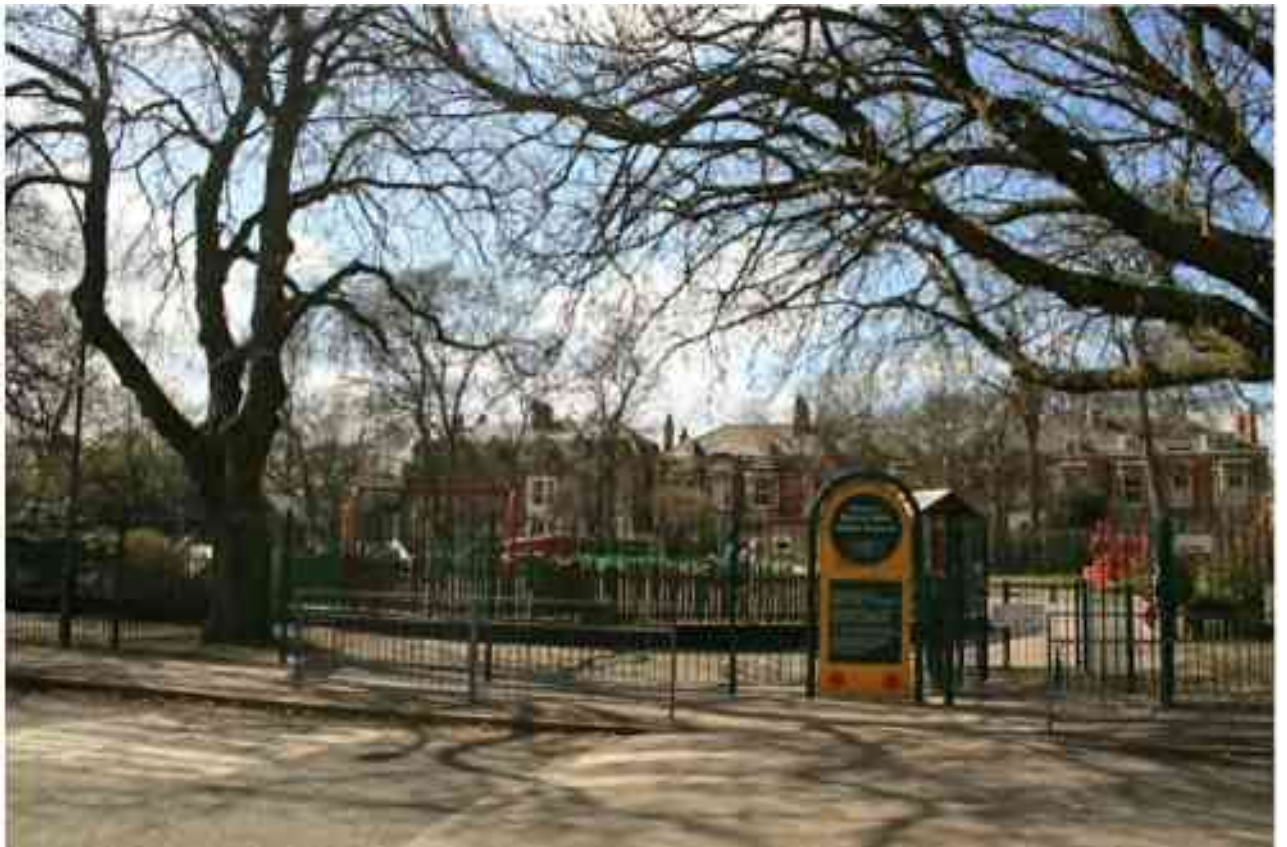
**Figure 93** Children's Play Area

- 7.3.8 The Children's Play Area is well used and located on the west side of the carriage road, opposite the lake and cafe. Verge protection has been laid in places to prevent vehicles encroaching on the grassed area. Large boulders have been installed on top of the plastic matting as further prevention against vehicular damage to the grass. Hindered by the matting and tree cover, grass growth is sparse, giving a tired appearance to the verge.

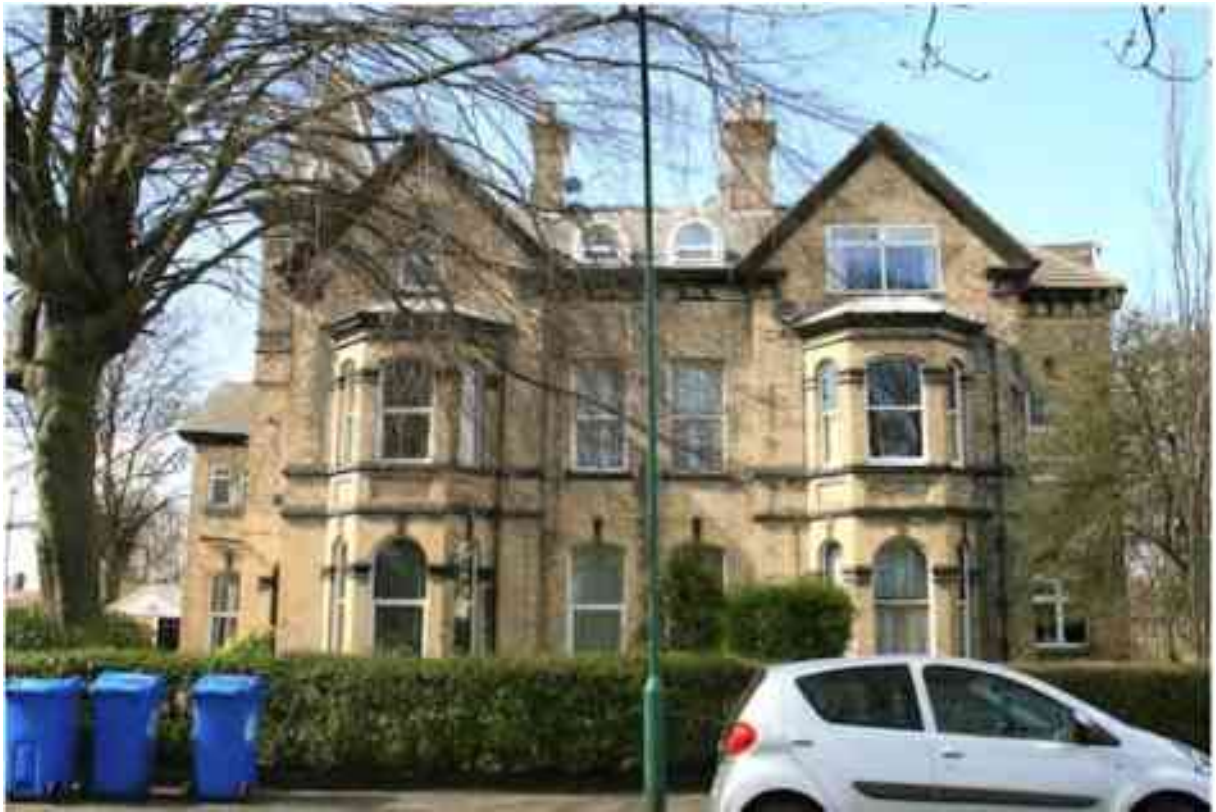
**Figure 99** Nos. 41 & 42

7.4.5.2 Satellite dishes on both properties are visual clutter, as is the faux-lead diamond-patterned glazing on all No. 41's bay windows and all four of the central sash windows. Unity is lost by the use of concrete tiles on the roof of No. 42. The dormer window on the side of No. 42 is an unattractive addition to the roofline. Wheelie bins litter the pavement and former grand entrance to No. 42.

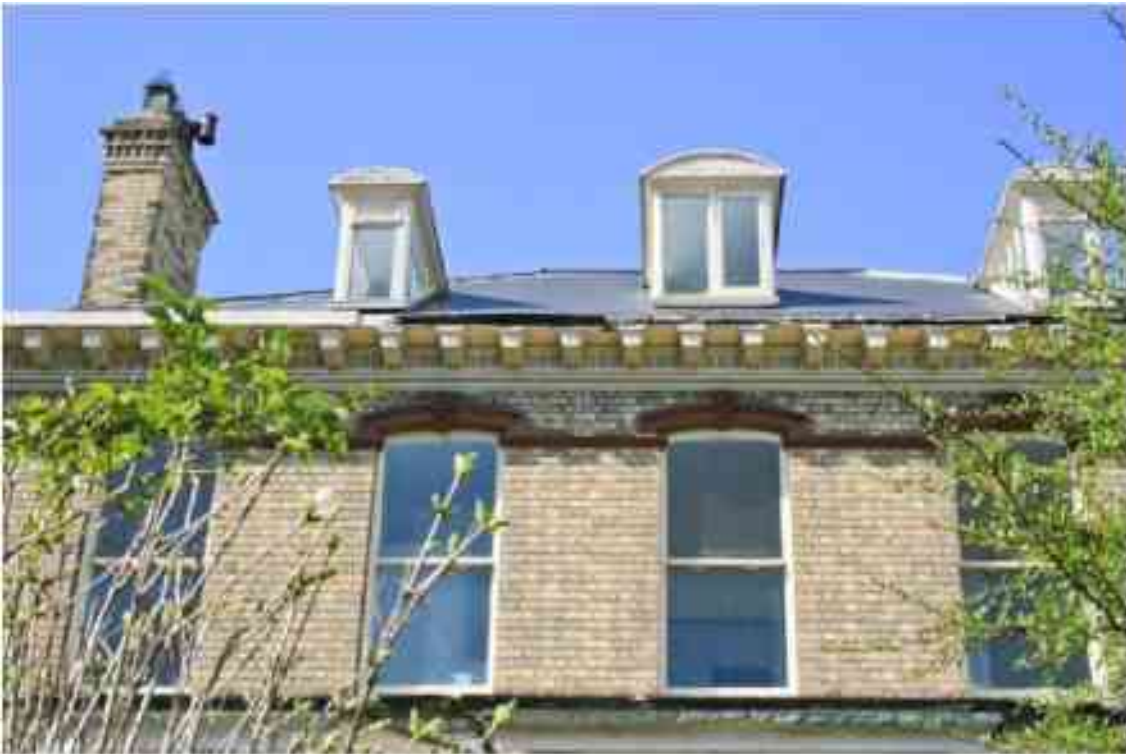
**Figure 103 No. 43 top windows**

- 7.4.6.5 Sadly there are features in a state of neglect: deteriorating stonework above both bay windows, and large portions of the gutter at the front are missing or decaying which, if not rectified, will cause substantial damage to the fabric of the building.
- 7.4.6.6 However, the sash windows look to be intact and the front path remains as flagstones, probably from when it was built, giving the dwelling a sense of place within its surroundings. The PVC downpipe and satellite dish to the left of the house are unattractive. Several bins are kept on the pavement: a disadvantage of houses in multiple occupation is the number of bins required for each flat.

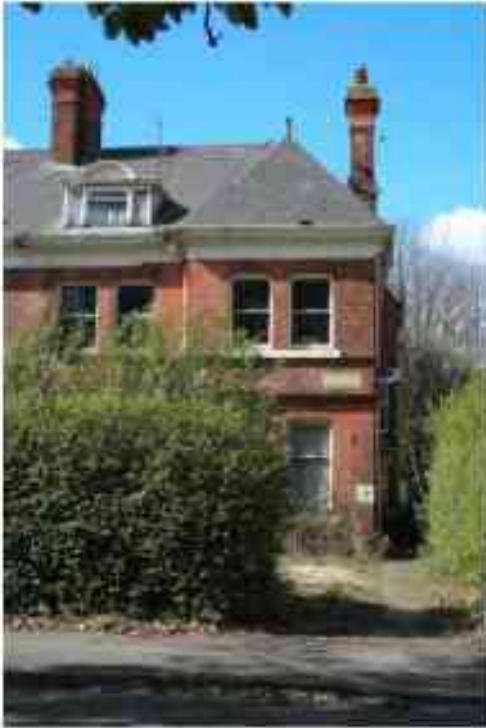
**Figure 113 No. 49 or *Beechwood* front**

7.4.10.2 *Beechwood*, like its adjoining neighbour, has many original features, such as slate roof, clay ridge tiles and finials, corbelled chimneys and Venetian style dormer window. Unfortunately, this has lost its original central glazing, losing harmony with its partner. This semi-detached pair are the only houses in the park to have a deep concave plaster-type fascia with timber architrave beneath and dentilated timber moulding above, on which the guttering sits.

7.4.10.3 The state of repair of this dwelling was cause for concern: timber window frames were clearly rotting. However, the beautifully ornate timber porch to the side was still intact. Update: *Beechwood* has recently been sold and is undergoing refurbishment and conversion to flats.

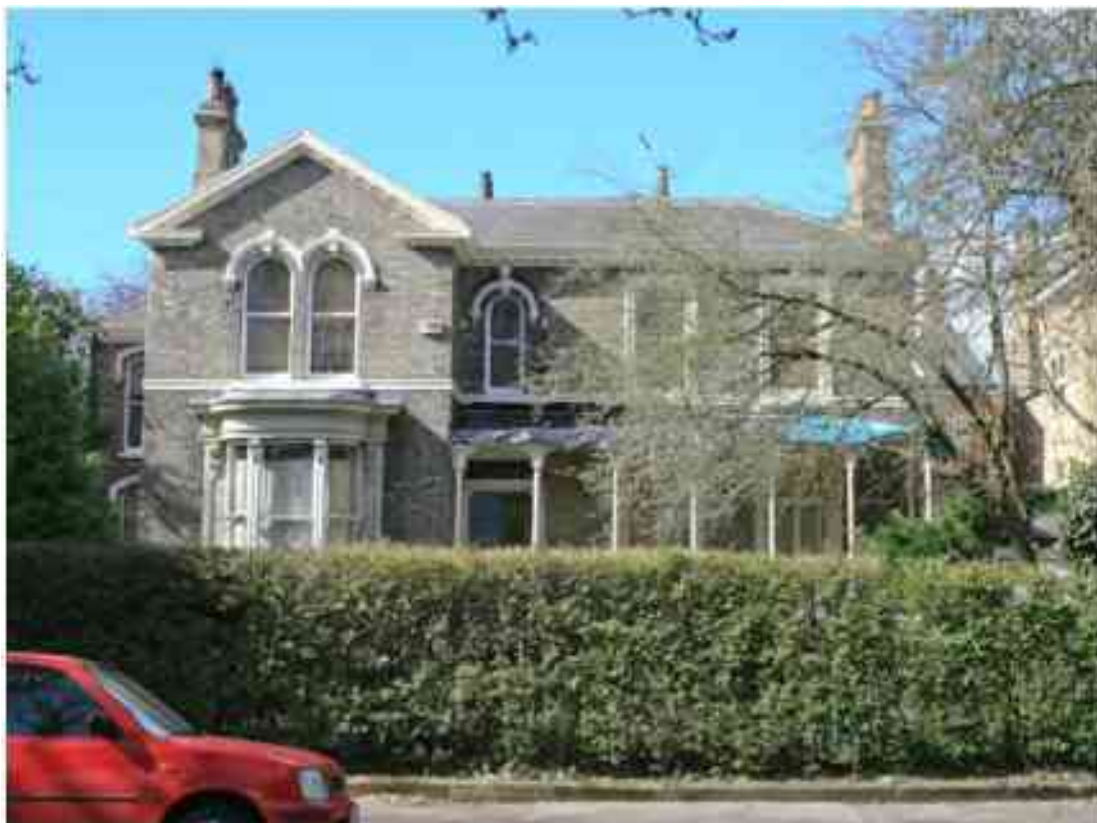
**Figure 121 No. 54 or *Avon Lodge* front**

- 7.4.13.1 Built in 1862, this detached villa is Grade II Listed and constructed from buff-grey brick with slate 'L' shaped roof, also known as a 'hip and valley' design. The villa extends to the west side towards the rear. The gable end is the most prominent part of the building and displays well-detailed timberwork of modillion-style gutter blocks and fascias. This feature is continued horizontally, and in part, on the gable, emphasising triangularity.

- 7.4.13.2 The Norman-style arch, of the same type seen on *Daulton House* (Area 2), is used on its own above the front door and in a pair above the ground floor curved-glass bay window on the prominent gable end. This focal point appears to have the original interior shutters. Externally, detailed carved scrolls are highlighted by the simplicity of the mullions and deep head. Segmented arches are located on the first floor and on the west protrusion.

- 7.4.13.3 The most striking feature is the Regency-inspired balcony: 'fine ironwork... made as delicate as gossamer, roofed in curving metal like a Chinese pagoda' (Observer's Book of Architecture, 1954). Large rectangular windows are located underneath the pagoda area which itself has a concrete base with decorative pillars and miniature fence. This ironwork is painted white, as are the decorative plaster surrounds on every window.

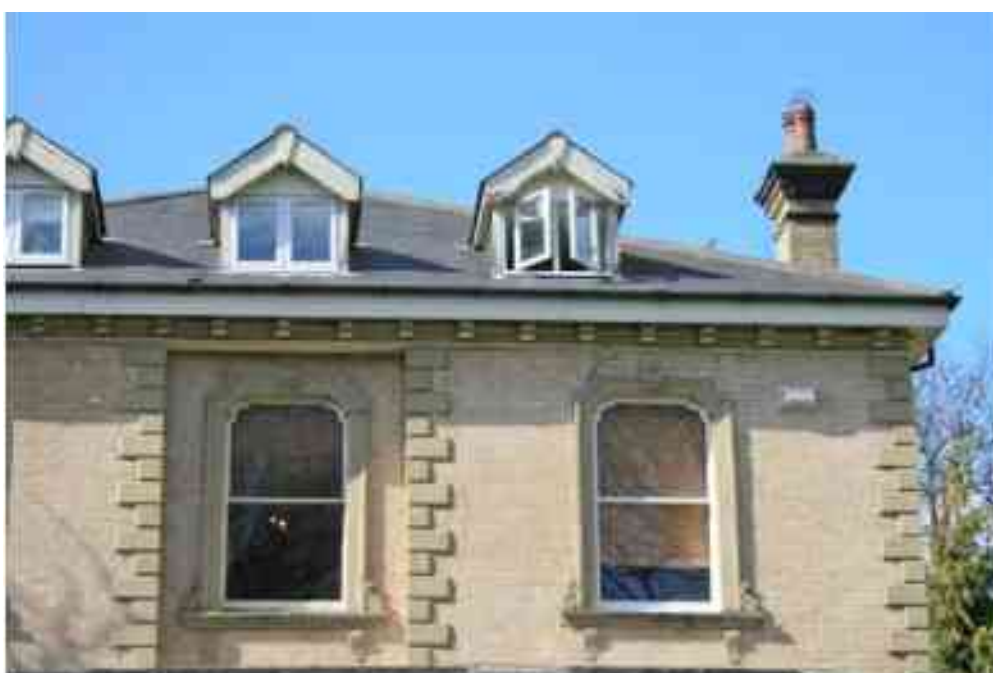
**Figure 124 No. 55 detail**

7.4.14.2 Unlike several other properties in the park, the fascia above the corbelled string course with

rope design has been replaced in modern materials. This detracts significantly from the original concept. Queen Anne style stonework on the corners of the villa is carefully proportioned to complement the whole design and works with the gutter blocks in unifying the composition. The replacement barge-boards on the three dormers are over-dominant.

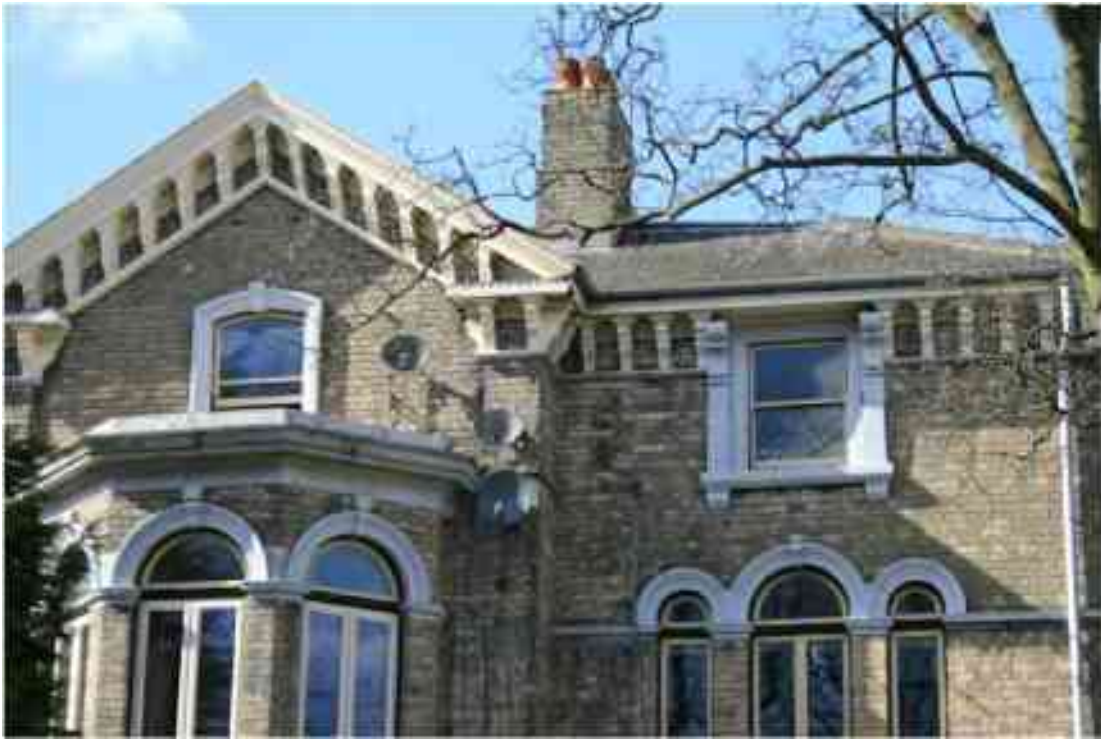
**Figure 126 No. 56 front angle detail**

- 7.4.15.2 The overhanging eave on this gable end is a striking feature with its rich timber corbelling and stone beading which is continued across the front elevation. The grey PVC guttering and fascia board on the recessed frontage are unwelcome modern appendages, as are the white replacement UPVC first-storey bay windows which jar with the rest of the colour scheme.
- 7.4.15.3 To the right of this protruding frontage is a three-storey rectangular section that hosts a rectangular window, flush to the roof, on the second floor; an Italianate triptych of semicircular windows on the first floor; and a triptych of segmented arched windows on the ground level. This section is finished with a shallow-hipped roof.
