**Avenues and  
Pearson Park  
Conservation Area  
Character  
Appraisals**

# Character Appraisal 2: Pearson Park

Published 2015

Published by Hull City Council, Kingston upon Hull, UK

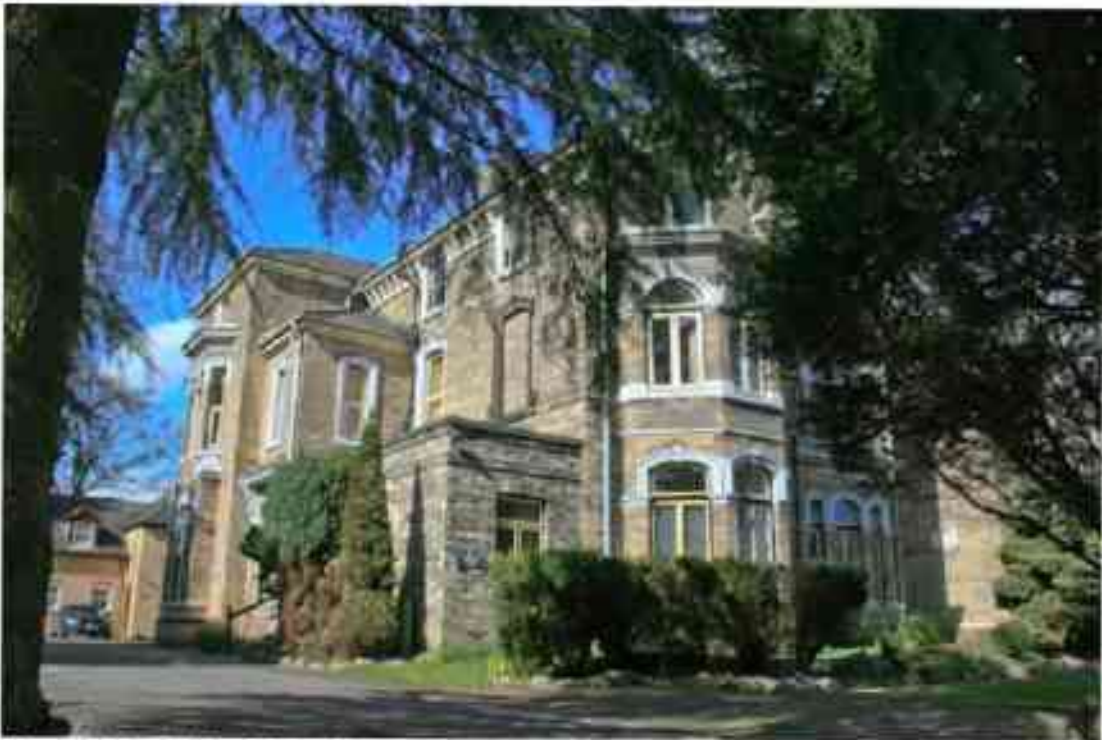
Figure 128 Side of No. 56 through trees

7.4.15.4 To the left of the ground-floor bay window is an out-of-character, flat-roofed extension. Above this is an unpainted stone window surround where a window once was, now replaced by bricks. The alteration and extension do not look new and similar bricks have been used to minimise disturbance.

7.4.15.5 To the back of the property, a new-build annexe-type dwelling is visible and is not an attractive addition to Pearson Park House. Satellite dishes, aerials and wires clutter the front of the property. Next to the front lawn, poorly maintained iron railings about the pavement and evergreen foliage does much to provide privacy, blocking the view of the villa. Throughout, ornate stonework painted white accentuates arches and surrounds windows to provide reference points.

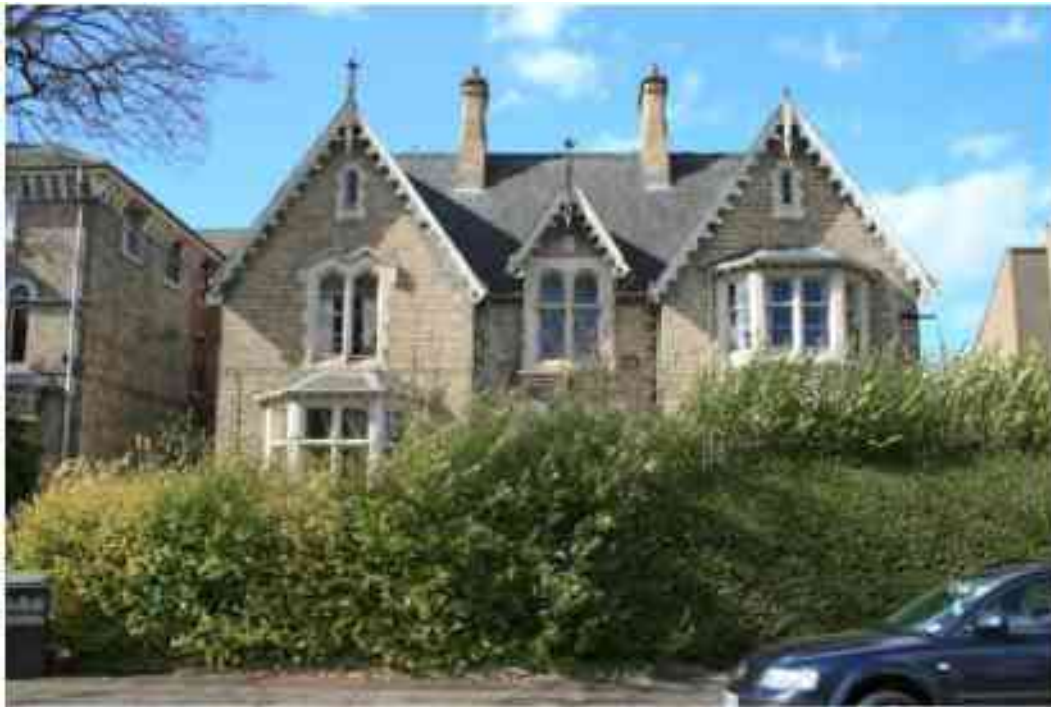
**Figure 129 Nos. 57 & 58 front**

7.4.16.1 The steeply pitched slate roofs, strong vertical lines of the windows and highly ornate barge-boards are characteristic of the Gothic Revival style. The barge-boards are finely crafted and, although in need of repair, balance with the visually heavy stone window surrounds. There are two types: flush with the brickwork, with straight and castellated edging; and relief which provides depth through catching the light and casting shadow. The front face is comprised of two gable ends, separated by a recessed wall meeting the hipped roof which bridges the gables. On this bridge sits a smaller gable tiled in slate, with barge-board. This window is comprised of two vertical glazed panels with stone mullion; and semi-hexagonal arches are atop both glazed verticals. In the triangular space between the window and roof is a stone shield, integral to the brickwork. Underneath this sits a larger window with three vertical sections with similar stone mullions. Each vertical has curved top corners pointing inwards that then reach up again before an abrupt horizontal top. The stonework has decorative motifs above the two centre mullions.

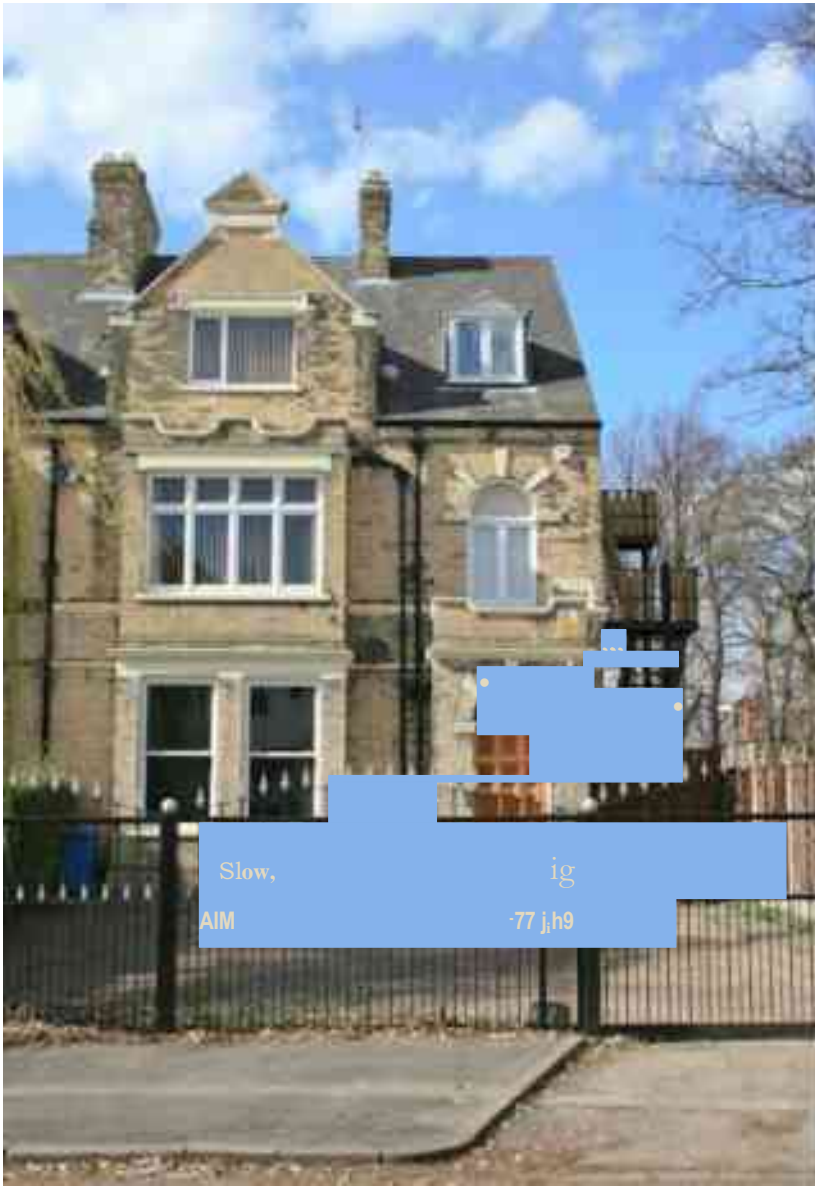
Figaro 137 No. 61 or Woothille frwit

7.4.18.4 On the corner above the front door the name plaque of No. 61 reads 'Woodville'. The plaque on No. 60 is virtually illegible ('Ryo...') as the stone has weathered severely. This could be due to pointing using incorrect materials which can accelerate damage to stonework. The stonework on No. 61 is painted cream and is well-maintained, although this is not necessarily how it would have looked originally. As the lintels and sills next door are unpainted, it is likely the original materials were celebrated and left exposed.

7.4.18.5 A very large fire escape on the side of No. 61 is clearly visible from the front and possibly provides access to flats but currently resembles New York tenements, uncharacteristic of Pearson Park. While necessary for safety in Houses of Multiple Occupation, fire escapes are unsightly additions to houses of this era.

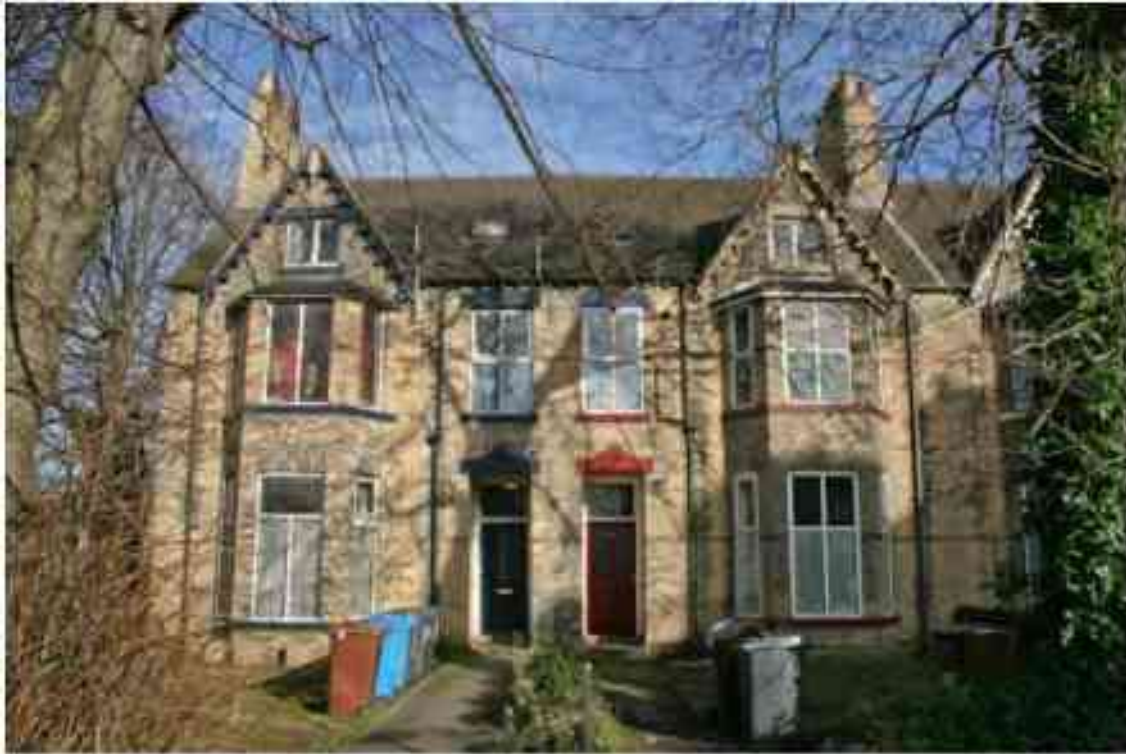
**Figure 140 Nos. 62 & 63 front**

7.4.19.2 Each has lost its original slate roof and had a Velux-style window implanted in its roof, located roughly above the front entrance. Nos. 62 to 64 also have a replacement finish to their bay window roofs: felt and bitumen, rather than lead which is seen on No. 65 and is likely to be the original material used. No. 64 & 65 have finials atop their gable: both appear to be replacing the originals.

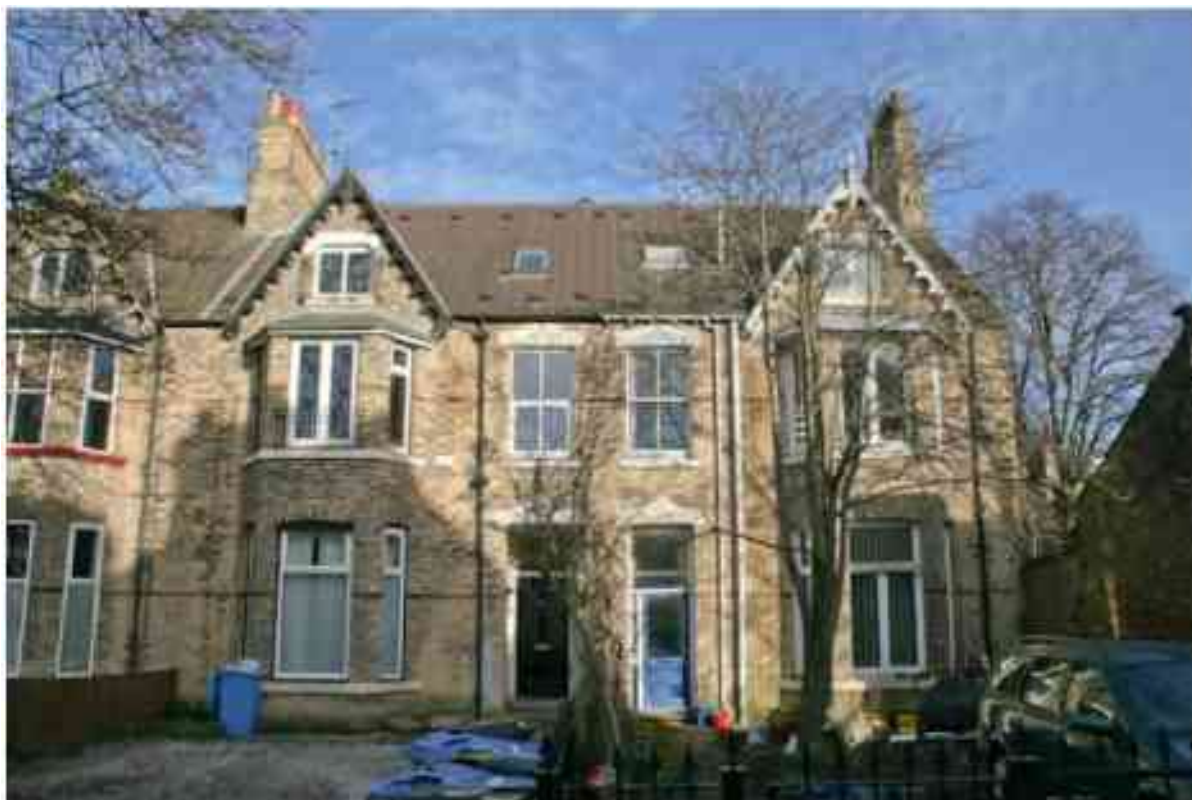
**Figure 144 Nos. 64 & 65 front**

- 7.4.20.1 This end terrace appears to be the only one of the properties which has not been split into flats. This is surmised by the number of wheelie bins outside the other houses. Unfortunately, No. 65 has replacement PVC guttering and although the other properties may well have the same material, this white PVC is demonstrative and a significant compromise of the design. Likewise, the addition of an exterior front door complicates the entrance and ignores the previous design. The property retains the only timber sash windows in the terrace: the rest are UPVC replacements whose varying styles disrupt the harmony of the front elevations of this row. No. 64 (no. 2 Elm Villas) was the house that Zachariah Pearson, donor of the park, lived in for the last 27 years of his life. He lived there with his wife and family till he died in 1891.

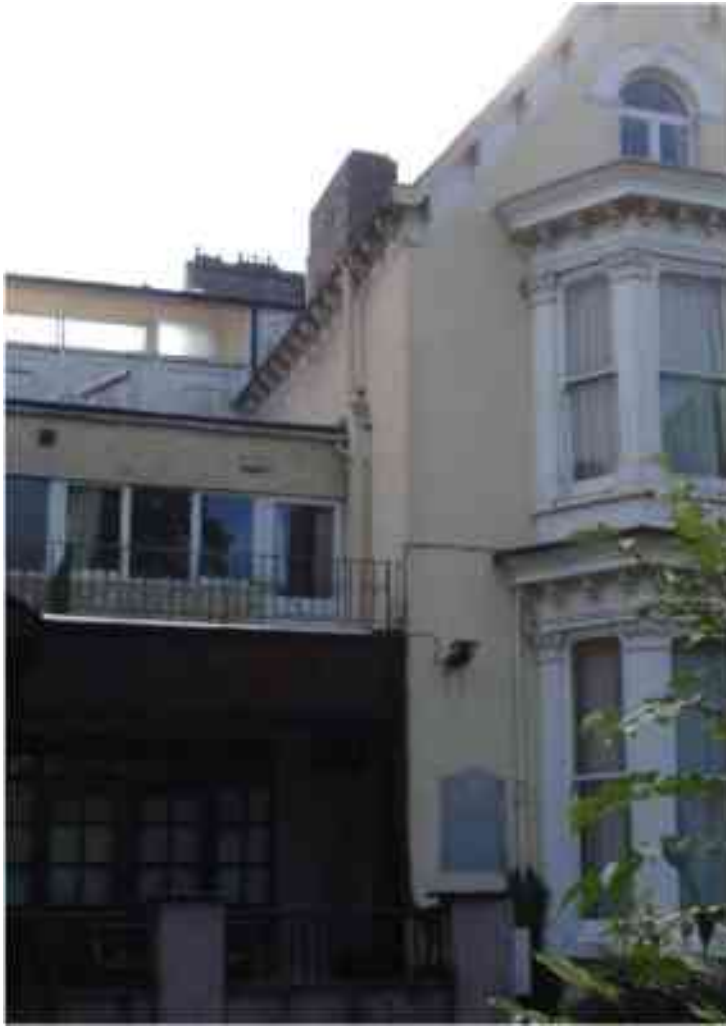
**Figure 155 Nos. 70 to 72 join detail**

7.4.25.2 Architecturally, the part that would have been No. 70 has been altered significantly. It is a composite of planes and pitches. On the third floor, the front has two gable ends of differing sizes, located side-by-side with the one on the right slightly smaller than the left. Both have red fish-scale tiles with cream render below and non-matching, horizontal, rectangular windows within the triangular tiled area. The left gable is protruding from the facade and the red tiles continue on the second floor to the left-hand side.

- 7.4.25.3      Features worth noting are the two tall corbelled chimneys; the ornate ridge tiles to the right-hand side of the roof and smaller gable with terracotta finial; Queen Anne style semi-cylindrical window with rectangular side panels and decorative angel support underneath on the larger gable; timber-framed sash windows; on the first floor to the left projects a small two-pane window in triangular prism form; red Rosemary roof tiles; dentilated brickwork at the top of the second storey. There is very little of architectural significance on the ground floor as previous renovation has attacked the unity and separated the ground and first floor with a broad band of plywood painted brown, acting as a sign board.

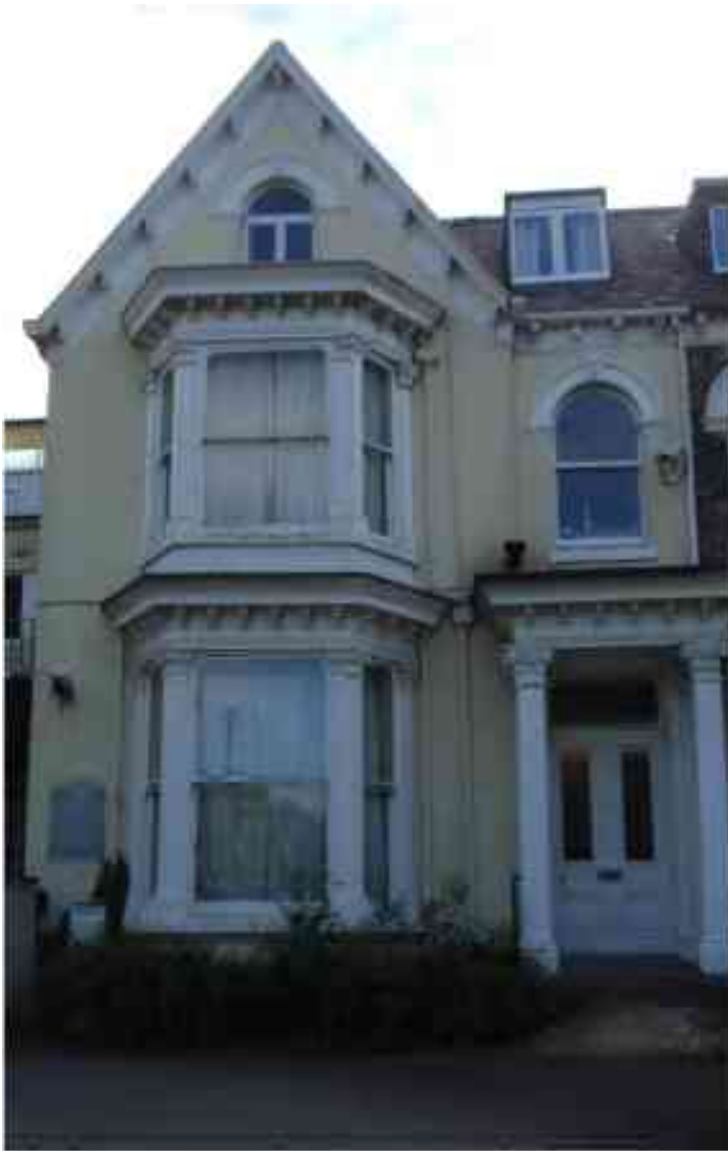
**Figure 156 No. 72 front**

- 7.4.25.4 No. 72 has a rendered veneer and still retains the look of a three-storey villa with two-storey bay windows intact. These have ornate corbels which are replicated on the grand front porch, hosting columns with Corinthian capitals. The mullions of the timber bay windows have similar decorative capitals, with detailed curved corners at the tops of the timber-framed sash windows. The front door has the original timber door with panels. Above this is a semicircular arched sash window similar to the adjoining No. 74. The dormer window above is out of line with the rest of the composition. In the gable end, above the bay windows, is a semicircular arched window with stucco detailing over the arch. The replacement window frame is not original in its design.

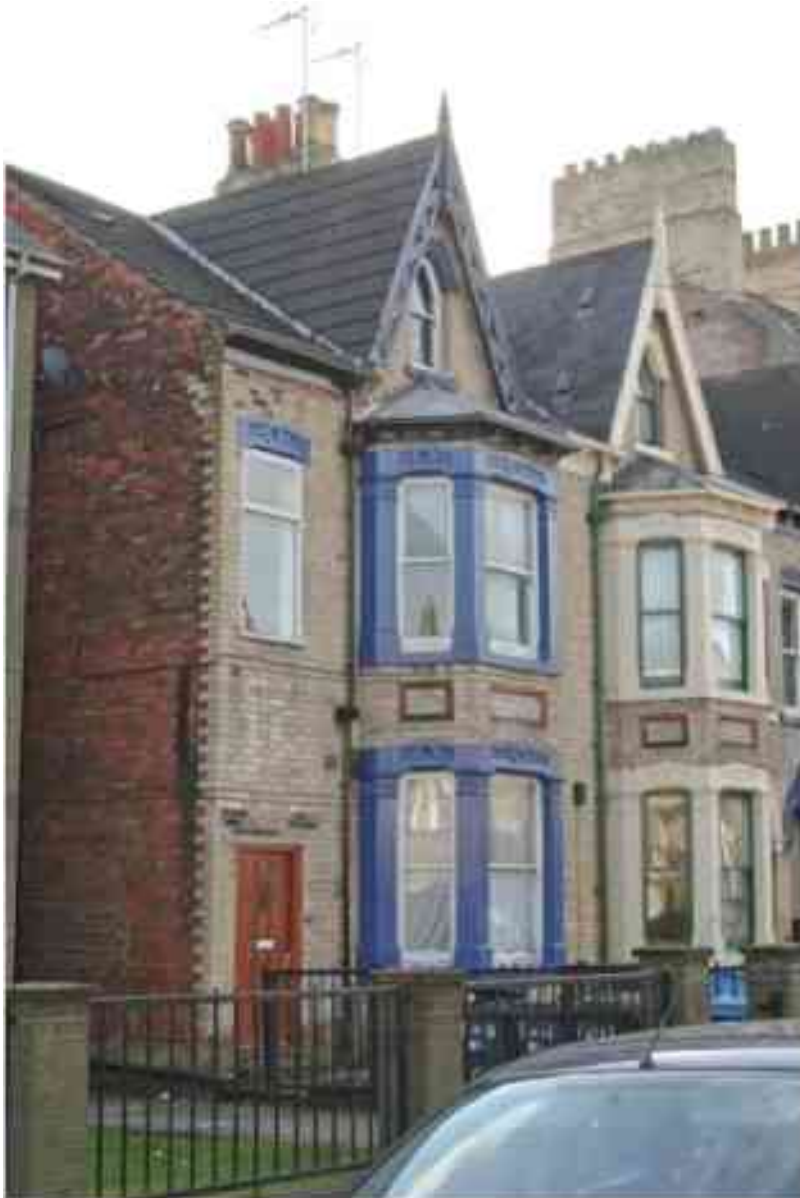
**Figure 166 No. 11 Pearson Ave angle**

7.5.5.2 Nos. 13 and 15 have retained their high-arched front entrances with decorative stonework, emphasising the strength of the steeply pitched gable. It is very unfortunate that No. 11 has had this entrance completely altered through the fitting of a rectangular door flush with the external brickwork, thus removing the porch. The stone arch has been removed and the area infilled with brick. This has sabotaged the design and only careful reinstatement of crafted exact matches could repair the damage. The stone ledge of the replacement UPVC window above has also been removed.

7.5.5.3 Like Nos. 13 and 15, No. 11 retains the decorative stonework above both bay windows and the rectangular window above the front door; red brick rectangular decoration between the bay windows; timber sash windows in the bays and third floor gable window; modillion-style gutter blocks atop the bays and horizontal roofline; decorative lace-style barge-board on the gable-end and chimneys with original pots and corbelling. Unfortunately, the rectangular window frame above the front door at No. 11 is a modern replacement and set too far forward in the reveal.

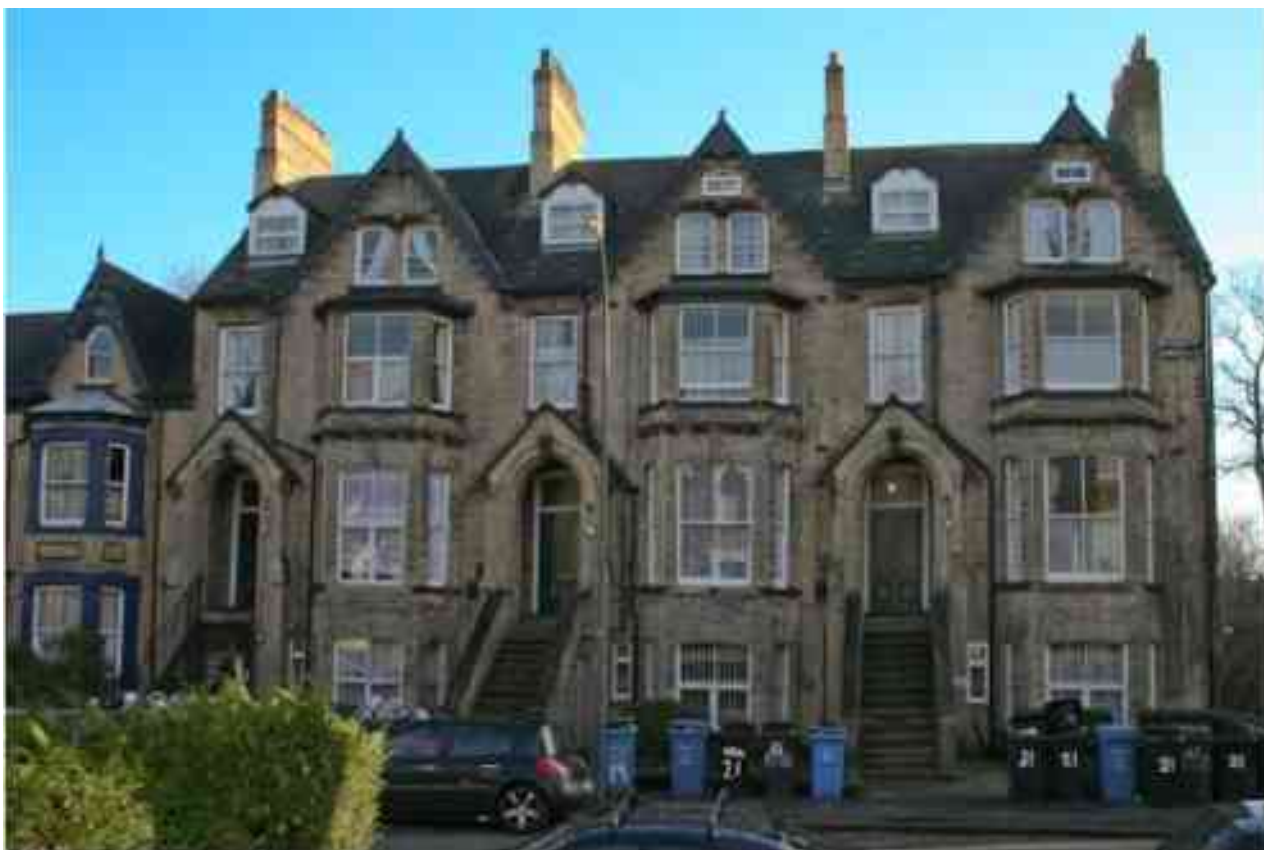
**Figure 170** View of Nos. 17 to 21 Pearson Ave or *Harrow Terrace* from No. 20

- 7.5.6.1 Nos. 17 to 21 are imposing three-storey town-houses constructed using buff-grey brick and slate roof tiles, with grand entrance porches on the first floor reached by a flight of, at least, eleven steps. No. 17 has a set of fourteen steel steps that replace the stone ones as seen on Nos. 19 and 20. The stone steps look as though the concrete side walls have been added at a later date as the steps protrude through the walls but without intention. The stonework, at waist-height, either side of the entrances is indicative of another fixture.

- 7.5.6.2 This terrace adjoining Nos. 11 to 15 is suffering significantly with subsidence. The weight of the chimneys appears to be where the buildings are under pressure and it is remarkable that they have changed shape so much without severe repairs being needed on the facade. The doorways resemble certain medieval buildings with their distorted appearance.

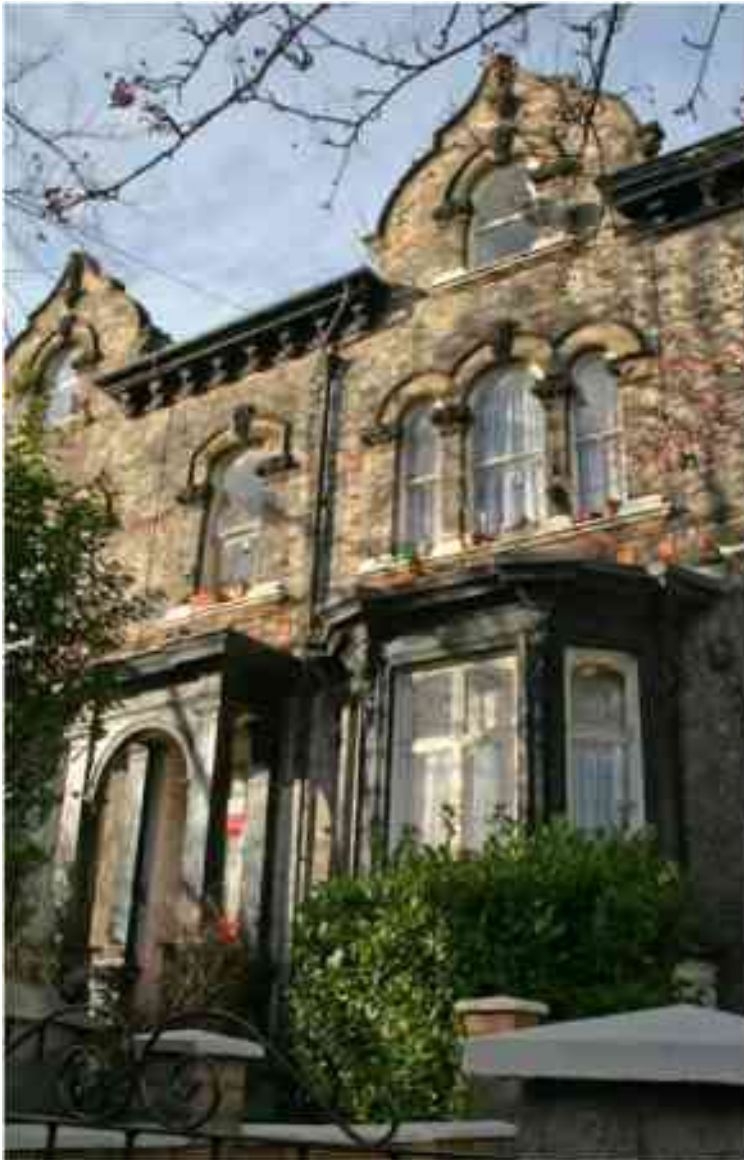
**Figure 177 No. 12 Pearson Ave low angle**

- 7.5.10.1 Stonework remains unpainted as it would have originally been finished. The bay window and porch remain intact with decorative detail, although the timber structure surrounding the door does appear distorted and suffering from subsidence. Other aspects of the house appear in good shape: the only exceptions are the stonework of the capital to the right of the triptych window and the missing finial atop the gable. None of the houses retains this delicate feature. Commendably, the cast-iron hopper is intact and the top part of the downpipe is still cast-iron.

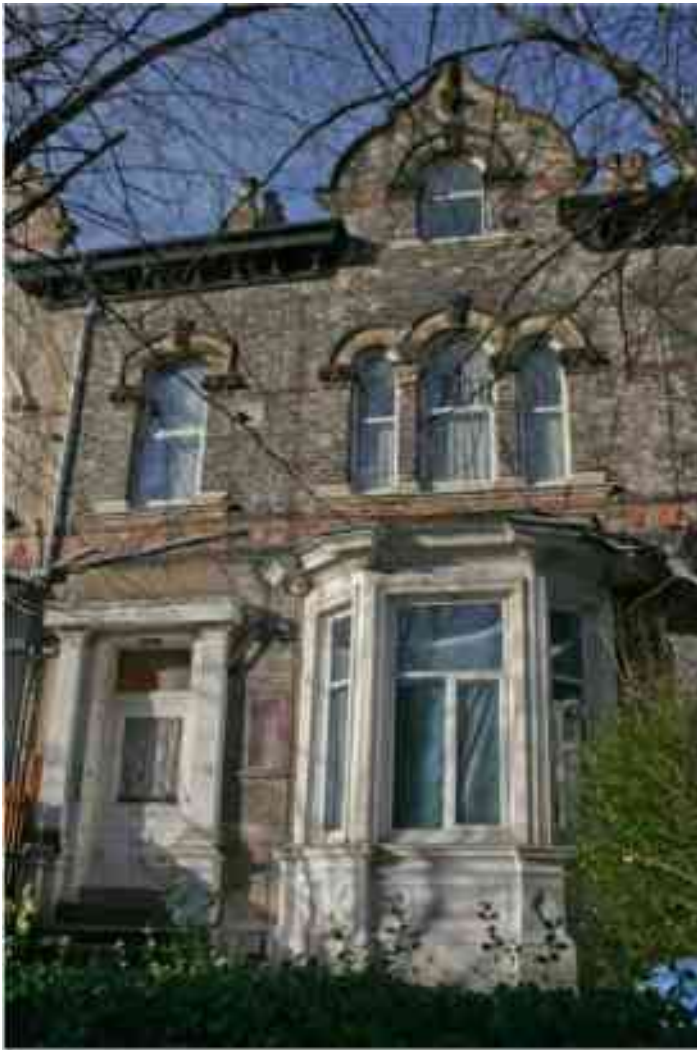
**Figure 178 No. 14 Pearson Ave front**

- 7.5.11.1 The key features that remain in place on this property are the bay window with projections; intricate stonework surrounding the first and second floor windows; timber guttering with decorative corbels; fine chimney with original pots; patterned brickwork and gable with carved head. A privet hedge borders the front concreted garden. Regrettably, the front porch has been removed and the wall has been infilled with concrete; the original front door has broken glass; the decorative corbels on the bay have been removed; the frames on the bay have been replaced; one of the capitals on the triptych is in need of restoration; waste pipes and a flue have been added above and next to the front door, and a small vertical rectangular window has been inserted in the narrow space between the front door and the bay. The building is on the way to becoming stripped of its original aesthetic sense.

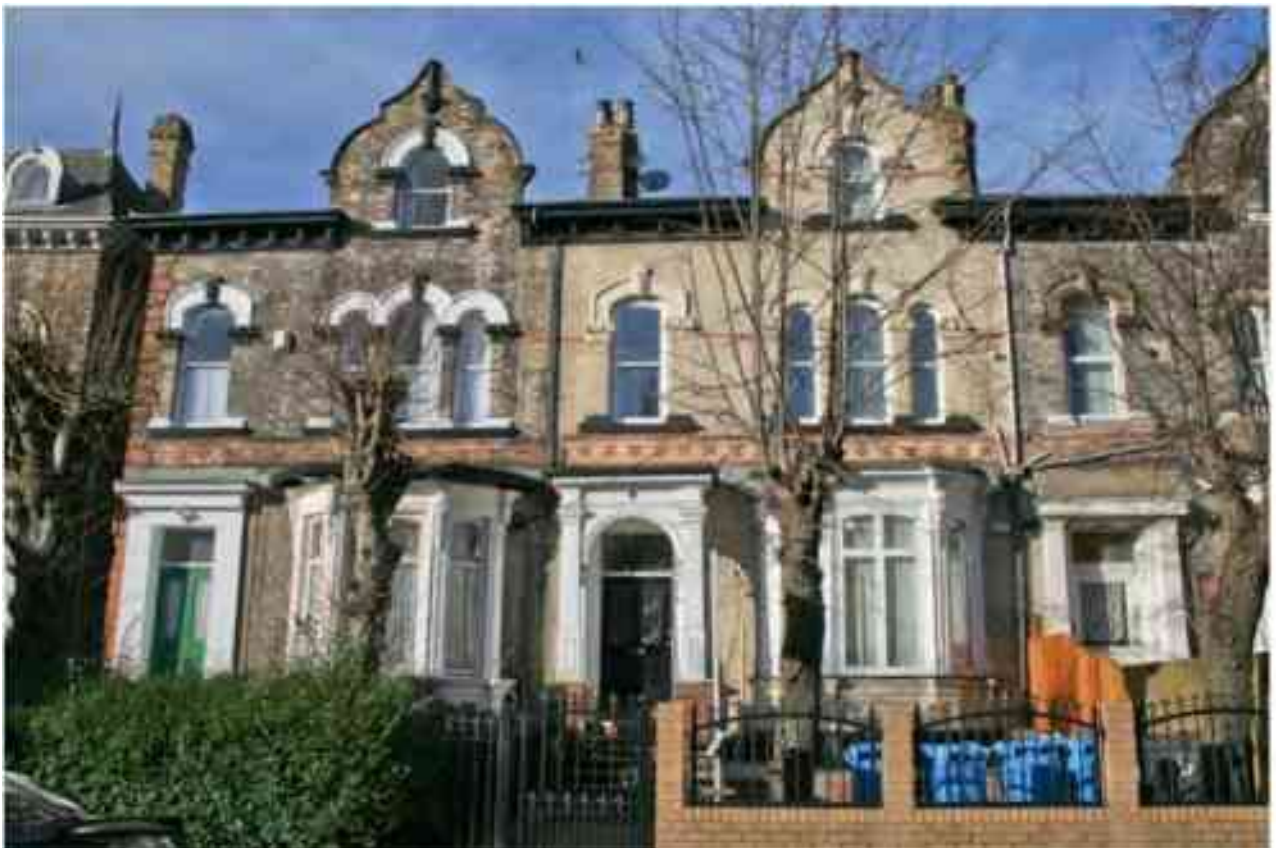
**Figure 179 Nos. 18 to 14 Pearson Ave**

7.5.13.1 The end terrace property appears to be in very good condition with all original features intact apart from the front porch, the removal of which disrupts the continuity of the terrace. The installation of a CCTV camera adds to the visual detriment. Wheelie bins clutter the path.

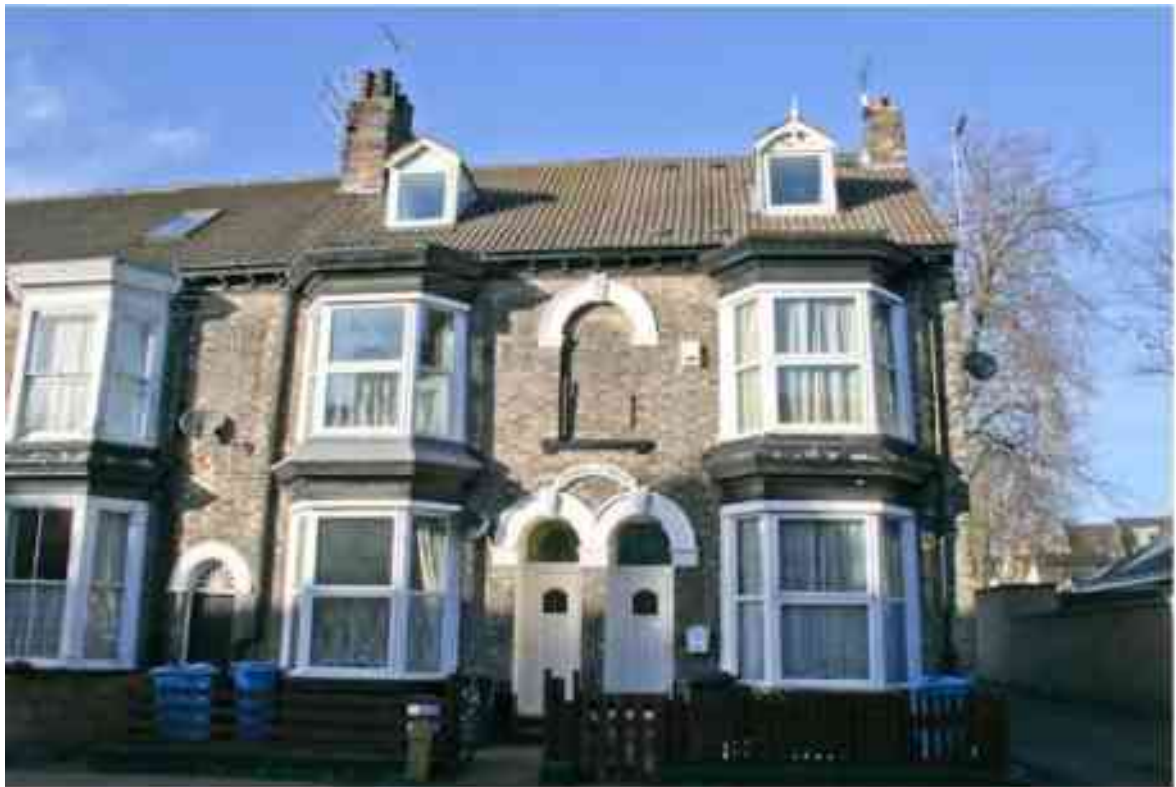
Figure 196 Nos. 2 & 4 or

7.5.16.2 Nos. 2 & 4 have UPVC replacement glazing and front doors. In the central arched window, splinters of wood from a modern sign have been left. Below this is the hand-written house name sign.

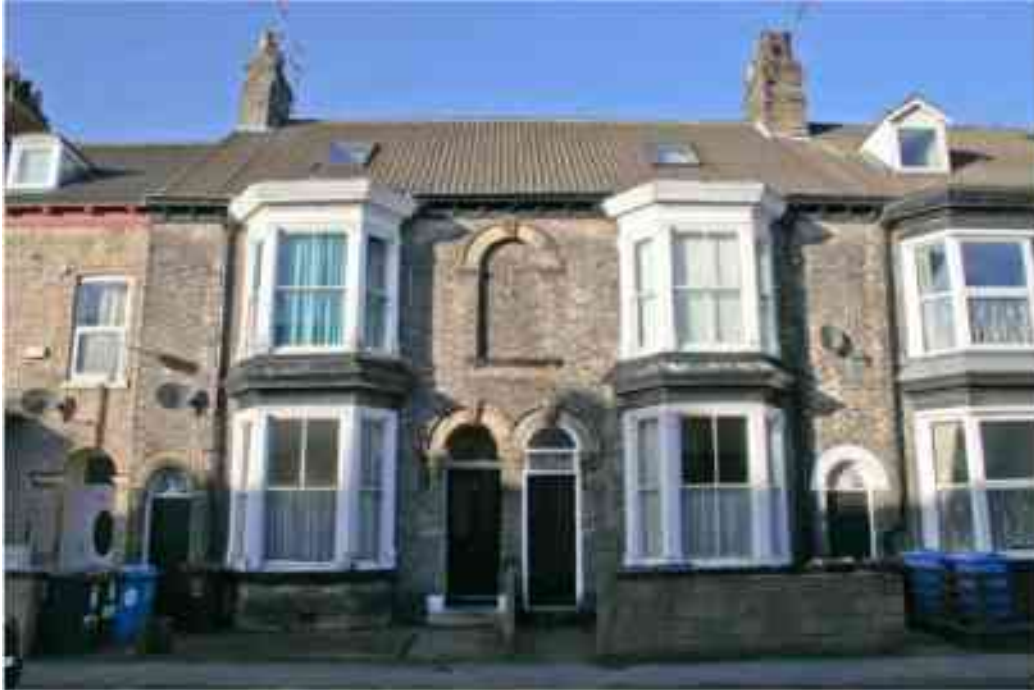
**Figure 199 Nos. 6 & 8, Grove Street, front**

7.5.17.1 These differ from Nos. 2 and 4 as the horizontal timberwork at the top of the bays is painted white rather than the usual black. The rest of the timber-framed sash windows are white: this plays an important role visually, with symmetry being an important part of the design. The satellite dishes on either side of the bays interrupt the concordance, as does the additional glazing at the entrance to No. 6. These properties have porches that are integral to the building and this installation of frame and glazing flush with the exterior wall creates aesthetic imbalance. The roofline of the terrace is imbalanced by a mixture of dormer and Velux-style windows and the loss of the tall chimney pots, at the end of the terrace at No. 2.

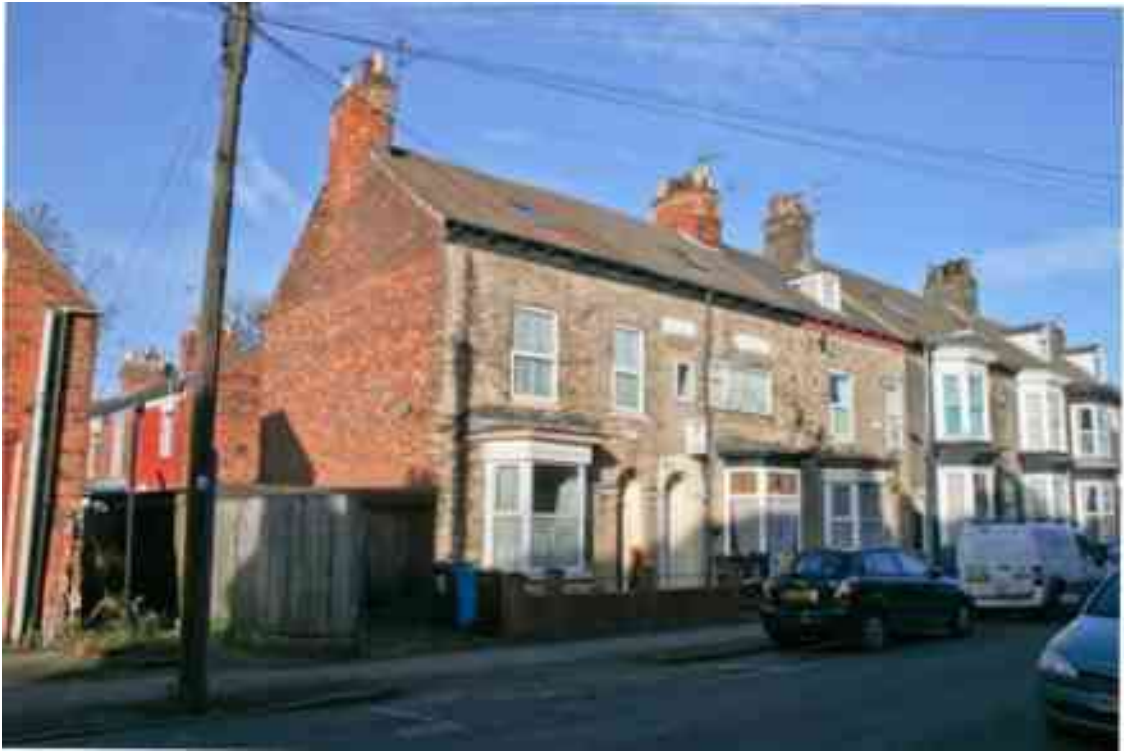
**Figure 201 View of Nos. 14 to 2, Grove Street with West View**

- 7.5.18.1 Constructed in red brick with smooth cream buff brick facade, these three terraced houses would also have been slate-roofed but now have concrete tiles. Each has a semi-circular brick arch above the front door with stone detail denoting where the arch ends and vertical brickwork begins. The bay window on the ground floor and two rectangular windows to the first floor are set apart so as to balance the composition: the lines of the front door are extended to the window above. To the left, the slightly larger of the two first floor windows complements the bay below.

- 7.5.18.2 All three houses have had their windows replaced: Nos. 10 and 14 in UPVC and No. 12 with timber. They all retain their bays, but the size and shape of the windows on the first floor of No. 12 have been completely changed, with large infilled areas of two or three different kinds of brick to compensate for the loss of the original windows. With the installation of a much smaller window above the front door and a horizontal rectangular window above the bay window, the form of the design has been grossly ignored. Scarce attempt has been made to arrange the windows in relation to other glazing within the context of this dwelling or those adjoining. The modest segmented brick arches painted cream, once standing proudly above the rectangular windows, now float pointlessly in a sea of brick.

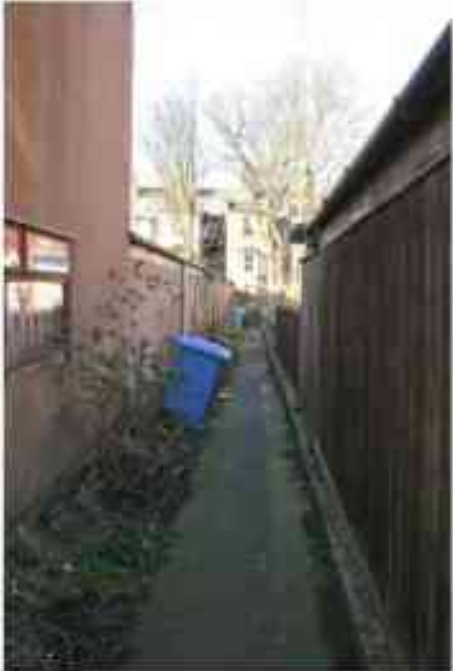
**Figure 202 West View snicket**

- 7.5.19.1 This is a terrace of six houses in a cul-de-sac that is reached via a snicket from Grove Street. The sign, minus the 'W' is located on the corner of No. 14, but the houses are not easily seen. A tall fence next to No. 14 blocks the view of this area and the snicket is unkempt with little direct sunlight reaching the path, leaving a light layer of green vegetation. Wheelie bins are balanced precariously and there is not room for two people to pass comfortably.
