**Spring Bank Conservation Area
Management Plan (South side)**
Draft for Review

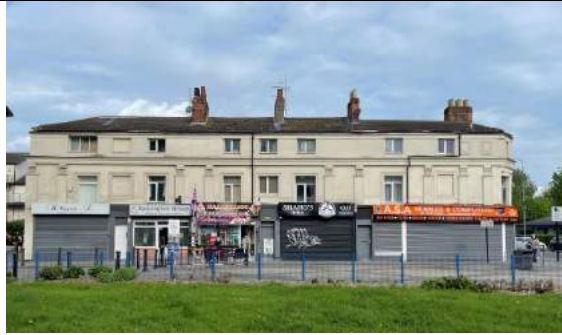
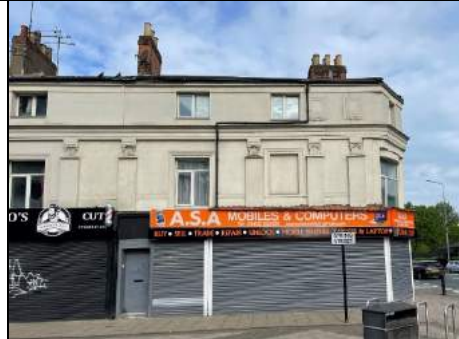
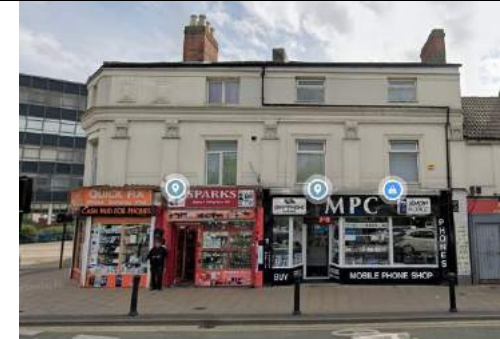
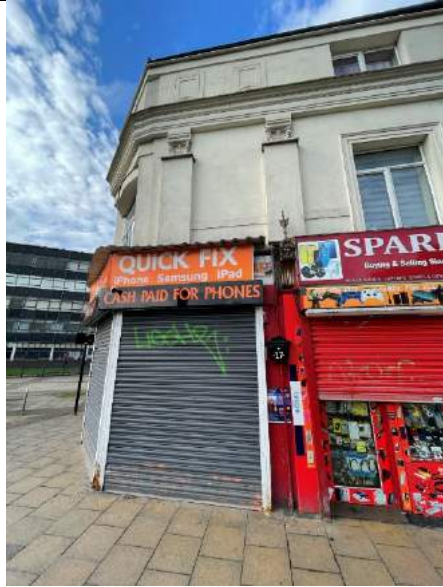
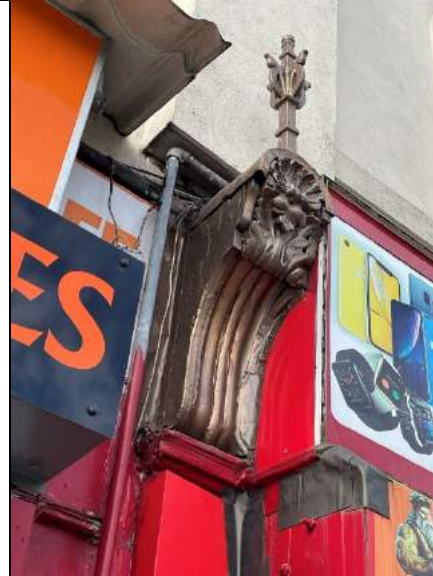
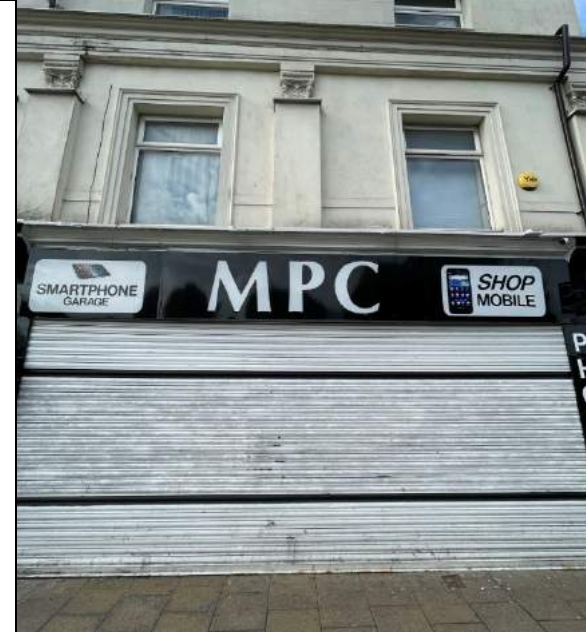
Address: Stone Boy House

The building was constructed pre 1836. Originally named Stone Boy house after the monument of a stone boy on the roof at the corner of Spring Bank/Spring Street. The building was renovated August 1929. The distinctive stucco classical column sections have been retained.

Monitoring Notes	Roof appears to be in poor condition with low quality patch repairs previously undertaken and missing tiles Staining above the second floor stone cornice would suggest that there is a potential need for a lead flashing detail to ensure water run-off and to avoid structural deterioration
Recommended Actions	<p>As a key focal building at the entrance of Spring Bank from Ferensway, this is an important building that would benefit from the following works:-</p> <ul style="list-style-type: none"> • Removal of existing shopfronts and inappropriate illuminated signage to all units within Stone Boy House and the reinstatement of the historic timber shopfront design including pilasters, fascia signs, corbels, incorporating new timber doors to upper floor apartments • Replacement of existing uPVC windows with timber framed sash windows throughout • Reinstatement of the original bay window to the corner of Spring Street and Spring Bank • Replacement of the existing roof finish with the original material • Re-routing and replacement of all rainwater goods with cast iron • Patch repairs and redecoration of the external rendered walls • Reinstatement of the carved stone corner detail and Stone Boy statue • Rationalisation/removal of conduits, redundant signage • Removal of the insulation and render to the columns to reveal the historic details

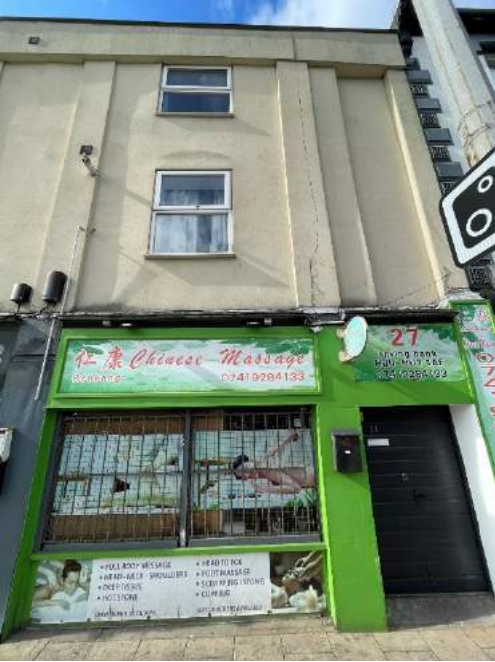
Street: Spring Bank	Address: Chinese Massage, 27 Spring Bank
Historic Photo 24/11/83	Current Photo – 11.05.2023 (author)

Building Notes	Pre 1893 façade which has been externally insulated and rendered which has concealed any original details including the arched niches, decorative window lintels and decorative Corinthian column heads. Has undergone extensive redevelopment to the rear of the property to form a Snooker Club/Night Club. All timber windows have been replaced with new uPVC casement windows. Does not contribute positively to the Conservation Area in its current condition.
Monitoring Notes	Shop front negatively contributes to the character of Spring Bank. Removal of external insulation should be encouraged due to harm caused to historic external walls by holding in moisture in the fabric and the concealment of decorative details that would add character to the Conservation Area.

Recommended Actions	<ul style="list-style-type: none"> • Remove external insulation to reveal historic decorative features. • Replace UPVC windows with timber sash windows. • Remove roller shutters. Remove fascia signage and projecting signage.

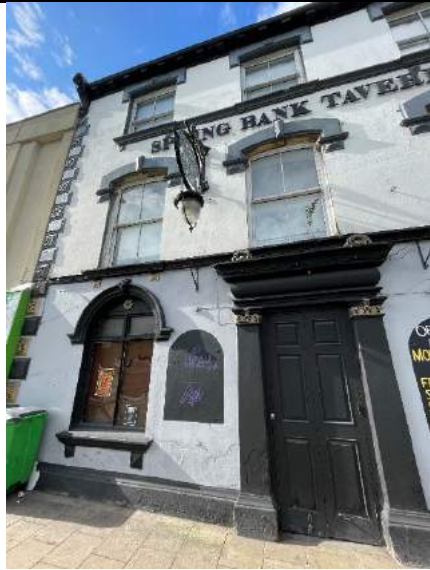
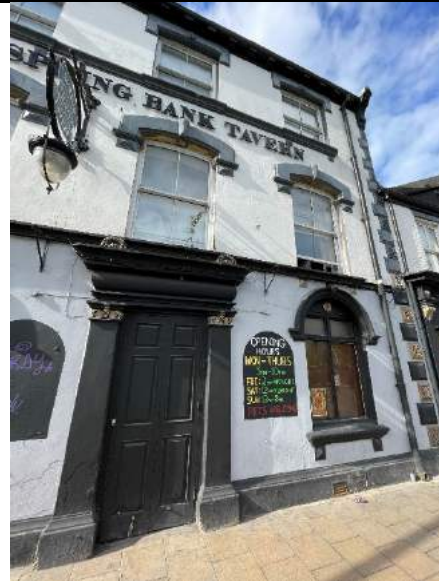
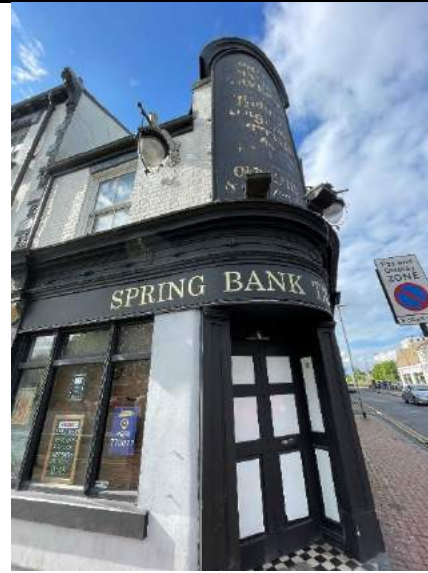
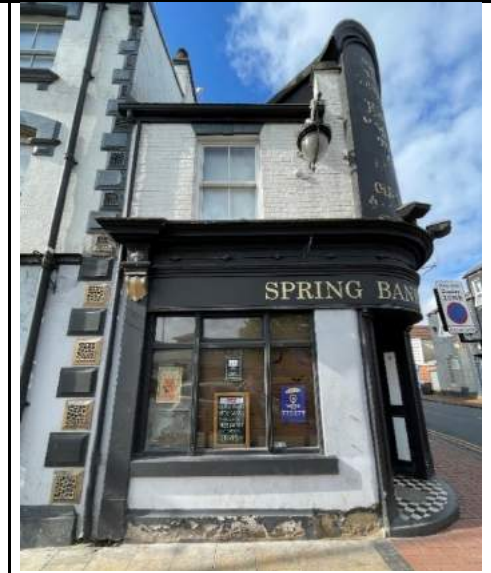
Street:	Spring Bank	Address	Spring Bank Tavern, 29-31 Spring Bank
Historic Photo taken 24/11/83 (Phil Hampel)		Historic Photo taken 24/11/83 (Phil Hampel)

<p>Building Notes</p>	<p>Dates from before 1820. Generally, positively contributes to the character of the street. Original Spring Bank Tavern comprises of rendered brickwork with feature stone keystones, window lintels, stone plinth and pedimented entrance door retained. Terracotta pantiles to roof. Timber sash windows to upper floor levels appear to be new double glazed timber sliding sash. Ground floor arched timber framed casement windows with carved rosette detail at the head retained to the original pub building retained. Decorative timber brackets supporting timber gutter, eaves and fascia add depth and detail at eaves level.</p> <p>Pub later extended into adjacent shop unit in the late 1990's and historic shopfront removed although it has retained the original timber curved fascia , pilasters and decorative cornice. Later addition curved sign to corner conceals first floor window. Cast iron rainwater goods retained in situ. Former shop unit comprises of brickwork external walls, currently painted to match rendered building with splayed stone lintel details.</p> <p>Locally listed building considered to be a key focal point to the street as a key corner gateway building. In reasonable condition generally.</p>

<p>Monitoring Notes</p>	<ul style="list-style-type: none"> • Ensure that any future works do not remove historical fabric to pub including stone pilasters, pedimented entrance, decorative arched window lintels, timber eaves brackets and stone details generally. • No works permitted to remove the historic shopfront fascia, cornice and pediments to the former shopfront (now main entrance to the Spring Bank Tavern). • Removal of the large corner sign would be supported as it conceals original window and arch to the corner. • Stepped access to main entrance is not fully accessible. • Retained cast iron rainwater goods to be retained and repaired where possible or replaced with cast iron if required.
<p>Recommended Actions</p>	<ul style="list-style-type: none"> • Damage to one of the pilasters. • Remove redundant wires and light fittings. • Limited urgent action required.

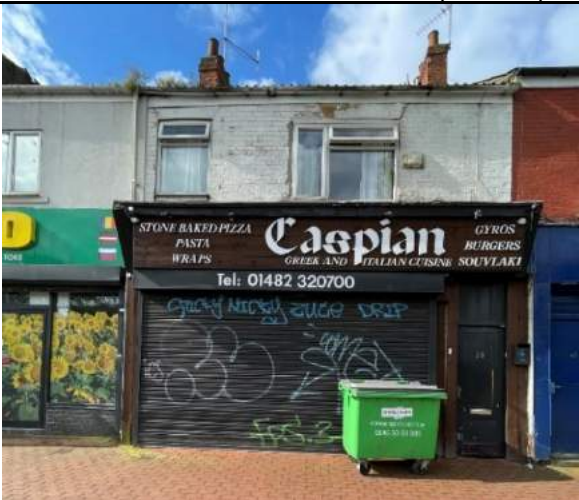
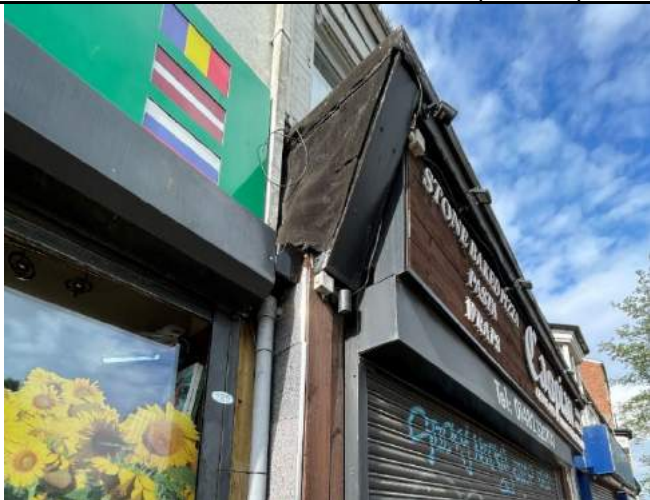
Street: Spring Bank	Address: Caspian, 39 Spring Bank
Historic Photo from 2008 (Google Maps)	Historic Photo from 2016 (Google Maps)

Building Notes	Pre 1856 building, likely built at the same time as the adjacent No 37 Spring Bank. Originally residential use over two floors with generous front garden. Later converted to retail use on the ground floor with residential above. Original timber sash windows have been removed and window to RHS increased in width (whilst retaining narrower stone lintel) and supported by timber lintel below. Replacement RHS window is of horizontal proportions which is out of character for the Conservation Area. Brickwork has been painted to conceal alterations to windows. First floor windows replaced with UPVC casement windows. Terracotta coloured concrete pantile roof finish with low quality UPVC gutters and downpipes. Stone lintels retained in situ but visually incongruous due to later widening of the RHS window. The ground floor shop front comprises of a large sloping boxed-in fascia surround which may be concealing remnants of the earlier shopfront fascia and cornice behind although the 2016 . Modern metal framed shopfront with external roller shutter above. Low quality timber door to apartment above. Original chimneys and chimney pots retained.

Monitoring Notes	Timber lintel supporting widened window opening does not appear to be sufficient to support load from the roof structure. Recommend structural survey to assess. Any works to remove existing modern fascia should be undertaken with care as it may conceal the historic shopfront behind. Chimneys and chimney pots to be retained.
Recommended Actions	<ul style="list-style-type: none"> • Strip paint from brickwork. • Reinstate original window proportions and undertake structural works to ensure sufficient support to roof structure above. • Repoint and repair brickwork following paint removal and window removal. • Replace both UPVC upper floor windows with timber sliding sash windows. • Remove modern signage fascia and investigate retained elements of historic shopfront behind. • Reduce fascia signage depth. • Remove external metal roller shutter and boxing. • Remove terracotta concrete tiles and replace with new slate tiles. • Remove UPVC gutters and downpipes and replace with new cast iron.

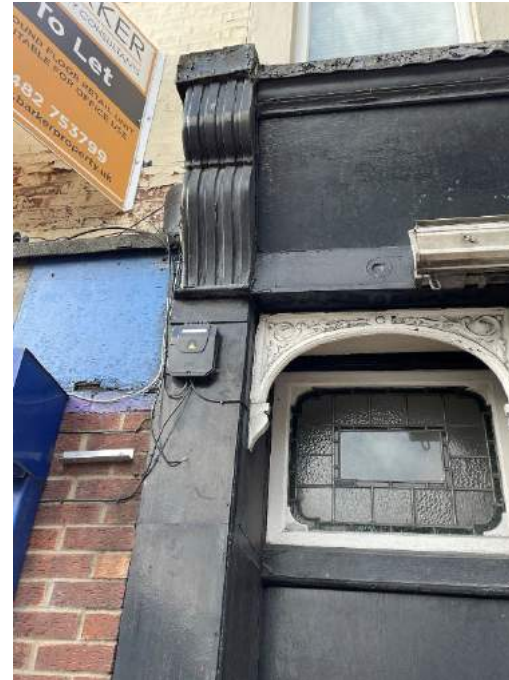
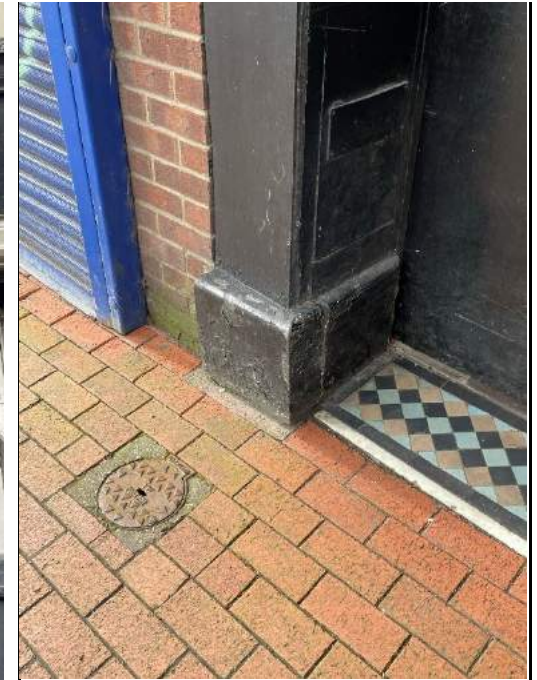
Current Photo – 11/05/2023 (author)		Current Photos – 11/05/2023 (author)

<p>Building Notes</p>	<p>Pre 1856 building, likely built at the same time as the adjacent No 41 and 43 Spring Bank. Original designed as residential property with generous front garden, later converted to retail at ground floor level in the early 1900's/ 1983 photo shows red brick external walls to the first floor level with painted finish, later rendered. Slate roof finish.</p> <p>Original shopfront details including console brackets, cornice, and pilasters with plinths retained. Original stained glass fanlight with corner details, decorative tiled threshold and cast iron archway detail to the original dwelling front door retained. Low quality timber door to first floor apartment. Early 1900's shopfront shown in the 1983 photographs with recessed door has been removed and replaced with new timber shopfront with external roller shutter. Bay window to first floor retained but earlier timber windows replaced with UPVC windows. Traditional awning still in situ.</p>

<p>Monitoring Notes</p>	<p>This shop front is one of the last remaining shopfronts from the early 1900's and should be retained in situ. Stained glass fanlight, tiled threshold and decorative cast iron arched details to be protected from removal.</p>

- Remove roller shutter and signage.
- Remove redundant services, wires and signage.
- Replace front door to first floor apartment.
- External render likely to be cement render. Recommend removal due to risk of render holding moisture within the brickwork.
- Protect the building from the removal of the existing retained historical features outlined above.
- Reinstate historic shopfront design and proportions.

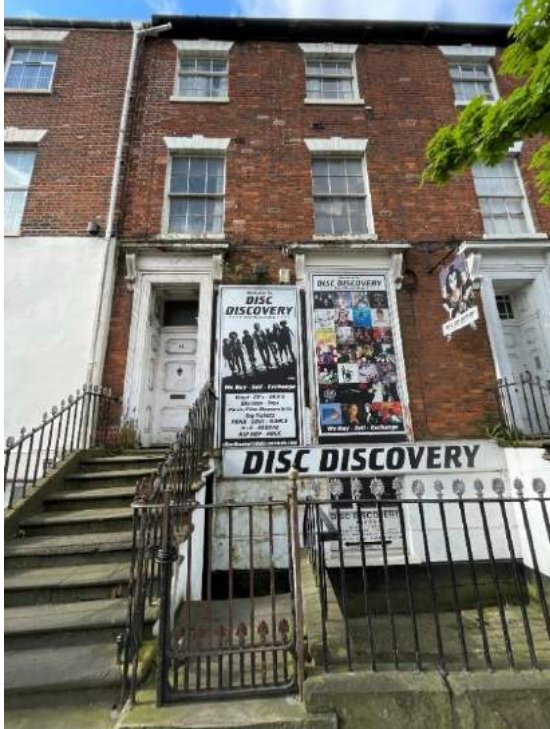
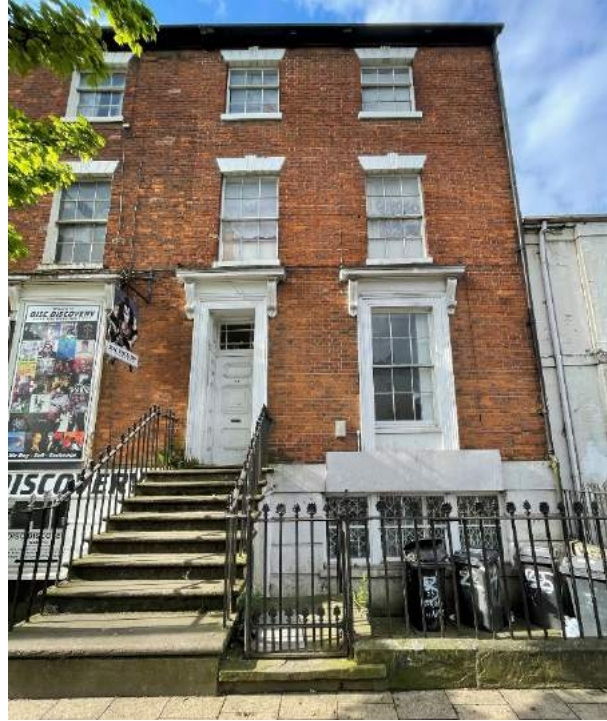
Current Photos – 11/05/2023 (author)

Monitoring Notes	In reasonable condition but would benefit from some localised repairs. Base of timber architrave to main entrance doors showing signs of decay and would benefit from localised repair to avoid further degradation of original details. Staining and moss growth to the projecting cornice of the entrance doors and ground floor windows would suggest that water is not being shed from the building and could cause increased rate of deterioration.
Recommended Actions	<ul style="list-style-type: none"> • Remove redundant cables, signs, lighting etc • Remove fascia sign to No 55 Basement to reveal original stucco. • Rationalise signage to No 53. • Install/reinstate lead flashing to projecting cornice details to entrance doors and window head. • Redecorate ironwork. • Undertake localised timber repairs to existing sash windows and redecorate. • Repair stonework to steps and low level boundary wall. • Repair stucco where damaged to basement (LHS) of No 53.

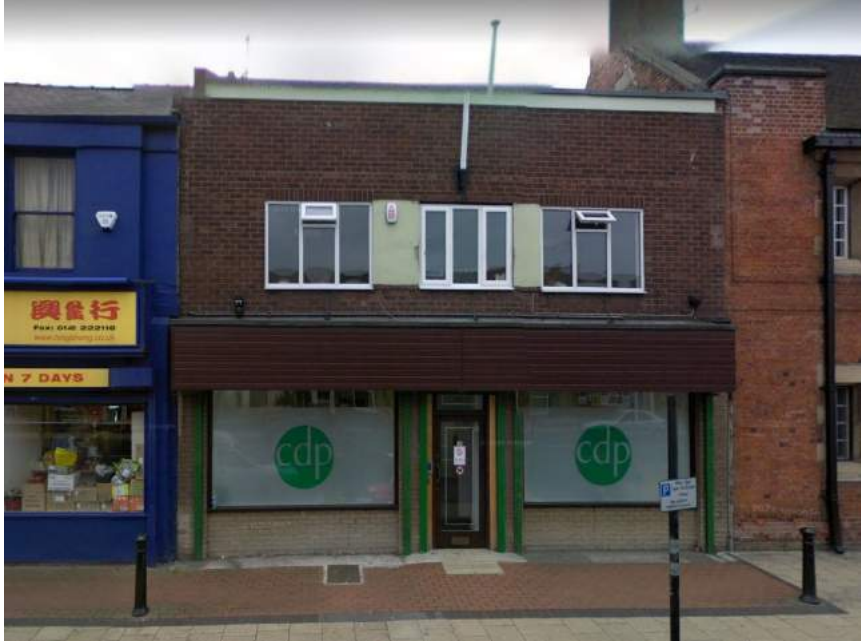
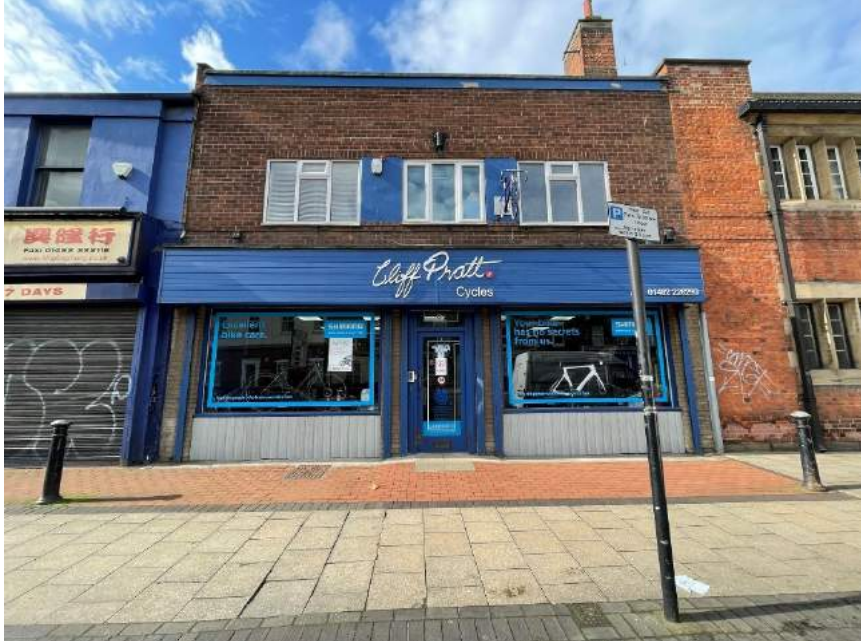
Street: Spring Bank	Address Cliff Pratt Cycles, 61 Spring Bank
Historic Photo from 2008 (Google maps)	Current Photo – 11/05/2023 (author)

Building Notes	<p>A C1950's infill building constructed following the demolition of 61, 63, 65, 67 and 69 Spring Bank and construction of the adjacent Deaf Institute built in 1926. Typical modernist details and proportions including horizontal proportioned windows grouped with cement rendered panels between to further emphasise the horizontal proportions, flat concrete roof and concrete details. Brown/red brick to first floor level and buff brickwork to ground floor level further emphasise the horizontal proportions. Later removal of original metal framed windows and the installation of UPVC windows to the first floor level have reduced the quality and integrity of the original 1950's façade. Flagpole bracket fixing retained above the central first floor window but flagpole now removed. A Change of Use application was submitted and approved in 2007 (Ref No. 07/00244/PCE) for change of use from retail to offices for CDP. The current tenants, Cliff Pratt Cycles, were established in 1934 and were previously based at No 84-86 Spring Bank before moving to the bigger premises at 61 Spring Bank following the closure of the CDP offices. The rear of the property has had a variety of</p>

<p>extensions since its construction. Large timber boarded fascia sign with 3 No roller shutters behind dominates the frontage however the timber fascia successfully conceals the roller shutters behind. The level that the brickwork changes from buff to red/brown would suggest that the large timber fascia may be a later addition, installed to conceal the roller shutters behind. Ground floor shopfront responds to the proportions of the first floor windows with a central slightly recessed door and shop windows each side to create a symmetrical arrangement.</p>
Monitoring Notes	No immediate issues identified.
Recommended Actions	<ul style="list-style-type: none"> • Recommend replacement of uPVC windows to the first floor level and reinstatement with metal framed windows which would be more sympathetic and appropriate to the 1950's design. • Recommend removal of large fascia sign and external roller shutters to reveal the original fascia if in-situ. • Install internal grills to provide enhanced security to protect high value goods within.

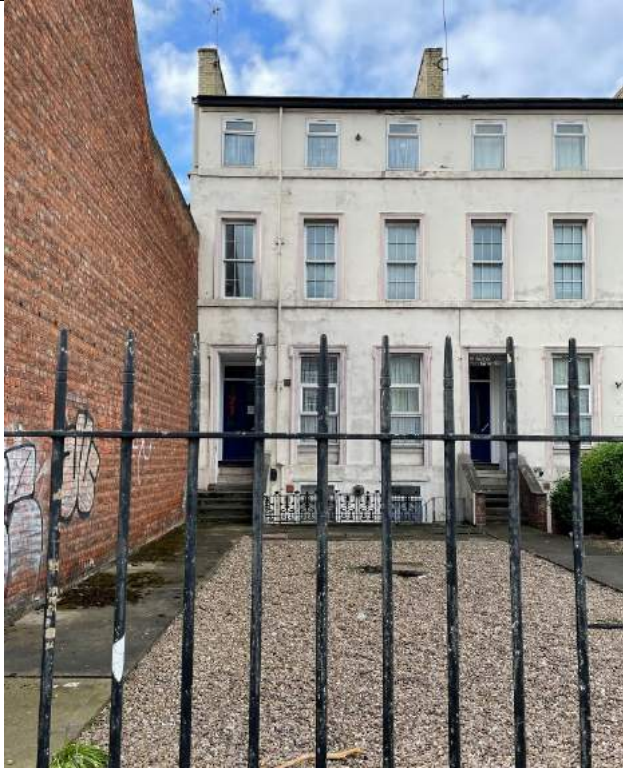
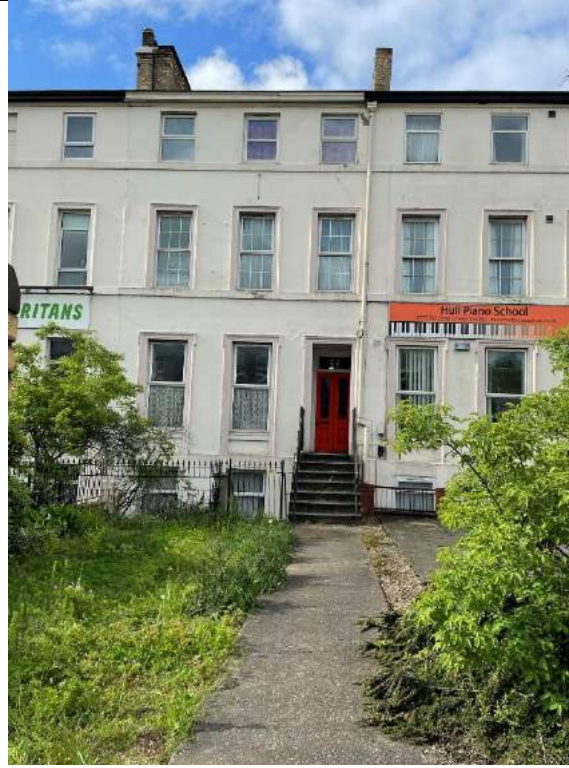
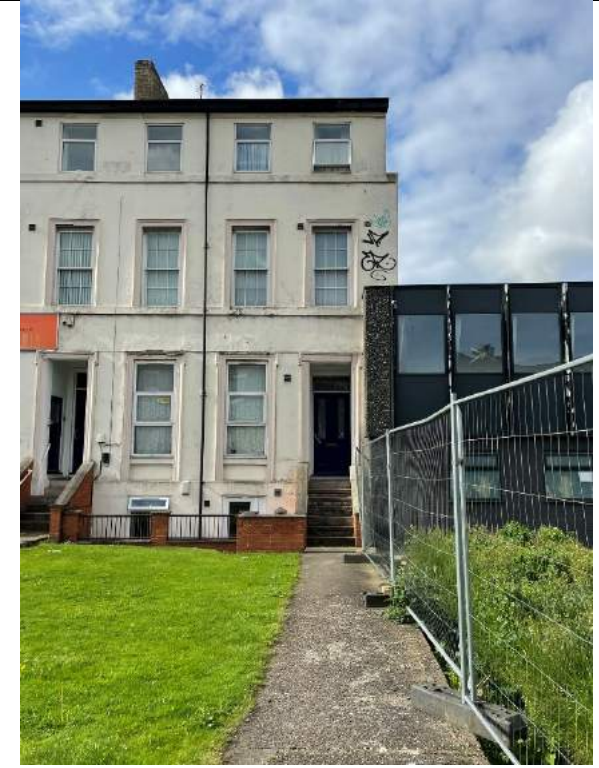
Street: Spring Bank	Address 71, 73, 75, 77, 79 and 81 Spring Bank	
Historic Photo taken 15/9/83 (by Phil Hampelnell)	Historic Photo taken 15/9/83 (by Phil Hampelnell)	Historic Photo taken 2005 (by Phil Hampelnell)

No 73 to 81 (odd numbers only) date from pre 1856 and were originally designed as grand four storey three bay residential dwellings with elevated ground floor reception rooms and a grand staircase leading to the main entrance door and servants quarters at basement level. Viewed as a group of buildings constructed at the same time, the building line is set back much further than the Georgian residential properties further east to create much more generous gardens the front of the property whilst still maintaining large gardens to the rear. The block is designed as a symmetrical group with three left handed properties and three right handed properties with consistent window heights, proportions and details. The buildings are typically Georgian in style with simple linear decoration, tall proportions and restrained detailing. Chimney stacks to each property has been retained which break up the mass of the building at roof level. Slate roof finish throughout. In 1983 the buildings were in a poor state of repair with missing windows, failing render finish, damaged cornice details, poor quality boundary treatment between properties and the later installation of rainwater goods and drainage

<p>systems that detracted from the historic proportions. In the late 1980's/early 1990's works were undertaken to restore the buildings including render repairs/replacement and rationalisation of the drainage system throughout the group. In the 1990's works were also undertaken to replace the first floor windows to 71, 73, 79 and 81 (possibly without permission) with Georgian style casement uPVC windows which were out of character with the buildings design. A further application was made later in 2005 to install replacement timber sliding sash windows to 71, 73, 79 and 81 (Ref. No: 05/01077/FULL) which was approved and are now installed. The installation of large fascia signs to no 75 and 79 are detracting from the character of the group. The current colour schampele to the render and decorative architraves has helped to homogenise the group and ensure that the group value is enhanced. The boundary treatment to the front gardens appears to have been undertaken in the 1980's using buff brickwork that is not in keeping with the Georgian style of the building.</p>

Monitoring Notes	No immediate risks identified at this time.
Recommended Actions	<ul style="list-style-type: none"> • Recommend painting the eaves fascia to No 77 black to homogenise the group visually. • Recommend painting the rain water downpipes a consistent colour to ensure the buildings read as a group. • Paint or re-render side gable elevation to No 81 which has been subject to graffiti.

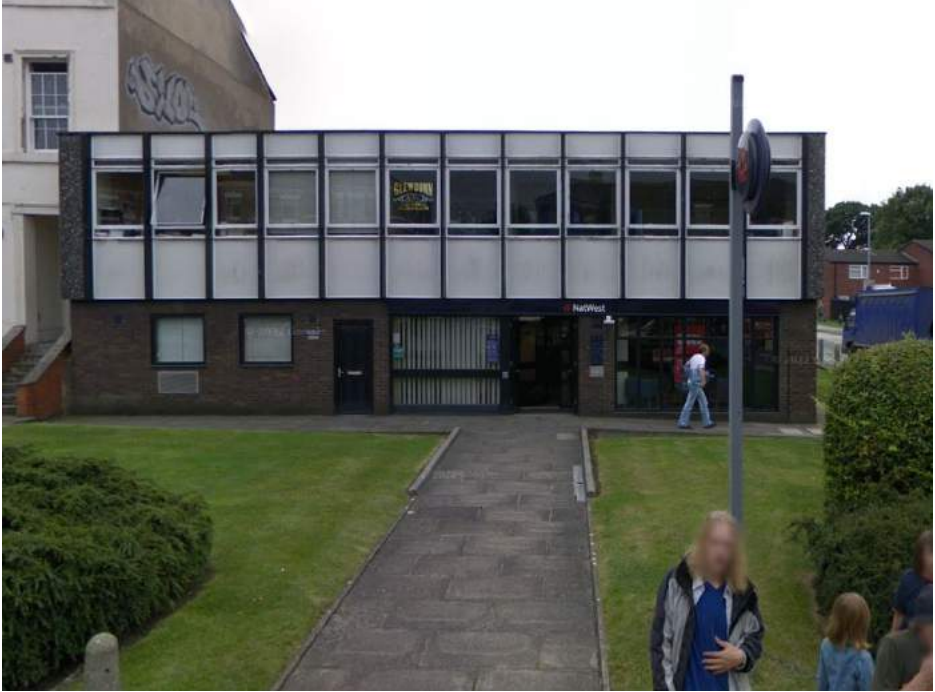
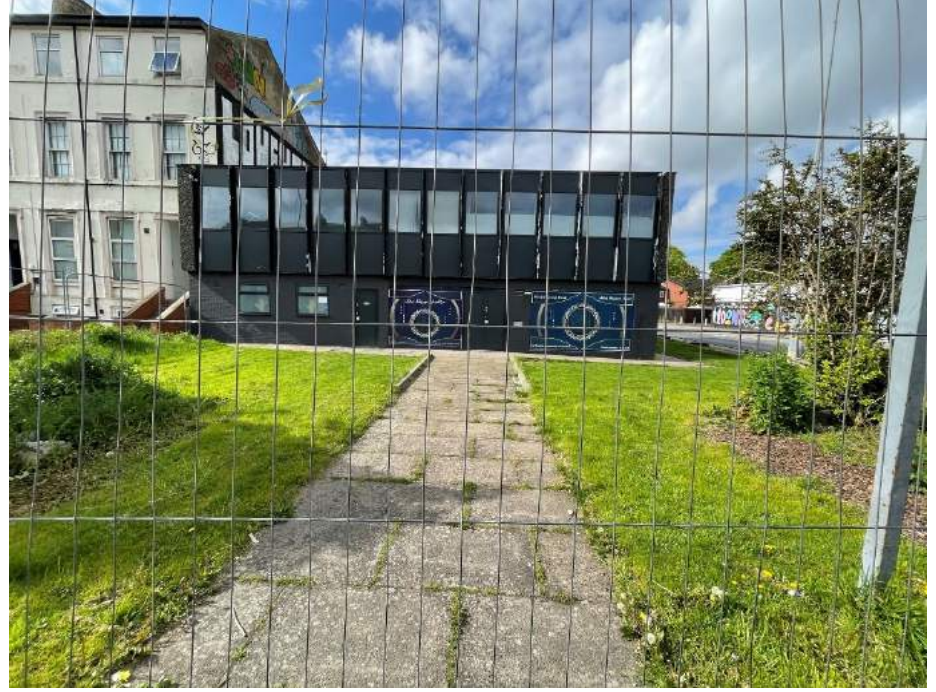
Street: Spring Bank	Address: VACANT 83 Spring Bank
Historic Photo from 2008 (Google maps)	Current Photo – 11/05/2023 (author)

Building Notes	Former purpose built Natwest Bank dating from the 1950's/1960's. Typical modernist design details including dark grey brickwork plinth, flat concrete roof, concrete precast panels to side elevations and projecting curtain walling at first floor level. The horizontal proportions and low scale of the building are typical of the period and are in stark contrast the vertically proportioned Georgian buildings adjacent at No 73 to 81. The building frontage is set back in line with the adjacent No 81. The building is sat within a soft landscaped setting with a directional footpath leading to the main entrance. The buildings location at the corner of Spring Bank and Park Street and the siting of the building set back from the road gives it greater emphasis and is considered to be a visual corner landmark building.

<p>Since the Natwest Bank closed between 2012-2015, the building has sat empty until more recently when the building was converted into the Spring Bank Mosque. The building today still retains the modernist proportions but the erection of a palisade fence to the perimeter has a detrimental impact on the character of the area.</p>
Monitoring Notes	<p>The palisade fence has a detrimental impact on the character of the Conservation Area and should be removed and replaced by a more appropriate form of security and boundary treatment. Boards to windows at ground floor level should be removed to reveal the original full height glazed screens.</p>
Recommended Actions	<ul style="list-style-type: none"> • Remove the palisade fence and replacement with new boundary treatment. This is considered a priority given the prominent position of the building on this key corner site. • Removal of boarding to ground floor windows to provide active frontage and to reveal the design of the building. • Redecorate of vertical support steelwork to first floor level.

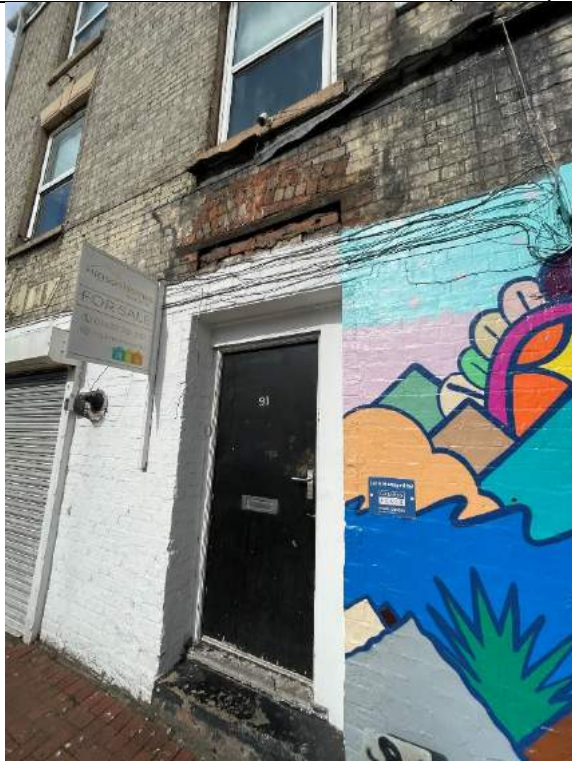
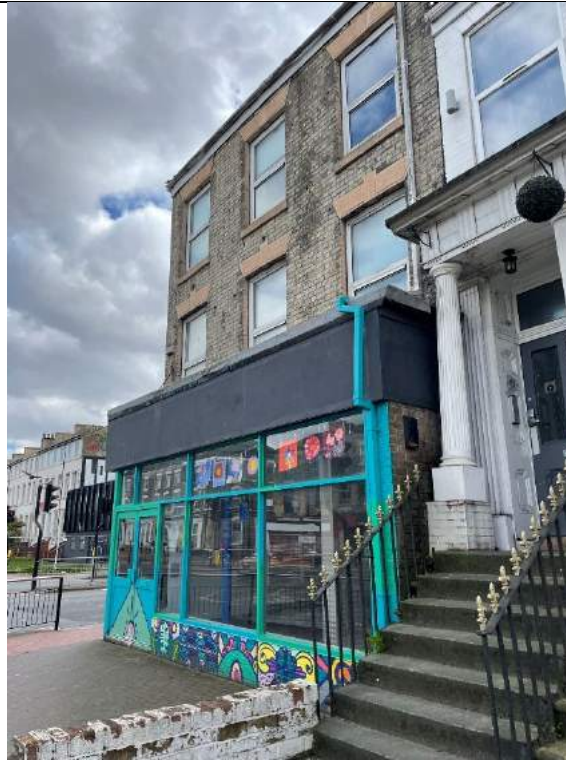
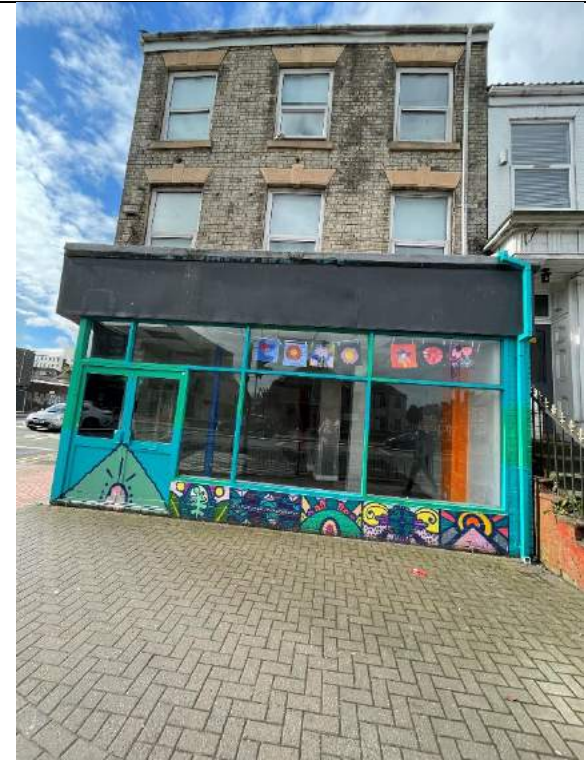
Current Photos – 11/05/2023 (author)

Built between 1956-1893 on the available corner site at the east end of Carlton Terrace, this three storey building comprises of buff brickwork elevations with decorative splayed stone lintel detail and stone cills to windows and a hipped roof form. Likely to have been built with retail at the ground floor level to maximise the opportunity for primary retail frontage following the rapid growth of Spring Bank in the late 1900's. Timber sash windows have been replaced with new UPVC casement windows that have a detrimental impact on the quality of the building. The ground floor shopfront was installed following a planning application in 1985 (Ref No 85/00499/PF). The different brickwork used on the side return of the shop frontage adjacent to the boundary with No 93 would suggest that the shopfront was extended out onto the street at a later date than the original building design. An application was made in 1994 (Ref No 94/00479/PF) to change the use of the first and second floors to shared accommodation for 7 students with a new entrance

Recommended Actions	<ul style="list-style-type: none"> • Replace PVC rainwater goods with cast iron. • Replace uPVC windows with timber sliding sash. • Reconfigure shopfront to respond more appropriately with the proportions of the windows above. • Remove roller shutters. • Remove deep signage fascia and reinstate with a more appropriate and refined signage fascia.

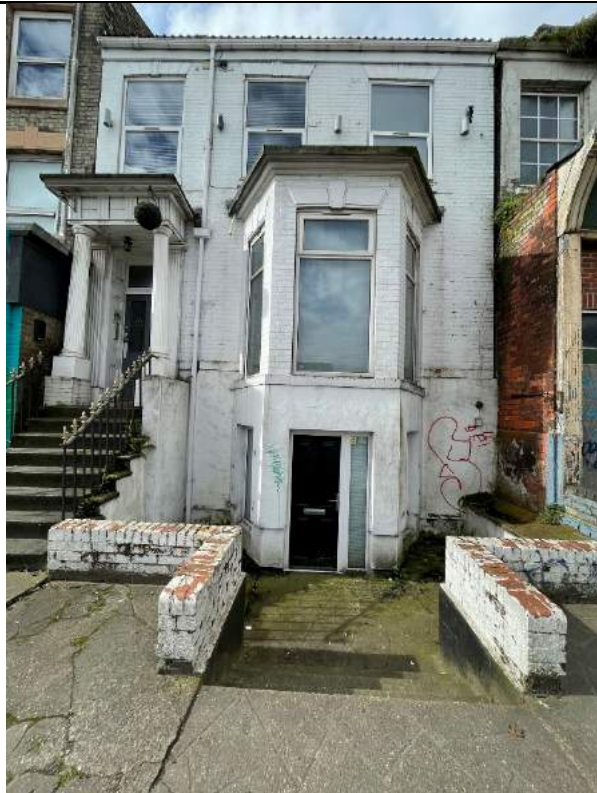
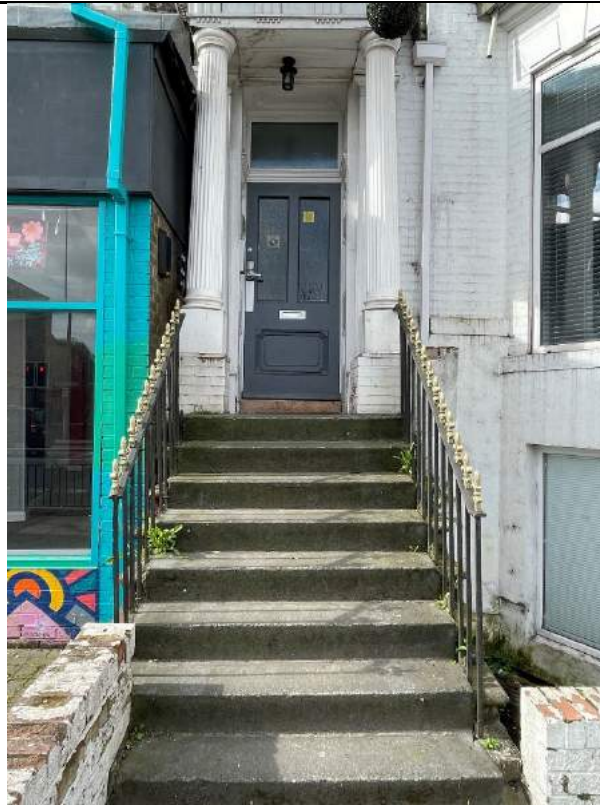
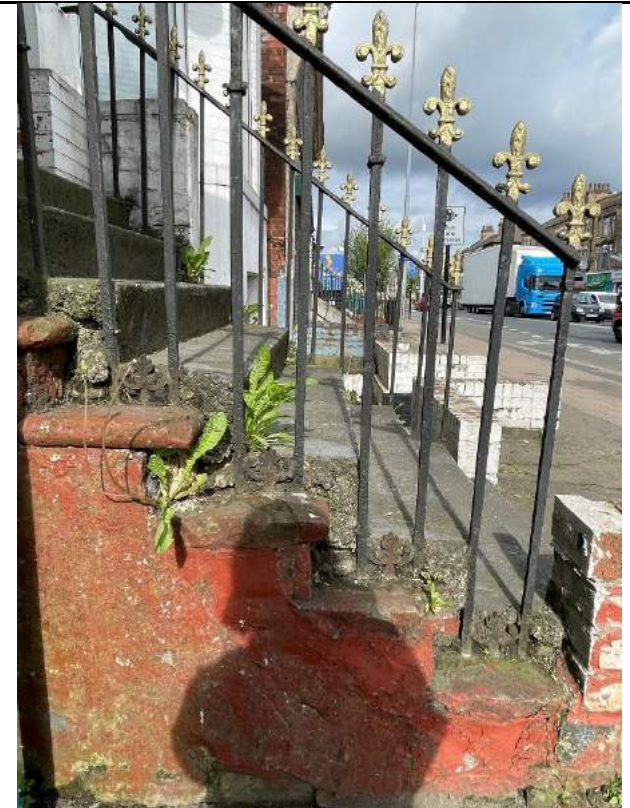
Pre 1856 C1830's built as part of the group of three buildings that formed Carlton Terrace, one of the earliest residential terraces built on Spring Bank. Has similar details to No 53 and 55 Spring Bank including entrance canopy with ionic column supports, deep fascia and cornice and splayed stone lintels to windows. Originally built as a grand 3 storey dwelling with sunken front garden and stone steps leading up to raised ground floor level, later converted to retail use. The built out shopfront with the roller shutter shown in the 2009 photograph was later removed following a Planning Application to convert the dwelling and retail unit to 4 x 2 bed flats. The 2009 photo also shows that the RHS column was missing to the entrance porch. At this time the bay window to the basement level was rebuilt and the building converted back to residential use. The entrance door to the central bay window to the basement level looks incongruous and would have historically been located beneath the entrance step landing. The

<p>replacement of windows with uPVC were also included in this application along with the replacement of the roof finish with terracotta coloured pantile roof tiles. The decorative brackets and timber fascia to the eaves have been retained or restored. Buff coloured brickwork finish now painted white with rendered finish to basement level. The original entrance door and fanlight appears to have been retained.</p> <p>The original stone steps have been overlaid with concrete (see photo). The low level boundary wall has been painted and the iron railings in the 2016 application have not been installed.</p>
Monitoring Notes	<p>Building is deteriorating due to lack of ongoing maintenance. Lack of gutter maintenance has led to plant growth in gutters, mould growth and spauling of brickwork is evident. Leadwork to projecting fascia appears to be missing or dislodged.</p>
Recommended Actions	<ul style="list-style-type: none"> • Remove paint from brickwork to allow brickwork to breath and to eliminate ongoing maintenance issue. • Replace uPVC windows with timber sliding sash windows. • Relocate basement entrance door to beneath entrance landing and replace door with sash window. • Remove concrete overlay to stone steps and repair stone steps as required. • Remove white paint from brickwork to boundary plinth, repair and install iron railings to basement apartment. • Replace roof finish with slate tiles. • Replace PVC rainwater goods with cast iron.

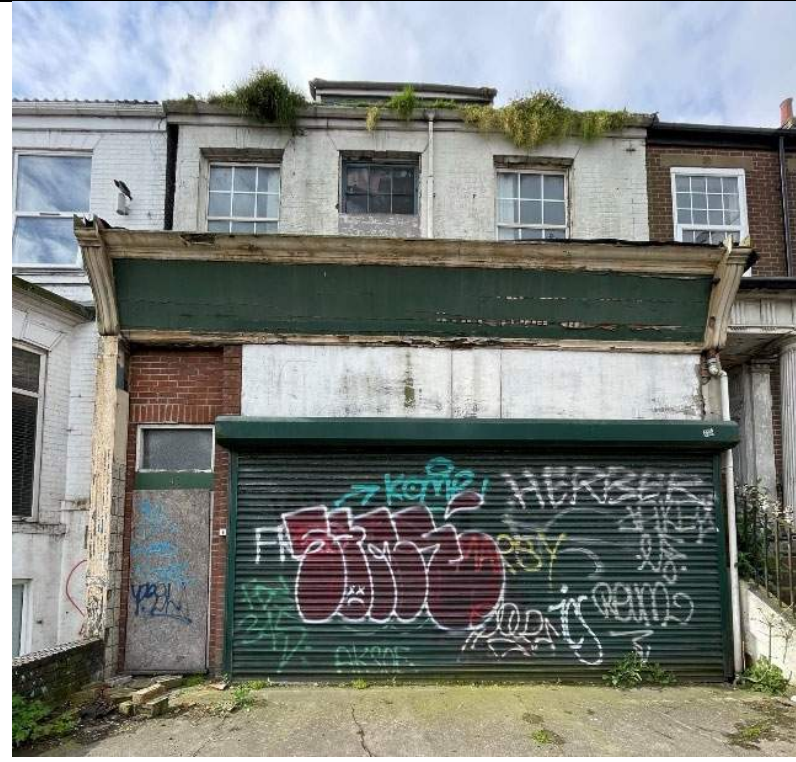
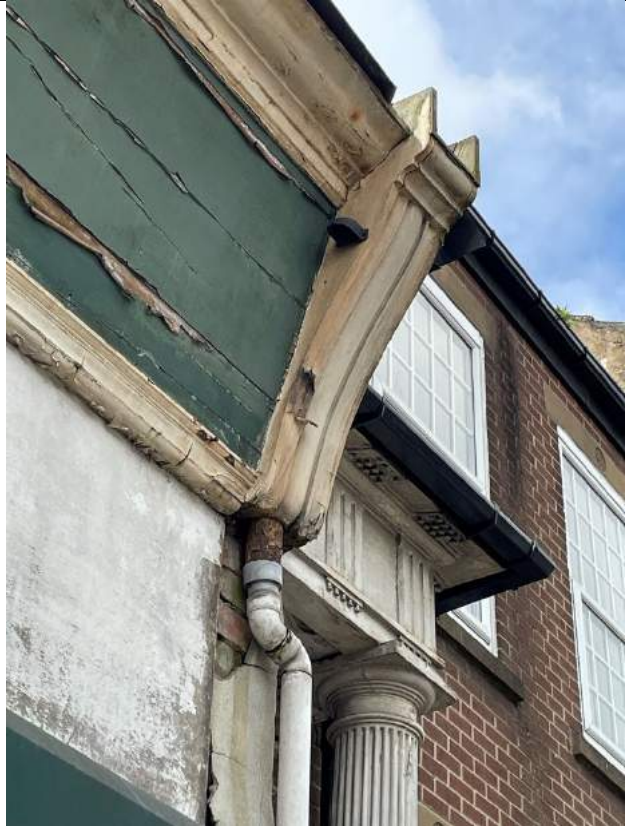
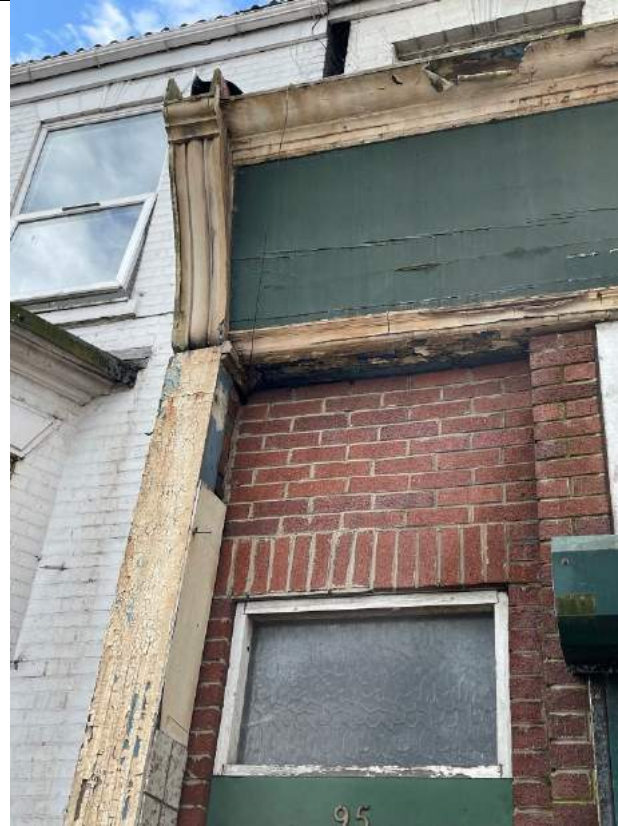
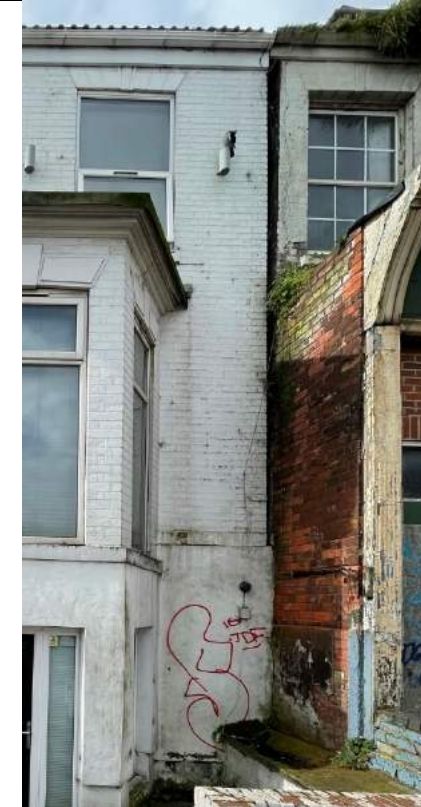
Address: Vacant, 95 Spring Bank

Pre 1856 C1830's built as part of the group of three buildings that formed Carlton Terrace, one of the earliest residential terraces built on Spring Bank. Has similar details to No 53 and 55 Spring Bank including splayed stone lintels to windows. Originally built as a grand 3 storey dwelling with sunken front garden and stone steps leading up to raised ground floor level (as No 93/97). Brickwork walls to first floor level with painted finish, likely buff brick to match No 93. Converted to retail use at ground floor in the late 1800's with bay window removed to ground and first floor level and the shop frontage extended out to provide glazed shop front with side door leading to upstairs accommodation. Late 1800's fascia, cornice, LHS pilaster and console brackets to shop front retained in situ. Brickwork to side return of shopfront extension is different to the brickwork to the main façade, suggesting that the brickwork infill to the shopfront was installed at a later date along with the side entrance door and external roller shutter. The building has been vacant since the early 2000's and is suffering

<p>considerably from a lack of maintenance. The building has been subject to a number of Planning Applications to bring it back into use. In 1995 an application was made to revert the building back to a single dwelling. In 2014 an application to convert the property to self contained flats which included the removal of the shop front (whilst retaining the fascia, console brackets and cornice) was approved but has yet to be undertaken. A 2014 application to approve pre-commencement conditions for the works (Ref No. 16/00433/CONDET) refer to the approval of pre-commencement conditions including the provision of UPVC heritage style glazing to the upper floor levels. The building today is in need of considerable investment to protect it from further decay in the near future. The lack of gutter maintenance (likely due to the limited accessibility due to the extended shopfront) has led to extensive mould growth and debris build up to the gutters, causing water to build up at the eaves and the projecting shopfront roof.</p>

<p>Monitoring Notes</p>	<p>Building at risk. Lack of gutter maintenance has led to plant growth in gutters, mould growth spauling of brickwork. Leadwork to projecting fascia appears to be missing or dislodged.</p>
<p>Recommended Actions</p>	<ul style="list-style-type: none"> • Remove uPVC gutters and downpipes and replace with new cast iron. Review all rainwater goods and drainage system generally. • Remove the later addition brickwork, shopfront and roller shutter and replace with new shop front for retail or residential use. • Repair and restore the late 1800's fascia sign, corbel brackets and cornice. Repair missing pillaster detail to RHS. • Remove uPVC windows to first floor and remove boarding from central window and replace with new sash windows. • Remove paint from brickwork to eliminate ongoing maintenance issue and to allow the walls to breath. • Remove metal railings and build new low brick plinth and boundary treatment (particularly if residential use) to improve quality and create threshold to property.

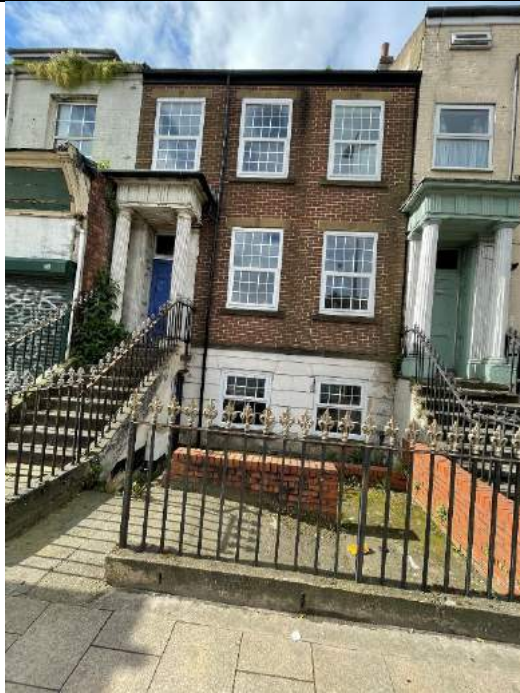
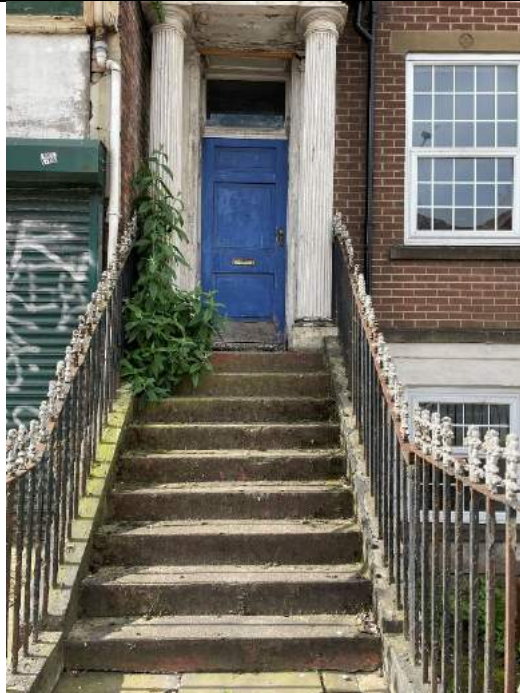
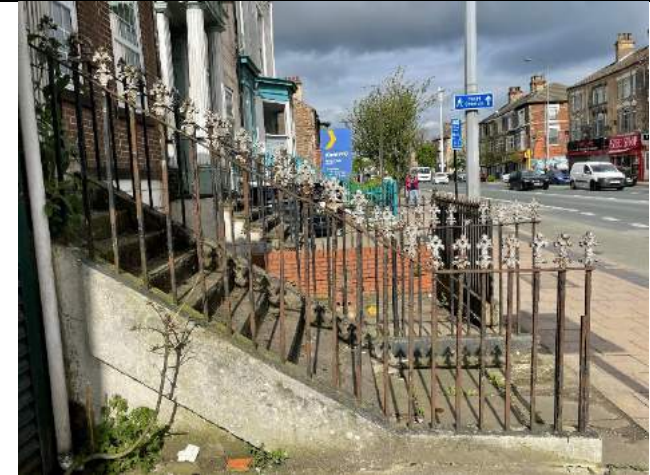
Dating from C1830, No 97 Spring Bank forms part of the group with No 93 and 95 Spring Bank adjacent and is a Grade II Listed building (along with the associated railings). Originally designed as residential use with a projecting curved front bay window to the basement, ground and first floor level (see 1989 photo), the building has undergone considerable changes that have been highly detrimental to the character of the listed building. An application in 1991 (Ref No. 91/00662/PF) for the conversion from residential to basement retail premises and offices to the upper floor level was submitted (outcome unknown). Extensive alterations were made in the early 1990's without consent which included the removal of the three storey curved bay windows and facing brickwork and replacement with new brickwork (likely required due to the extensive loss of external wall fabric following the removal of the bay window), yorkstone cills and lintels, replacement of all windows with UPVC in mock Georgian style, replacement of gutter, removal of railings to front section of boundary wall removal of existing door and replacement with new timber door. A subsequent retrospective application for Listed Building Consent was submitted in 1994 but subsequently refused. A further application was made in 2012 (Ref No

12/00727/COU) for change of use from office to residential use which was approved. A planning enforcement notice was served in 2021 and is pending consideration.
Monitoring Notes	A general lack of maintenance continues to have a detrimental impact on what features of the historical fabric are retained. Blocked rainwater goods are causing extensive staining to the front elevation.
Recommended Actions	<p>Although the repaired façade has made some attempts to mimic Georgian style features, the choice of brickwork, the UPVC windows and the lack of reveal is considered inappropriate and would have originally have been buff brickwork when built as the adjacent 93 and 95 Spring Bank. The cumulative impact of these alterations has been highly detrimental to the character of this Listed Building.</p> <ul style="list-style-type: none"> • Recommend repairs to protect the projecting portico details which are degrading and require repair. • Restore and redecorate the iron railings that are showing signs of deterioration. • Remove vegetation from stone steps. • Repair stucco to basement which is showing signs of degradation. • Enhance the quality of the front garden through landscape finishes and planting.
