**Spring Bank Conservation Area
Management Plan (South side)**
Draft for Review

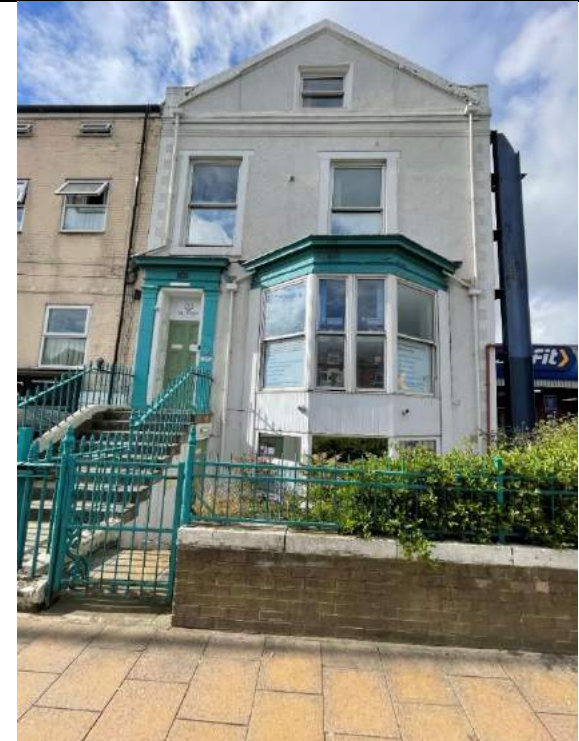
Street:	Spring Bank	Address	Victory Social Care, 101 Spring Bank
----------------	--------------------	----------------	---

Building Notes	<p>Dating from pre 1856, the building was originally designed as a large residential property over four floors with large two storey bay window to ground and basement level. Exposed gable frontage which might suggest that the building marked the end of Carlton Terrace. Railings and stone steps to main entrance door have been retained and in good condition. New modern railings to front elevation.</p> <p>Windows to the upper floor levels are asymmetric in design and are not centred on the façade which is unusual for a building of this period. Originally exposed brickwork façade, later rendered finish to the main façade onto Spring Bank with keystone corner details. Photos from 2015 show extensive spalling to the brickwork and decorative brickwork frieze detail at second floor level adjacent to the rainwater outlets to the LHS and RHS of the gable.. The RHS western gable has had a substantial system of structural support added due to structural movement of the gable. The windows have been replaced on</p>

<p>a number of occasions and have more recently been replaced in 2017 with new timber sliding sash windows. The introduction of a central mullion to the bay window at ground floor level and the introduction of a low level infill to the bay window has had a detrimental impact on the proportions and appearance of the building.</p> <p>The building has been substantially extended on a number of occasions to the rear to respond to the changing uses over recent years. The building today occupies the majority of the rear garden with later addition extensions.</p> <p>The building has had a number of planning applications that reflect the continued change of use. In 1992 the ground and basement level were converted to a café/sandwich bar (ref No 95/01155/PF). In 2001 an application was made to change the building from office and shop to educational use (Ref No 01/00821/PF). In 2008 an application was granted to convert the building to two shops on the ground and basement level and create 6 apartments on the upper floors (Ref No. 08/01228/COU). In 2015 the building was converted to a respite health care centre which included external alterations, replacement windows to the front elevation and a new lift shaft (15/00425/FUL). In 2017 an application was made to retain the white rendered finish on the front elevation and reinstate profile detail to the windows (Ref No. 17/01138/FUL).</p>

Monitoring Notes	No immediate concerns identified.
Recommended Actions	<ul style="list-style-type: none"> • Redecorate iron railings in a more sympathetic colour schampele. • Dark blue paint colour to side gable and supporting structure (left over from blue and yellow colour schampele in 2008) dominates the street frontage. Would benefit from redecoration in a more subdued colour.

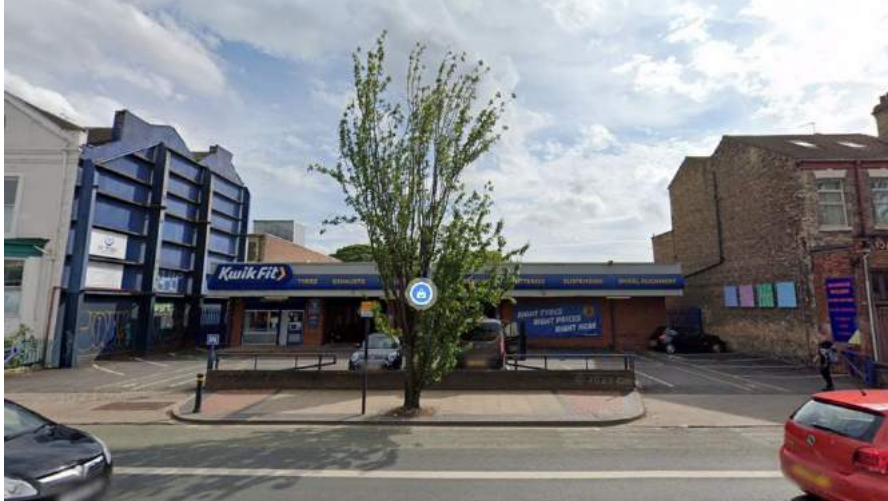
Current Photo – 11/05/2023 (author)

The site was originally occupied by a Chapel that was built between 1956 and 1893. The Chapel was retained until the mid 1900’s and later demolished. The site was then redeveloped as a petrol filling station before an application was submitted in 1998 for the demolition of the existing PFS and the construction a new Kwik Fit garage. Approval was granted on the basis that the original forecourt canopy to the petrol filling station was retained (Ref No. 88/00500/PF).

Recommended Actions	<ul style="list-style-type: none">• Enhanced landscape treatment to the boundary would help to reduce the visual impact of the garage to the street.• This site would benefit from future redevelopment to accommodate a new building that contributes positively to the character of the Conservation Area or to create a green space for the local area.
--------------------------------	---

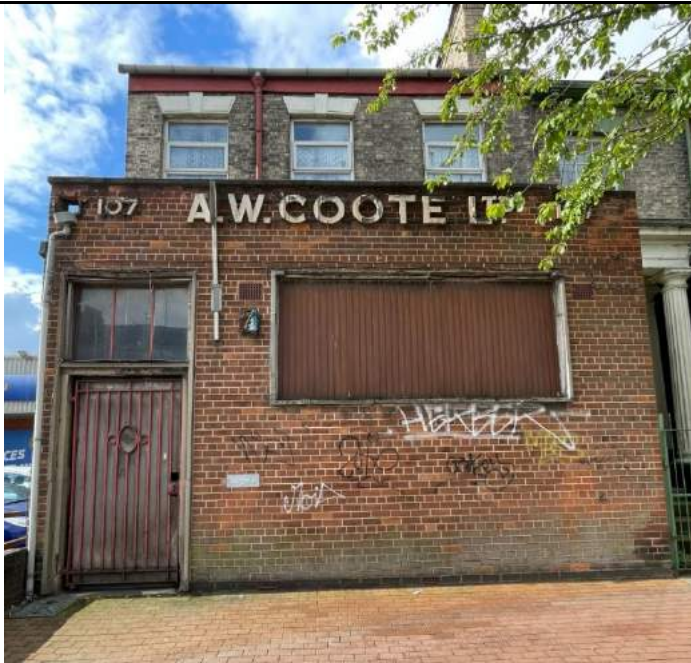
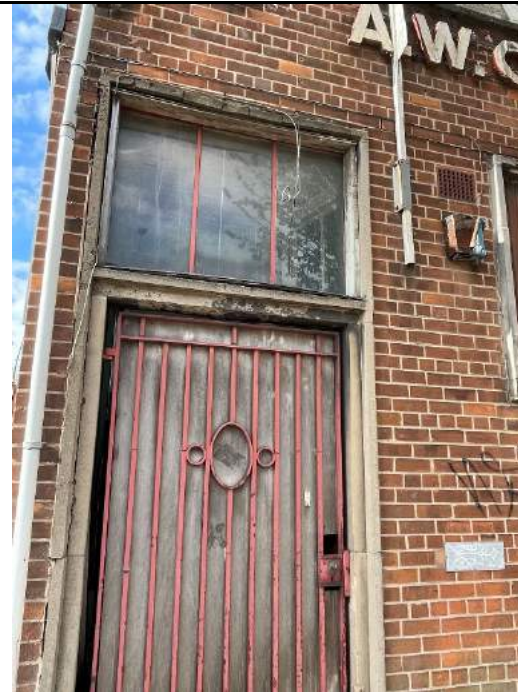
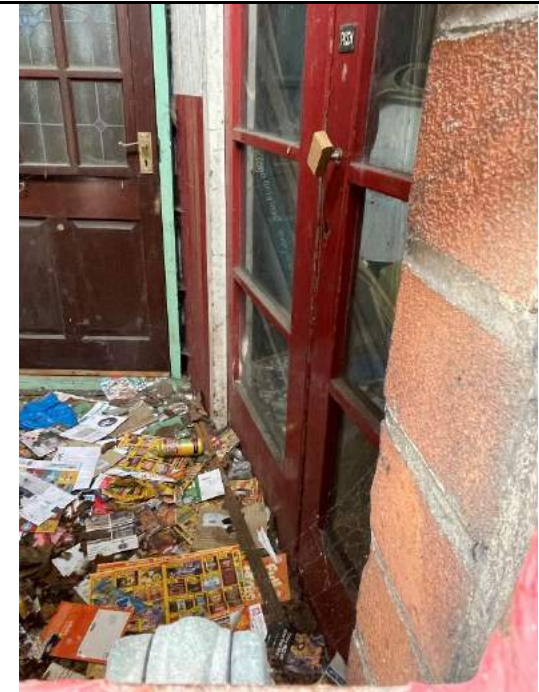
Street:	Spring Bank	Address	A.W Coote Ltd Confectionary Wholesales, 107 Spring Bank (Vacant since 2008)
<p>Historic Photo in 1905 of No 109 with No 107 partially visible to the LHS (Hull Then and Now by Paul Gibson)</p>		<p>Historic Photo from 2008 (Google maps)</p>

Built before 1856 likely to be C1830s due to similar details and features as Carlton Terrace adjacent to the east. Originally built as a grand 3 storey Georgian dwelling with buff brick external walls, vertically proportioned windows and splayed stone window heads and stone cills. Timber sash windows have been replaced with uPVC. Originally had a projecting bay window at ground floor level, later removed or adapted to extend the building to create a shop frontage. Shop front extension dates from C1930 with typical details of the time including the use of horizontal proportions to the windows and the use of concrete framing to door and window reveals. Terracotta pantile roof tiles to double pile pitched roof.

warehouse to women and childrens centre including the erection of a three storey extension to the rear was submitted and approved (Ref No 08/00586/COU).
Monitoring Notes	Has been vacant since 2008 but appears to be in reasonable condition. No immediate risks identified.
Recommended Actions	<ul style="list-style-type: none"> • Replace uPVC windows with timber sliding sash windows. • Potential to adapt the later 1930's shopfront to increase visibility into the retail unit or to remove the later shopfront and reinstate earlier residential use with ground floor bay window. • Remove terracotta concrete pantiles and replace with timber sliding sash. • Replace PVC gutters and rainwater goods with cast iron and reinstate decorative timber eaves brackets. • Remove pantile roof finish and reinstate with slate tiles.

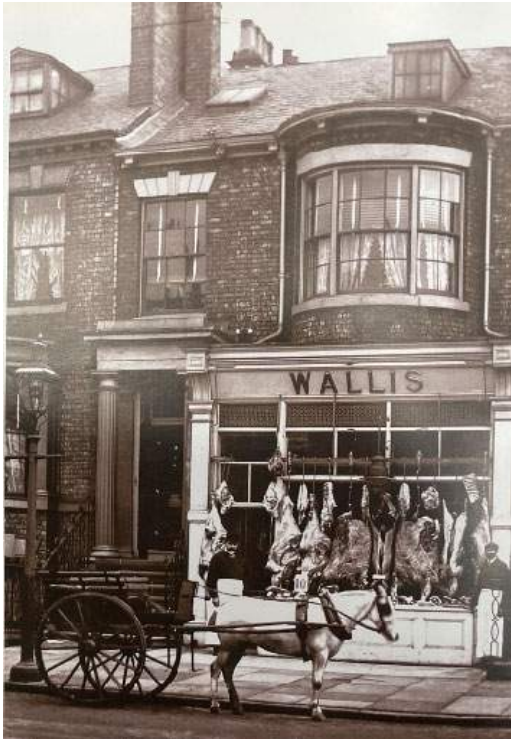
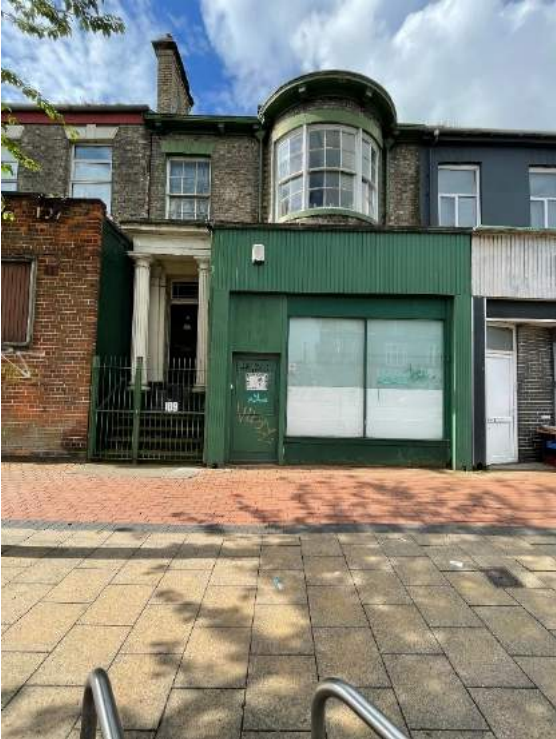
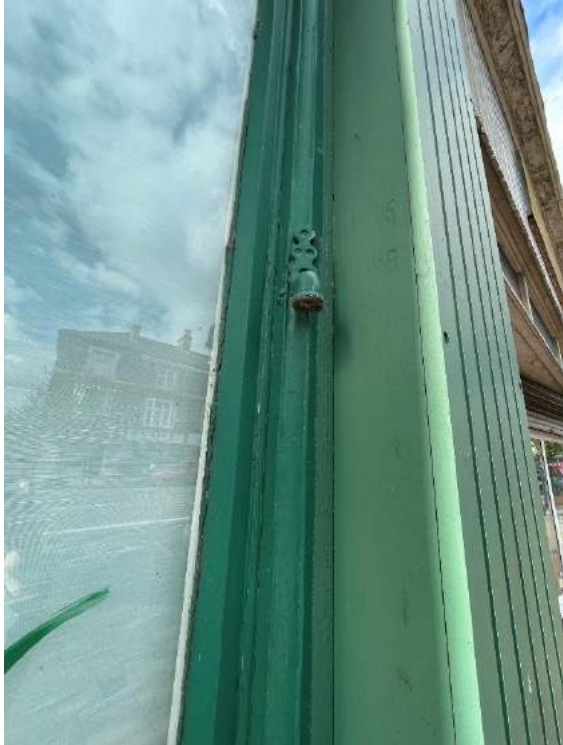
Street: Spring Bank	Address Bulman Eric, 109 Spring Bank	
Historic Photo in 1905 (Hull Then and Now by Paul Gibson)	Current Photo – 11/05/2023 (author)	Current Photo – 11/05/2023 (author)

Building Notes	<p>Built in C1830, the building was originally designed as a large 2 storey dwelling with an elegant curved bay window to both ground and first floor level. Built as a group of five dwellings with No 107, 111, 113 and 115 adjacent. The external walls comprise of buff brickwork construction with decorative splayed stone window lintels and stone cills. The curved stone cills and lintels to the curved bay window give the building a sense of quality and elegance. The roof was originally slate with a dormer centred over the bay window and a rooflight centred over the entrance door. The elevated front door, stone steps, doric columns and entrance portico have all been retained in-situ today.</p>

<p>The ground floor level was later converted in late 1900's to office use and was home to a solicitors until 1904 when Wallis Butchers took over the tenancy. The earlier 1905 shopfront shown, in the early Victorian shopfront with the decorative corbel brackets, sloping fascia, cornice detail and decorative pilasters. Although the shopfront has undergone modernisation in the 1950's, some of these original features such as the fascia and cornice may still be insitu. The shopfront designs to No 109 forms part of a group with 111, 113 and 115 adjacent. Although the console bracket details have been removed, these have still been retained to No 115 Spring Bank which could be used as a template to reinstate tHampel to No 109. A decorative hanging bracket is still fixed to the RHS of the existing timber shopfront which could be a retained bracket used to hang the meat at the front of the butchers as shown in the 1905 photo. This could suggest that the original shopfront frame is retained in situ and has been adapted and partially concealed by the vertical timber cladding applied later. The proportion and location of the shop entrance door and fanlight is consistent with the 1905 photo whilst the fanlight may have been covered over with the timber panel.</p> <p>The slate roof tiles have been replaced with terracotta concrete pantiles. Cast iron rainwater goods are retained in situ along with the decorative timber eaves brackets and mouldings to the eaves.</p> <p>Unlike many of the early Georgian buildings on Spring Bank, No 109 has not been extended to the rear, enabling it to be converted back to residential use in the future. The building has also retained its timber sliding sash windows to the Spring Bank elevation, although the windows to the rear elevation have since been replaced by UPVC windows. Some windows to the rear elevation have been partially bricked up and reduced in size.</p>

Monitoring Notes	<p>No works to remove the existing shop front should be permitted as it may contain historic details behind existing fabric that could be retained and restored. Suggest further investigation to establish if reinstatement is feasible. Building is in reasonable condition with limited signs of degradation or any areas at risk, despite the ground floor being vacant for a number of years.</p>
Recommended Actions	<ul style="list-style-type: none"> • Potential to restore Victorian shopfront with limited work if the existing frontage is found to be still in place. • Remove later addition timber panelling to establish if the original shopfront is retained along with the fascia and cornice details. • Replace pantile roof with slate finish. • Reinststate corbel brackets (using 111 as a template) and pilaster details and repair/repoint brickwork.

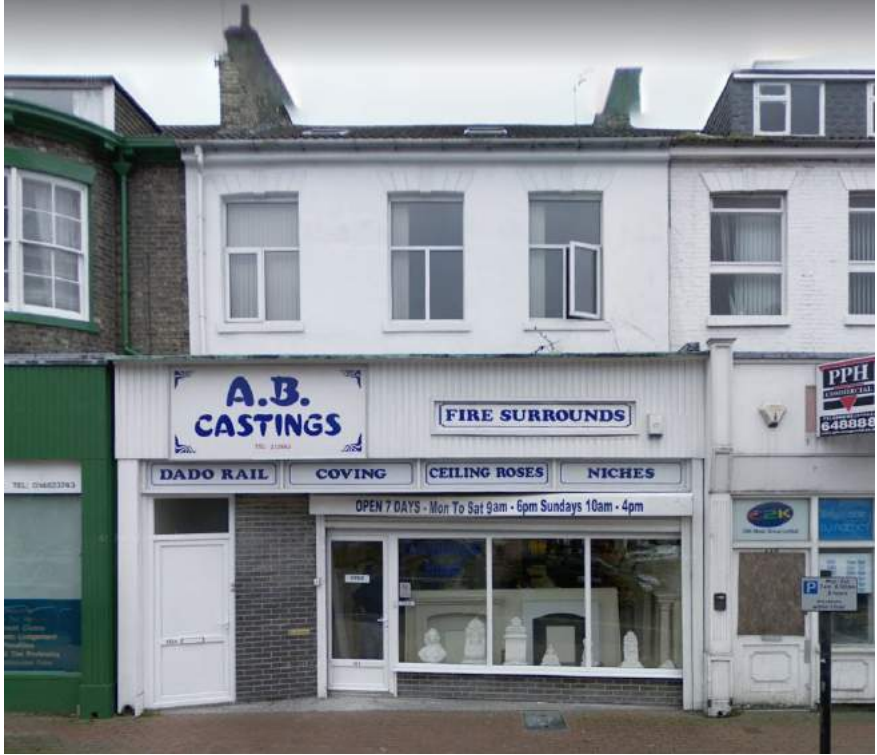
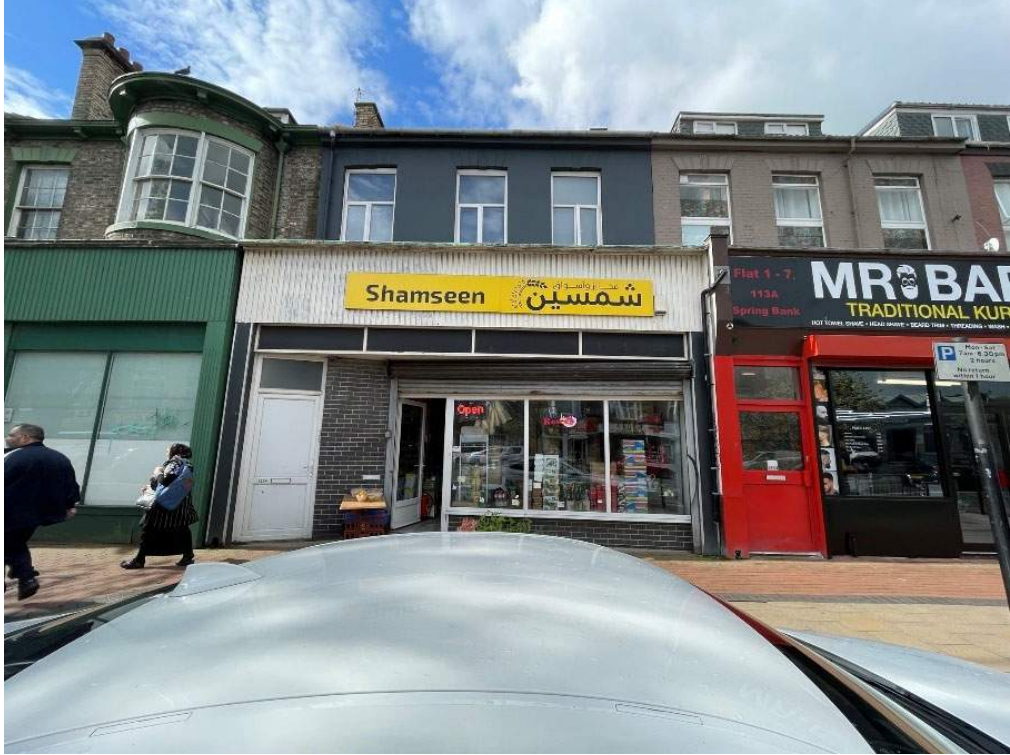
Street:	Spring Bank	Address	Second hand power tools, 111 Spring Bank
Historic Photo from 2008 (Google maps)		Current Photo – 11/05/2023 (author)

Building Notes	<p>Built in C1830, the building was originally designed as a large 2 storey dwelling with an elevated entrance door similar to the adjacent No 109. Built as a group of five dwellings with No 107, 109, 113 and 115 adjacent. The external walls comprise of buff brickwork construction with decorative splayed stone window lintels and stone cills. The roof was originally slate with cast iron rainwater goods and would have featured decorative timber eaves brackets.</p> <p>The ground floor level was later converted in early 1900's to retail use. The earlier 1905 shopfront shown in the photo for Wallis's Butchers (see No 109), shows a shopfront with decorative corbel brackets, sloping fascia, cornice detail and decorative pilasters. Although the shopfront has undergone modernisation in the 1950's, some of these original features such as the fascia and cornice may still be insitu. The shopfront</p>

<p>designs to No 111 forms part of a group with 109, 113 and 115 adjacent. Although console brackets are located above the pilaster between No 111 and 113, this is not thought to be the original corbel and is poor in detail and proportions. No 113, however, still has the original early Victorian console brackets in place and could be used as a template to reinstate the console brackets to No 111.</p> <p>The elevated front door, stone steps, doric columns and entrance portico have all been removed in early 1900's to facilitate the conversion to retail use to ground floor level. A separate door is provided within the new shopfront to provide access to the first floor level residential accommodation.</p> <p>The existing shopfront was installed in the 2000's and comprises of a slightly splayed shop front with a grey brick stall riser and panel with timber framed shopfront and an external roller shutter.</p> <p>Windows to the first floor level would have been 6 over 6 sliding sash windows (as the adjacent No 109). These have now been replaced with uPVC casement windows that do not respect the original window proportions. The brickwork has been painted which has concealed the decorative stone splayed window lintels and cills. Grey PVC gutters and downpipes have been installed to replace the earlier cast iron rainwater goods. The slate finish to the roof has been replaced with terracotta concrete pantiles.</p> <p>A Planning Application was submitted in 2007 to build a two storey extension to the rear which was approved. The more recent works have had a detrimental impact on the character of the property and do not contribute positively to the character of the Conservation Area.</p>

<p>Monitoring Notes</p>	<p>No works to remove the existing fascia should be permitted as it may contain historic details behind existing fabric that could be retained and restored. Suggest further investigation to establish if reinstatement is feasible.</p> <p>Building is in reasonable condition with limited signs of degradation or any areas at risk.</p>
<p>Recommended Actions</p>	<ul style="list-style-type: none"> • Potential to restore Victorian shopfront fascia, corbel brackets and pilasters with limited work. • Remove later addition timber panelling to establish if the original shopfront is retained along with the fascia and cornice details. • Replace pantile roof with slate finish. • Replace PVC gutters and rainwater goods with cast iron and reinstate decorative timber eaves brackets. • Reinststate corbel brackets (using 111 as a template) and pilaster details. • Remove paint from brickwork at first floor level to reveal historical details and repair/repoint brickwork.

- Replace uPVC windows with timber sliding sash.

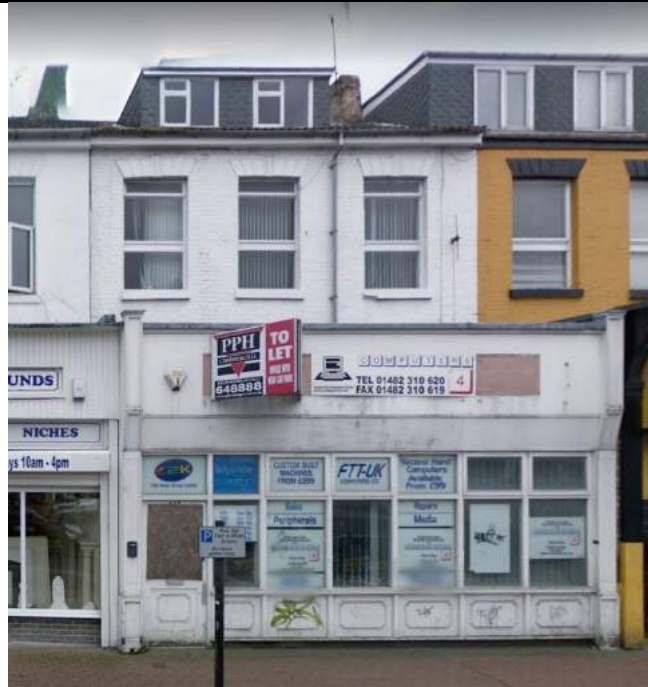
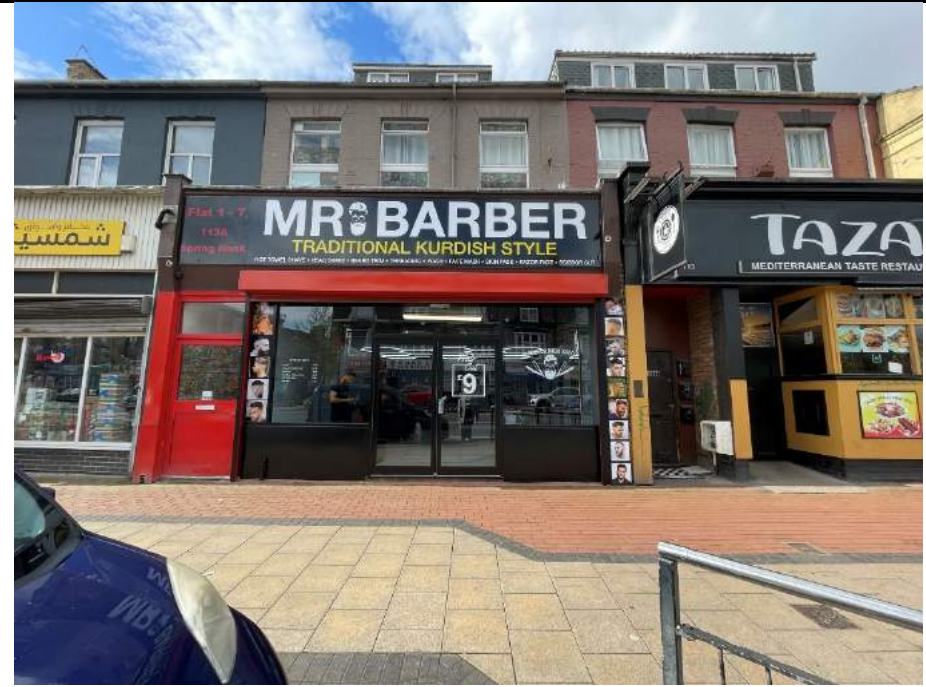
Address Mr Barber, 113 Spring Bank

Built in C1830, the building was originally designed as a large 2 storey dwelling with an elevated entrance door similar to the adjacent No 109. Built as a group of five dwellings with No 107, 109, 111 and 115 adjacent. The external walls comprise of buff brickwork construction with decorative splayed stone window lintels and stone cills. The roof was originally slate with cast iron rainwater goods and would have featured decorative timber eaves brackets as No 109.

<p>Monitoring Notes</p>	<p>Works to remove the existing fascia should not be permitted as it may contain historic details behind existing fabric that could be retained and restored. Suggest further investigation to establish if reinstatement is feasible. Building is in reasonable condition with limited signs of degradation or any areas at risk.</p>
<p>Recommended Actions</p>	<ul style="list-style-type: none"> • Potential to restore Victorian shopfront fascia, corbel brackets and pilasters with limited work. • Remove later addition timber panelling to establish if the original shopfront is retained along with the fascia and cornice details. • Replace pantile roof with slate finish. • Replace PVC gutters and rainwater goods with cast iron and reinstate decorative timber eaves brackets. • Reinstatement corbel brackets (using 111 as a template) and pilaster details. • Remove paint from brickwork at first floor level to reveal historical details and repair/repoint brickwork.

- Replace uPVC windows with timber sliding sash.

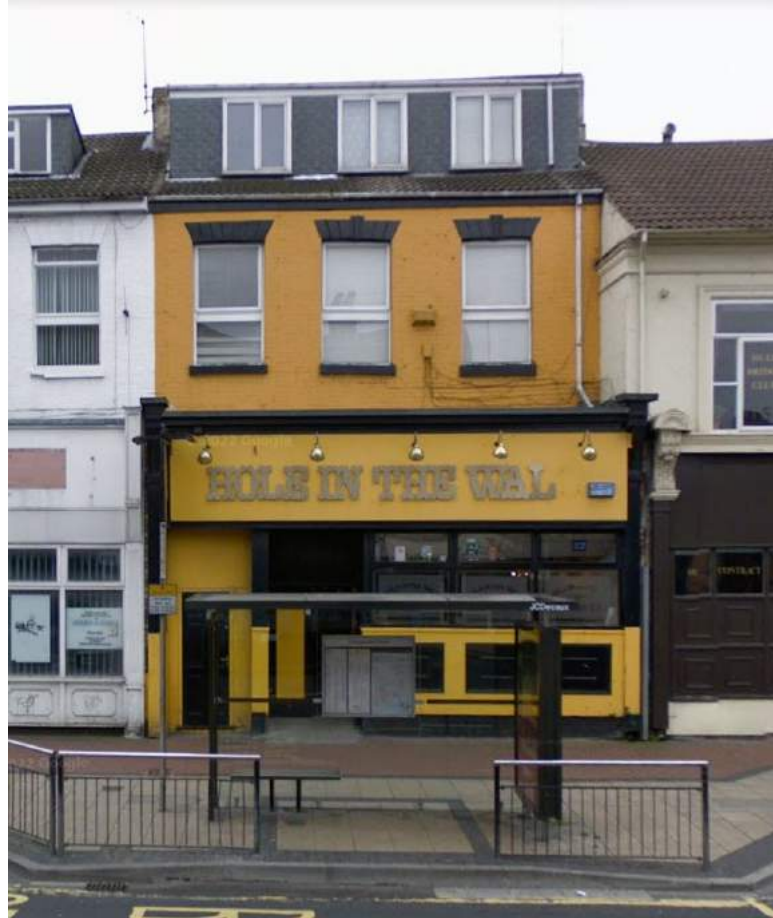
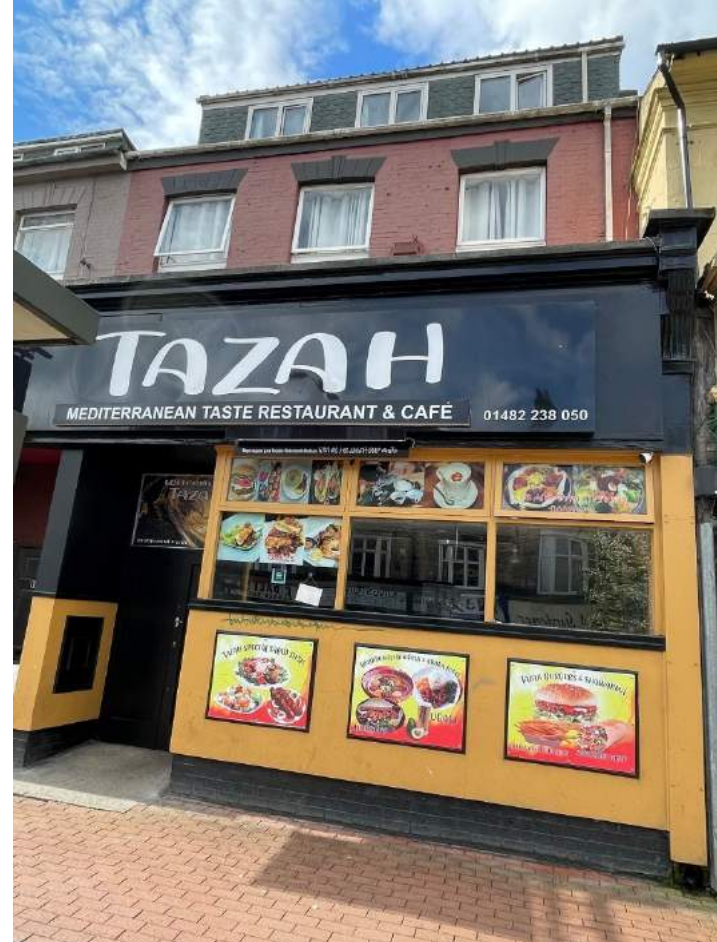
Address: Tazah restaurant and café, 115 Spring Bank

Windows to the first floor level would have been 6 over 6 sliding sash windows (as the adjacent No 109). These have now been replaced with uPVC casement windows that do not respect the original window proportions. The brickwork has been painted which has concealed the decorative stone splayed window lintels and cills. Grey PVC gutters and downpipes have been installed to replace the earlier cast iron rainwater goods. The slate finish to the roof has been replaced with terracotta concrete pantiles. Later addition dormer window to the full extent of the roof is low in quality.

Works to remove the existing fascia should not be permitted as it may contain historic details behind existing fabric that could be retained and restored. Suggest further investigation to establish if reinstatement is feasible. No works to remove the last remaining console brackets should be permitted as these are part of the original shopfront and provide a template for reinstatement of the Victorian shopfronts. Building is in reasonable condition with limited signs of degradation or any areas at risk.

- Potential to restore Victorian shopfront fascia, corbel brackets and pilasters with limited work.
- Remove later addition timber panelling to establish if the original shopfront is retained along with the fascia and cornice details.
- Replace pantile roof with slate finish.
- Replace PVC gutters and rainwater goods with cast iron and reinstate decorative timber eaves brackets.
- Restore retained corbel brackets and reinstate the pilaster details.
- Remove paint from brickwork at first floor level to reveal historical details and repair/repoint brickwork.
- Replace uPVC windows with timber sliding sash.

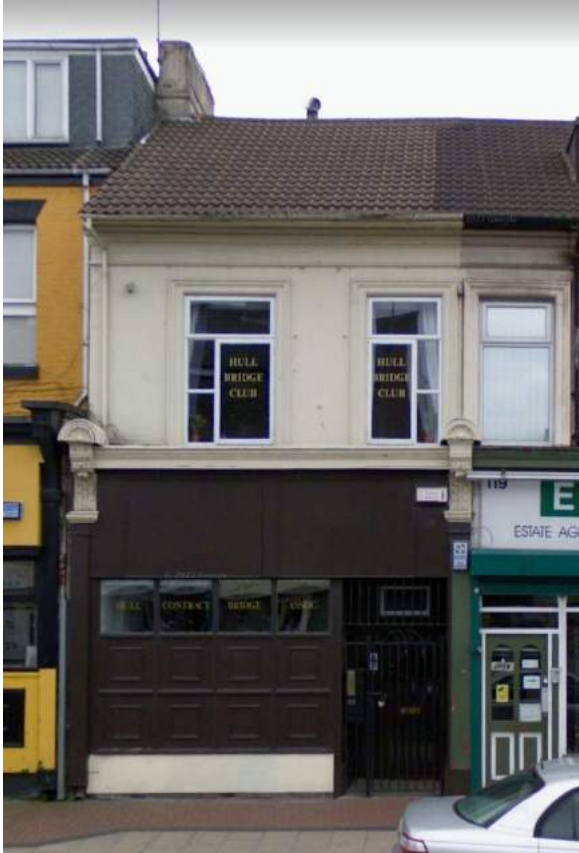
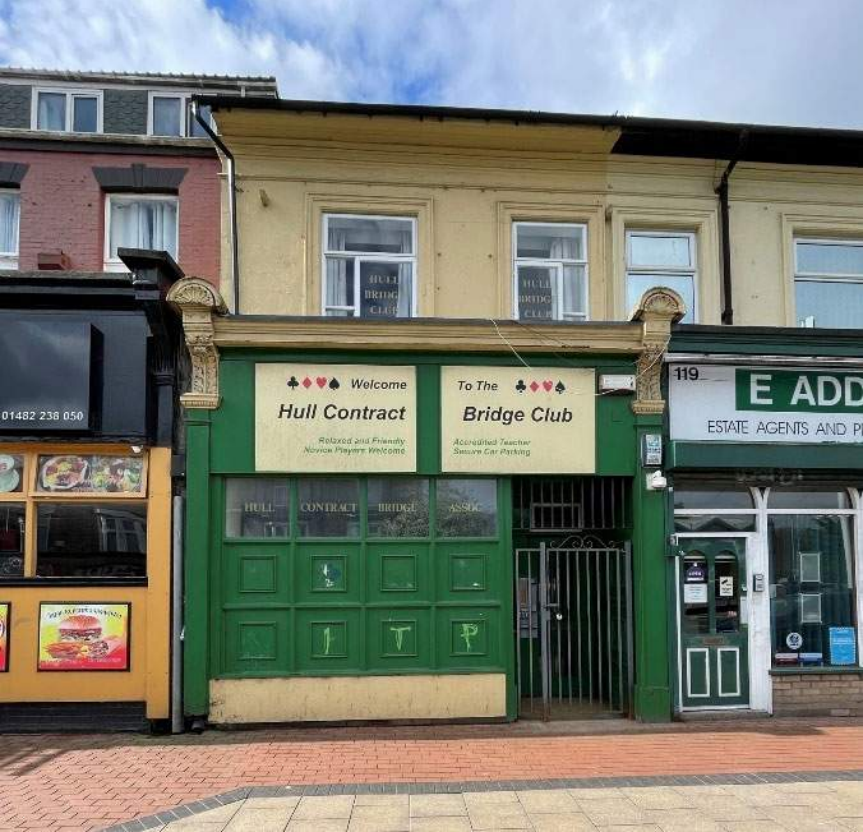
Street: Spring bank	Address: Hull Contact Bridge Club, 117
Historic Photo from 2008 (Google maps)	Current Photo – 11/05/2023 (author)

Building Notes	Built in late 1800's between 1856-1893, the building was built as a group of three buildings with No 119 and 121 adjacent. The external walls comprise of a render finish with decorative architraves framing the upper floor windows. The roof was originally slate with cast iron rainwater goods and features a deep eaves overhang and decorative plaster cornice and frieze detail.

<p>The ground floor level shopfront has retained the original console brackets and deep, expressed cornice. The pilasters have been adapted and the LHS pilaster reduced in width during the installation of the shopfront. The shopfront is a relatively modern timber framed shopfront with high level windows. It is likely that this was installed during the works in 2000 when an application was submitted for a change of use from Bingo Hall to use as the Head Quarters for the Bridge Association who are still based in the building (Ref No. 00/00406/PF). The deep signage fascia detracts from the quality of the original shopfront and should ideally align with the base of the retained console bracket. The ground floor shopfront has a recessed door with grey painted gates that are unsympathetic to the character of the building.</p> <p>Windows to the first floor level would have originally been sliding sash windows. These have now been replaced with uPVC casement windows that do not respect the original window proportions. The buildings within the group of 117, 119 and 121 are all painted in different colours which detracts from the collective aesthetic of the group. Black PVC gutters and downpipes have been installed to replace the earlier cast iron rainwater goods and the deep eaves overhang means that these become a dominant feature to the first floor level. The slate finish to the roof has been replaced with terracotta concrete pantiles. Later addition dormer window to the full extent of the roof is low in quality.</p> <p>The more recent works have had a detrimental impact on the character of the property and do not contribute positively to the character of the Conservation Area.</p>

Monitoring Notes	<p>Works to remove the console brackets and cornice (and any remaining shopfront behind) should not be permitted.</p> <p>Building generally in good condition with no immediate risks identified.</p>		
Recommended Actions	<ul style="list-style-type: none"> • Replace gates with more suitable gates • Paint first floor elevation to 117, 119 and 121 with consistent colour to enhance the group aesthetic. • Remove uPVC windows and replace with timber sliding sash windows with consistent design to 117, 119 and 121. • Reduce depth of signage fascia to align with the base of the console brackets and install new signage. • Replace shopfront with a timber shopfront design that is more sympathetic to the building design. • Replace terracotta concrete tiles with slate. • Remove PVC gutters and downpipes and replace with new, decorative cast iron rainwater goods. • 		
Street:	Spring Bank	Address	E Addy and Co Estate Agents, 119

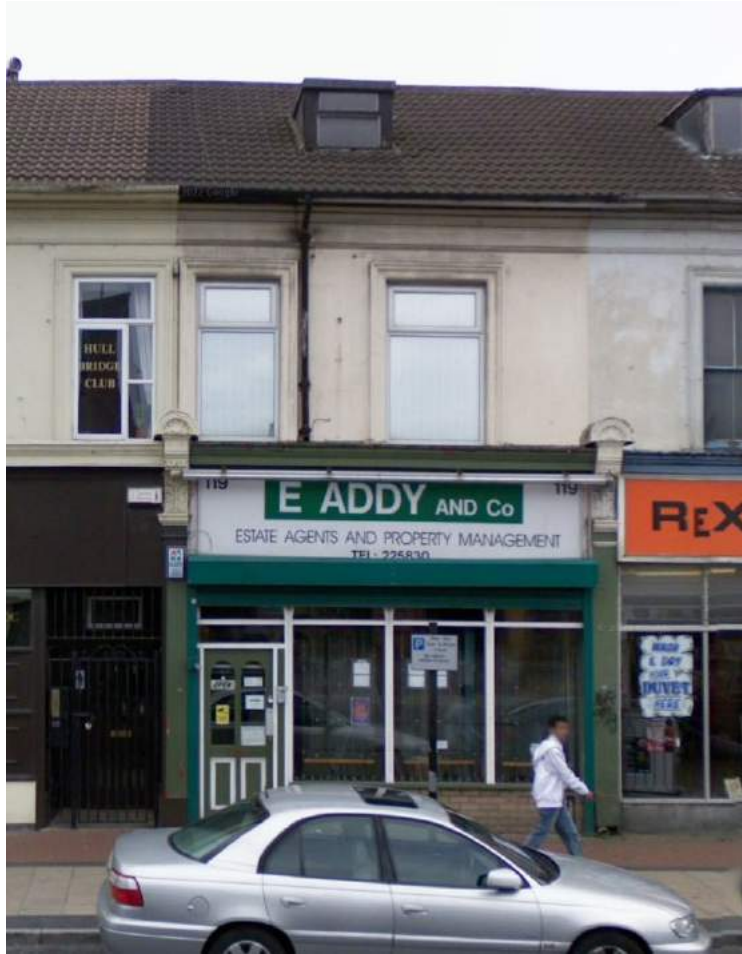
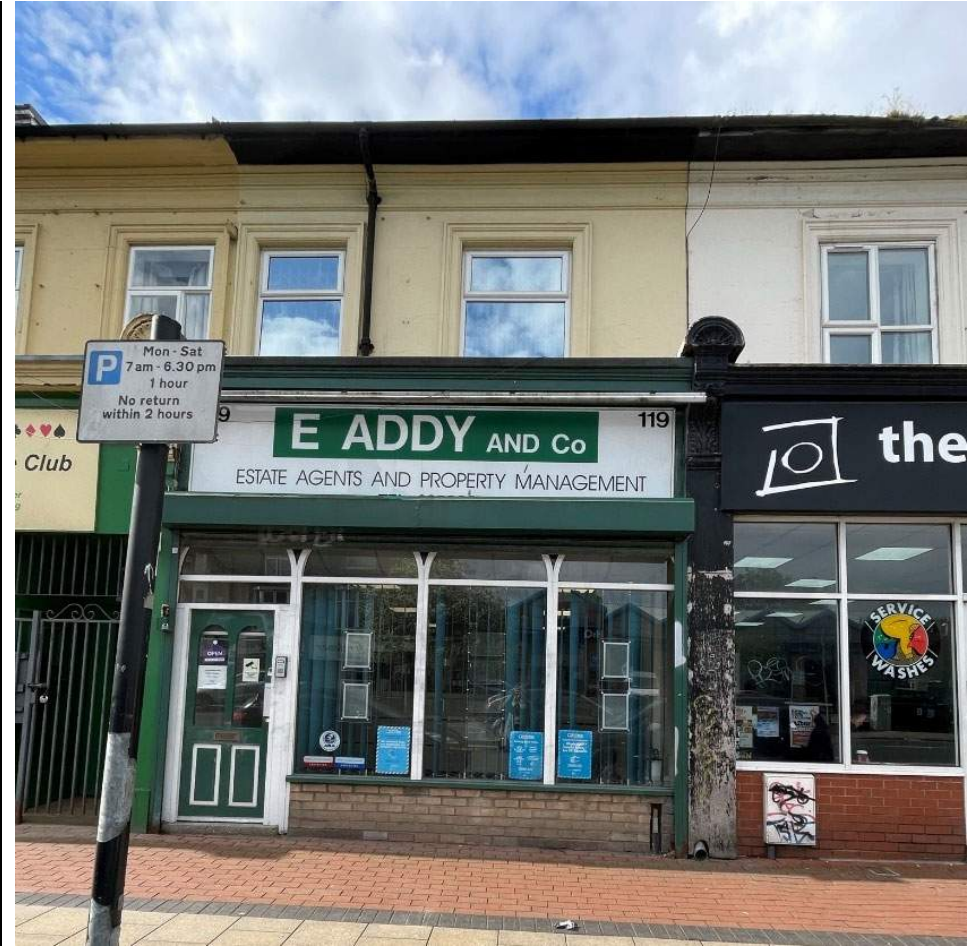
Built in late 1800's between 1856-1893, the building was built as a group of three buildings with No 117 and 121 adjacent. The external walls comprise of a render finish with decorative architraves framing the upper floor windows. The roof was originally slate with cast iron rainwater goods and features a deep eaves overhang, and decorative plaster cornice and frieze detail.

Monitoring Notes	<p>Works to remove the console brackets and cornice (and any remaining shopfront behind) should not be permitted.</p> <p>Building generally in good condition with no immediate risks identified.</p>
Recommended Actions	<ul style="list-style-type: none"> • Paint first floor elevation to 117, 119 and 121 with consistent colour to enhance the group aesthetic. • Remove uPVC windows and replace with timber sliding sash windows with consistent design to 117, 119 and 121 (as the 2008 photo of No 121). • Reduce depth of signage fascia to align with the base of the console brackets and install new signage. • Replace shopfront with a timber shopfront design that is more sympathetic to the building design and open up the shopfront to allow views in and increase active frontage. • Replace terracotta concrete tiles with slate. • Remove PVC gutters and downpipes and replace with new, decorative cast iron rainwater goods.

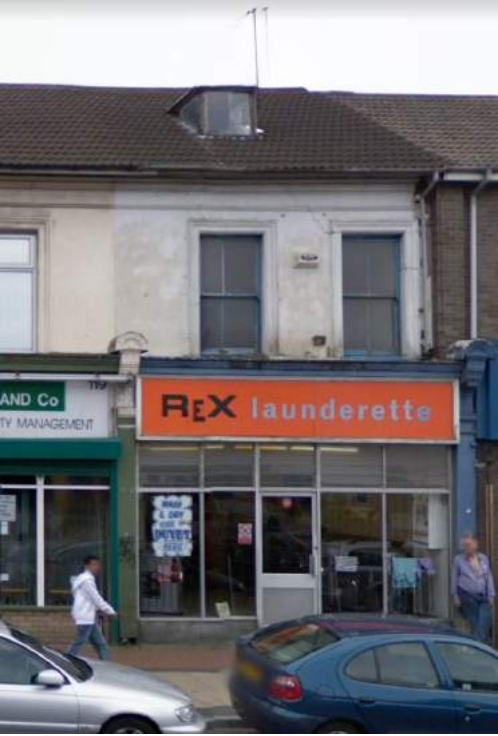
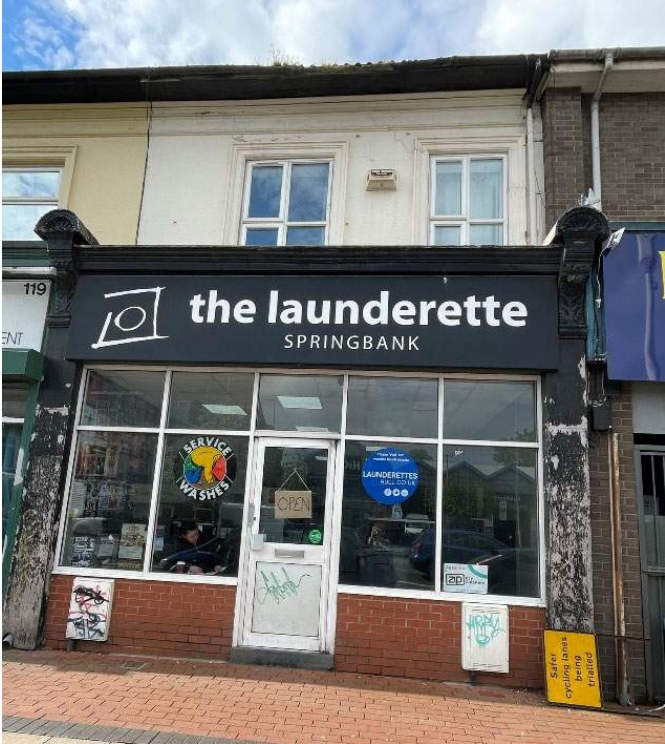
Street: Spring Bank	Address: The Launderette, 121 Spring Bank
Historic Photo from 2008 (Google maps)	Current Photo – 11/05/2023 (author)

Building Notes	<p>Built in late 1800's between 1856-1893, the building was built as a group of three buildings with No 117 and 179 adjacent. The external walls comprise of a render finish with decorative architraves framing the upper floor windows. The roof was originally slate with cast iron rainwater goods and features a deep eaves overhang and decorative plaster cornice and frieze detail.</p> <p>The ground floor level shopfront has retained the original console brackets and deep, expressed cornice. The pilasters have been adapted and widened and have lost their decorative detail. The shopfront is a modern metal framed shopfront with a red brick stall riser installed after 2008. The deep signage fascia detracts from the quality of the original shopfront and should ideally align with the base of the retained console bracket.</p> <p>Windows to the first floor level were originally sliding sash windows with a central vertical bead (see 2008 photo). These have now been replaced with uPVC casement windows that do not respect the original window</p>

<p>proportions and detailing. The buildings within the group of 117, 119 and 121 are all painted in different colours which detracts from the collective aesthetic of the group. Black PVC gutters and downpipes have been installed to replace the earlier cast iron rainwater goods and the deep eaves overhang means that these become a dominant feature to the first floor level. The slate finish to the roof has been replaced with terracotta concrete pantiles. Later addition dormer window to the full extent of the roof is low in quality.</p> <p>The more recent works have had a detrimental impact on the character of the property and do not contribute positively to the character of the Conservation Area.</p>
Monitoring Notes	<p>Works to remove the console brackets and cornice (and any remaining shopfront behind) should not be permitted.</p> <p>Gutter appears to be blocked with debris and fungal growth which is causing the gutter to sag. This could lead to long term issues of water damage if not addressed in the short term.</p>

Recommended Actions	<ul style="list-style-type: none"> • Paint first floor elevation to 117, 119 and 121 with consistent colour to enhance the group aesthetic. • Remove uPVC windows and replace with timber sliding sash windows with consistent design to 117, 119 and 121 (as 2008 photo of 121 above). • Reduce depth of signage fascia to align with the base of the console brackets and install new signage. • Replace shopfront with a timber shopfront design that is more sympathetic to the building design and open up the shopfront to allow views in and increase active frontage. • Replace terracotta concrete tiles with slate. • Remove PVC gutters and downpipes and replace with new, decorative cast iron rainwater goods.

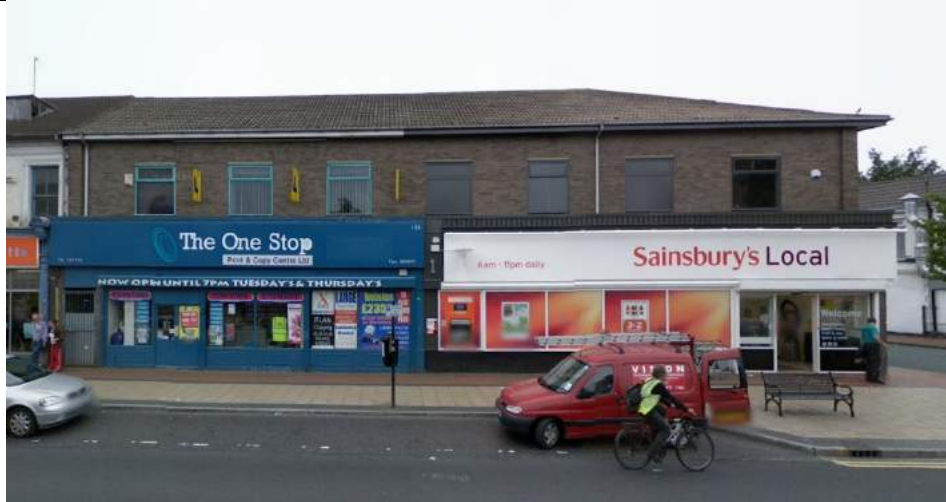
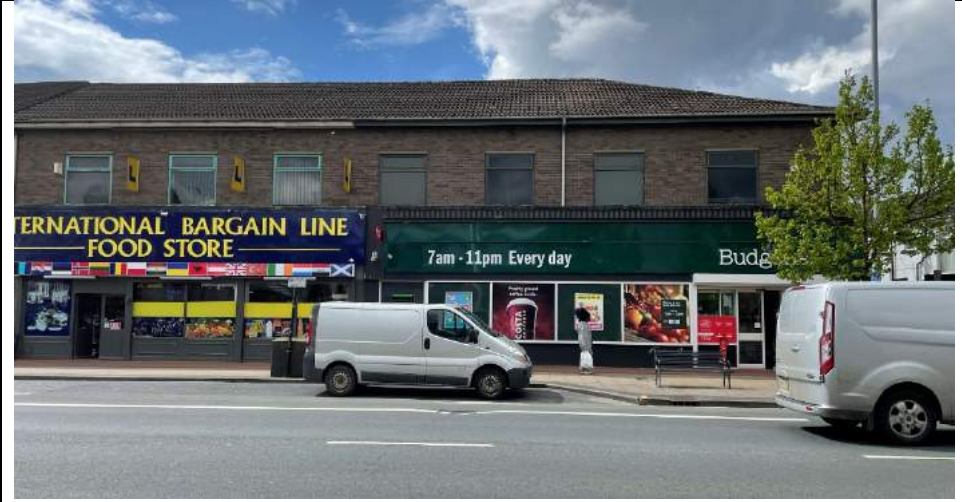
Street:	Spring Bank	Address	International Bargain Line Food Store/ Budgens, 123-129
----------------	--------------------	----------------	--

The former Cooperative store was built on this site between 1856-1893 but was later demolished. The existing building was built later in the early 2000's to provide larger scale retail units on Spring Bank and utilising the former gardens to the rear. The external elevations are a multi-tone grey brick with a concrete pantile roof finish and UPVC gutters. Although the window proportions reflect the vertical rhythm of the adjacent early Victorian properties, the window fenestration pattern is more modern with opening toplight casement windows. The fascia signage is excessively deep, dominating the façade (taking up 1/3 of the elevation). The glazing to the corner unit has had vinyl graphics applied that prevents views into the unit and does little to contribute to a vibrant active frontage. External roller shutter to Bugdens is concealed behind the signage. The International Food Store has an externally mounted roller shutter.

- Reduce the extent of the fascia signage
- Improve visibility into the units by removing/reducing the extent of the vinyl
- Replace pantile roof finish with slate finish to reflect the traditional materials of the street.

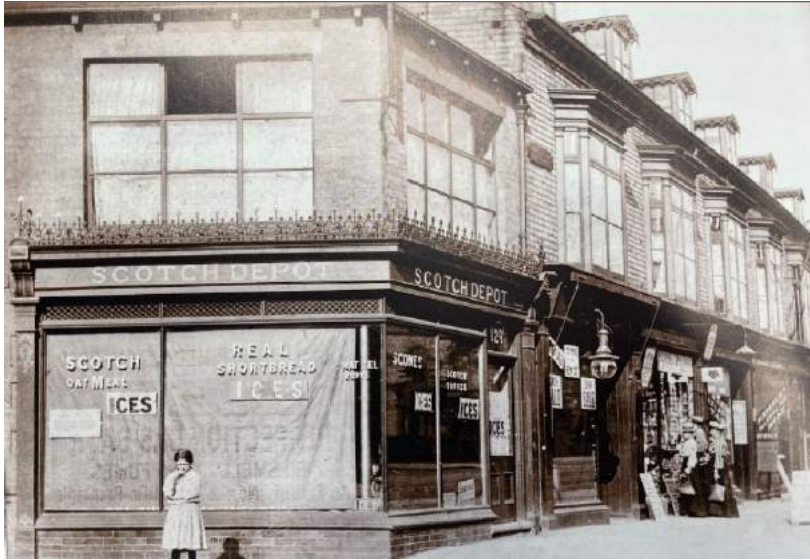
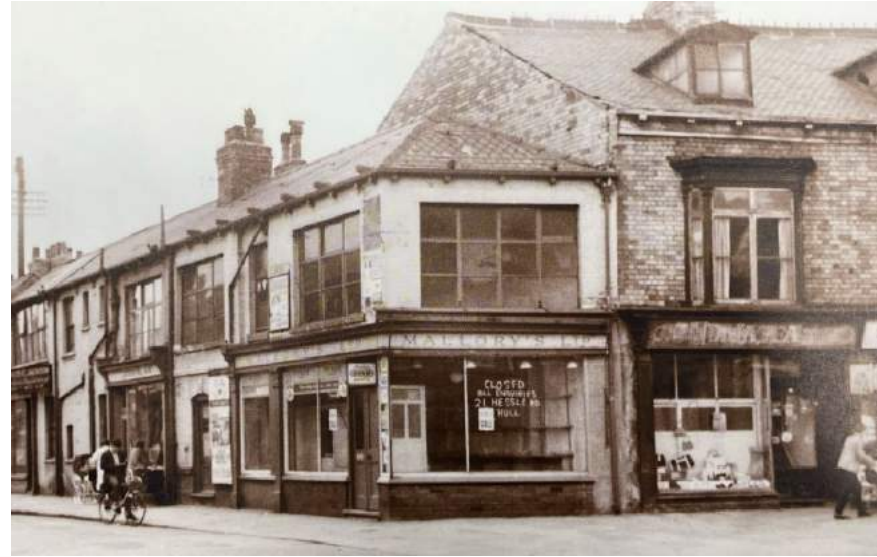
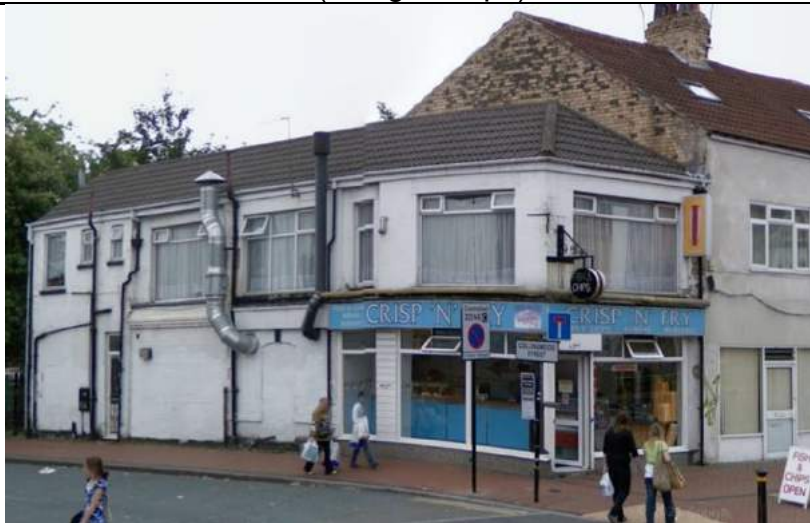
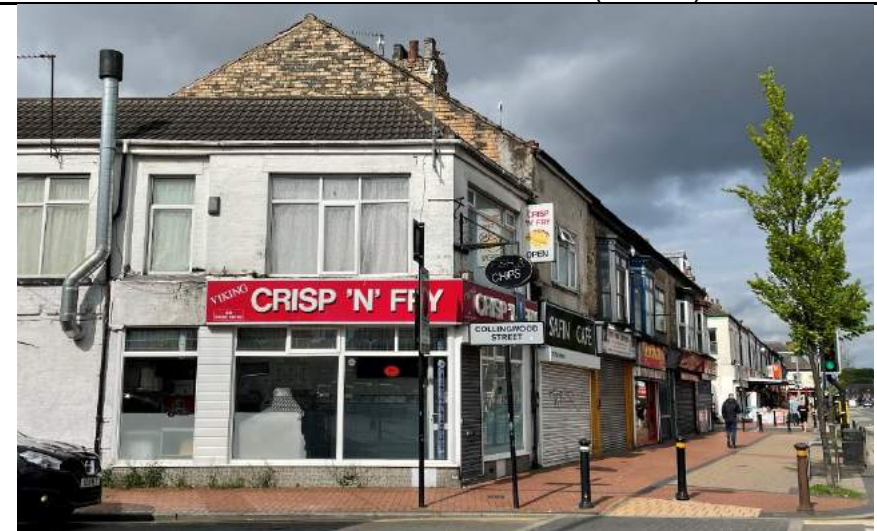
Street: Spring Bank	Address	Crispy 'N' Fry, 129a Spring Bank
Historic Photo from 1903 (Hull Then and Now 3, Paul Gibson)		Historic photo from 1948 (Hull Then and Now 3, Paul Gibson)

The building today has lost many of the original features with all of the shopfront features including the pilasters, console brackets and retractable canopy removed. The painting of the brickwork has concealed the texture of the brickwork. The decorative diamond slates have been removed to the roof and replaced with concrete

<p>pantiles. The cast iron gutters and downpipes have been removed and the decorative gutter support brackets removed and the rainwater goods replaced with PVC. The shopfront has been replaced again with a metal framed shopfront with the door relocated to the Spring Bank frontage. The first floor windows have been replaced with new uPVC windows that do not reflect the proportions of the original design. The shopfront to the LHS of the first floor access door (which can be seen in the 1948 photograph) has been removed and the opening blocked up and rendered.</p>
Monitoring Notes	<p>There are limited historical features retained and there are no immediate risk items identified at this time. There is structural movement evident on the former shop unit to the LHS of the first floor entrance door that should be investigated.</p>
Recommended Actions	<p>This building is a key focal corner building on Spring Bank and would benefit from restoration. Although many of the original features have been removed, there is sufficient evidence in the remaining fabric and the photographic evidence to restore the building either in part or in its entirety. The following is suggested :-</p> <ul style="list-style-type: none"> • Removal of the paint from the brickwork, brickwork repair and repointing. • Replacement of the first floor uPVC windows with a design that reflects the original proportions. • Re-routing of the extract vents to the kitchen extract. • Replacement of the shopfront with a restored shopfront based on the earlier photographic evidence and the remaining features. Reinstatement of the pilasters, corbels, fascia and decorative ironwork to the top of the fascia. • Reinstatement of the shopfront to the rear unit on Collingwood Street. • Removal of the uPVC rainwater goods and fascia and the rationalisation of the drainage system generally. Replacement with cast iron gutters and downpipes and reinstate the decorative gutter support brackets based on the sockets/markings found beneath the fascia. • Remove the pantile roof and replace with decorative diamond slate finish.
