**Spring Bank Conservation Area
Management Plan (South side)**
Draft for Review

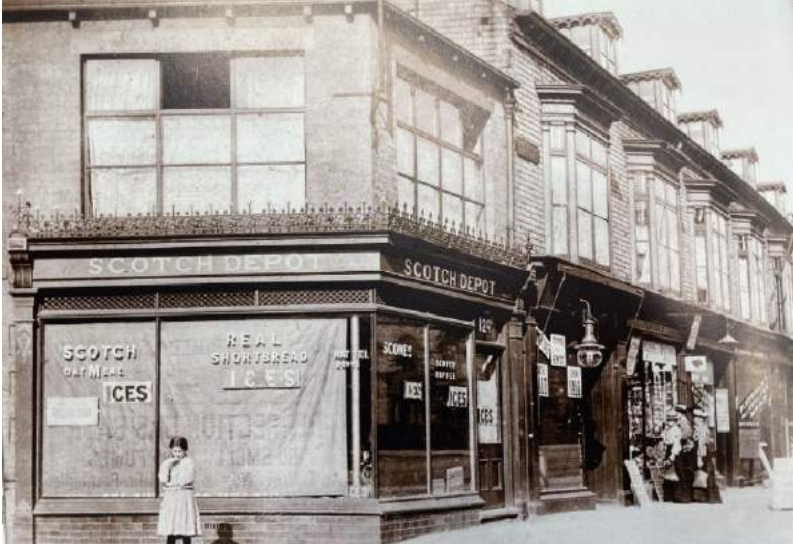
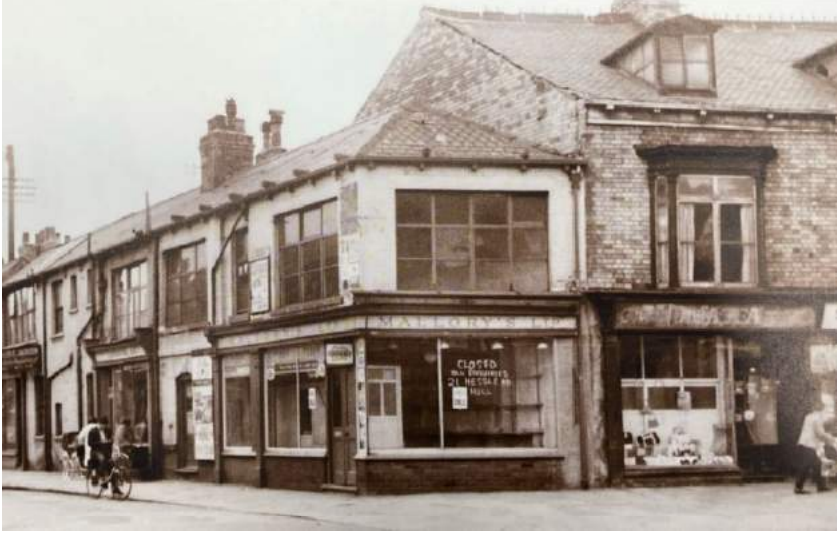
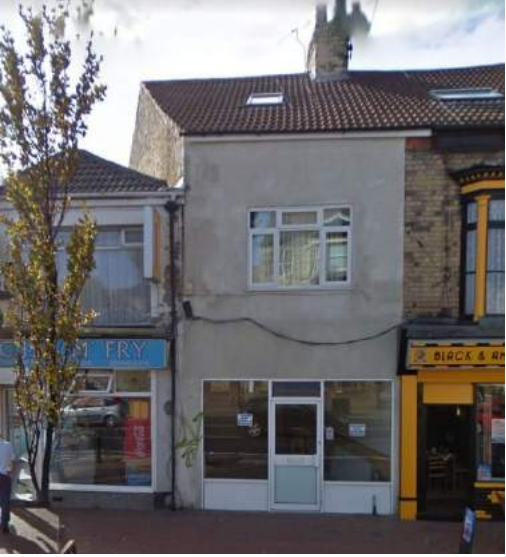
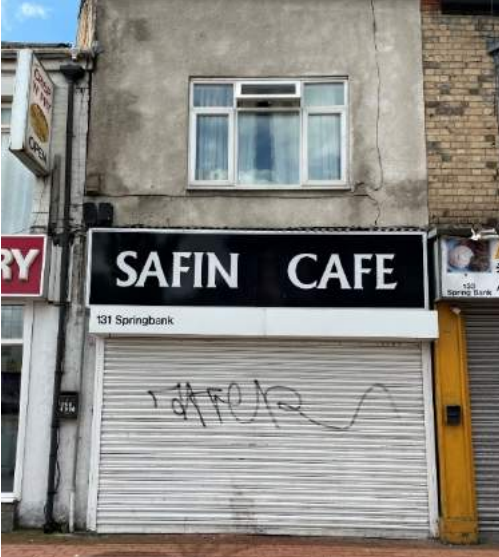
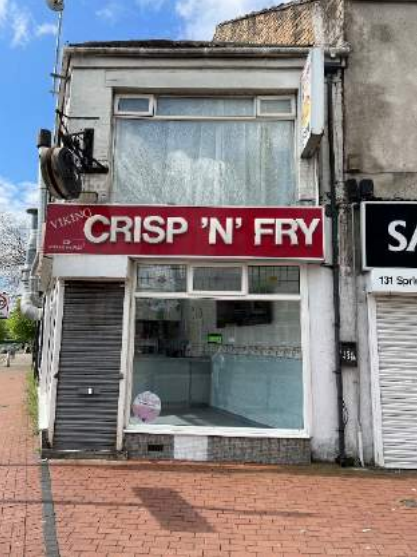
Street: Spring Bank	Address Safin Café/ mado sweet, 131	
Historic Photo from 1903 (Hull Then and Now 3, Paul Gibson)	Historic photo from 1948 (Hull Then and Now 3, Paul Gibson)

The building today has lost all of its historical features, although evidence is retained in the adjacent shopfronts along Emporium Buildings that would enable some or all of these features to be restored. The first floor bay window has been removed and replaced with a horizontally proportioned uPVC window. As this requires extensive brickwork repair, the buff brickwork has been rendered to conceal the brickwork repairs and the cement render has not been through coloured or decorated. The slate roof, cast iron gutter and decorative gutter brackets have been removed and replaced with terracotta concrete pantiles. The dormer windows have been removed and replaced with a rooflight. The 2008 image shows that the shopfront fascia, corbels and pilasters have all been removed.

Staining of the cement render to the vertical edges (including the windows), particularly where it joins 129a and the gutter location would suggest that water is finding its way into the render (and the brickwork behind) which could cause long term damage to the brickwork. Recommend immediate action to have the render removed to avoid long-term damage.

- Remove cement render and restore brickwork
- Reinststate the bay window using the bay window to No 135 as a template for the details, dimensions and proportions.
- Remove the shopfront and reinststate the original shopfront design with corbels, pilasters, fascia sign, all consistent with the other buildings in the group.
- Reinststate the dormer window using the dormer window to 141 as a template.
- Remove the pantile roof finish and replace with slate.
- Replace the rainwater goods with cast iron and reinststate the decorative fascia's and gutter brackets based on the adjacent building.
- Replace the chimney pots with those matching the chimney to No 137.
- Consistent paint colour throughout the group to windows, gutter brackets and fascias.

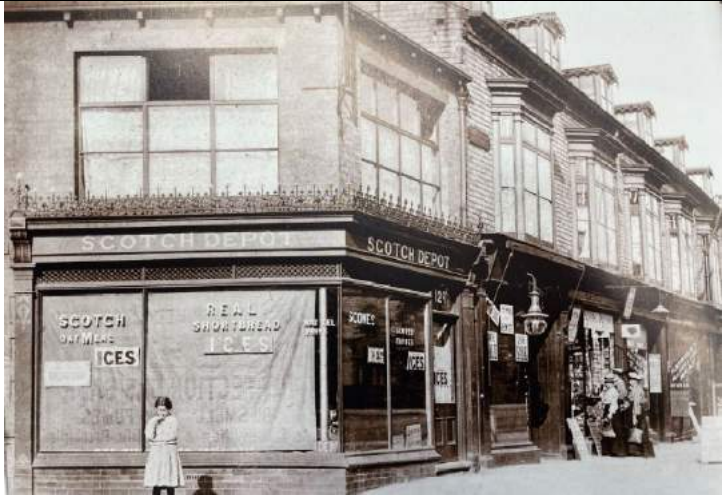
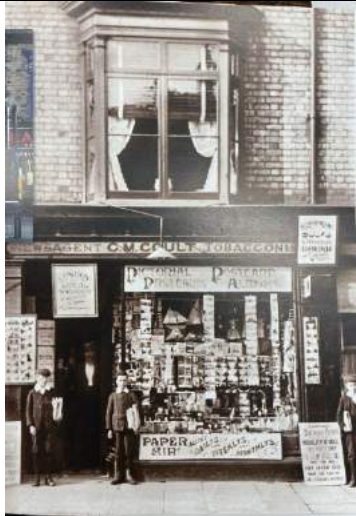
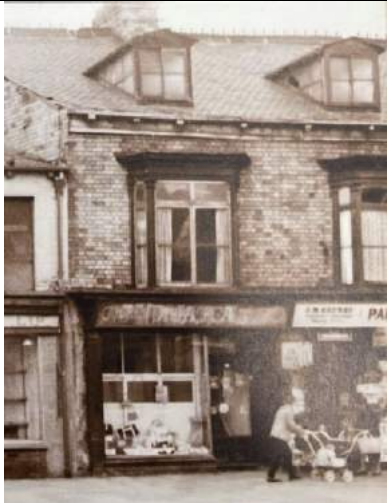
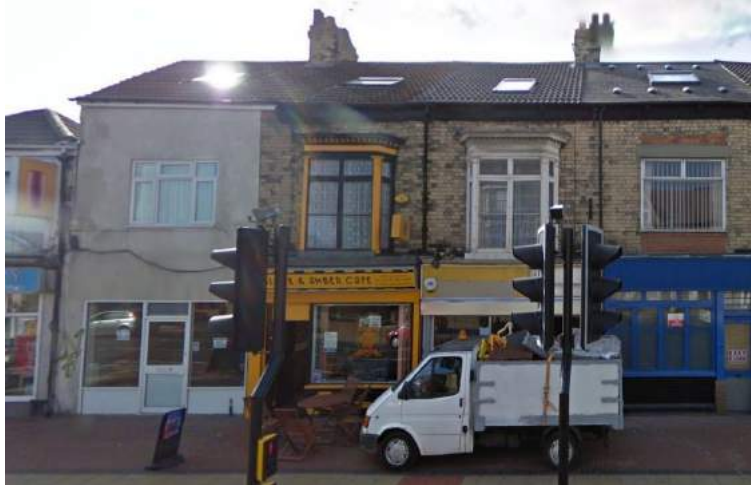
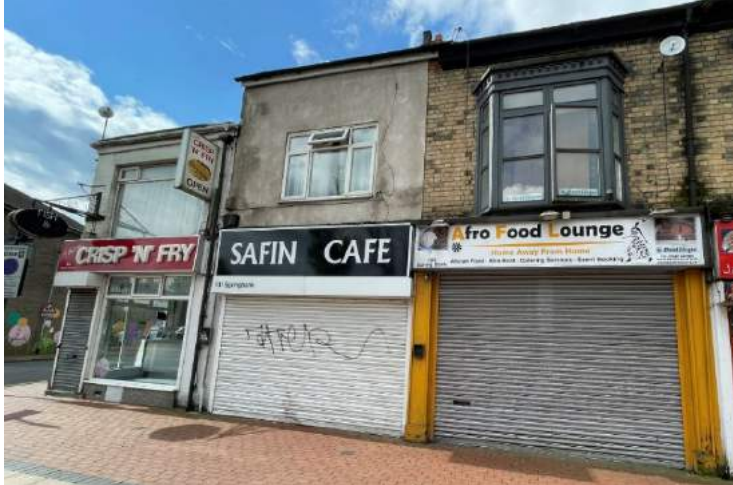
Built between 1856-1893, No 133 forms part of a group of 6 buildings along with No's 131, 135, 137, 139, 141 (called Emporium Buildings) which were built at the same time and with identical detailing and style. The terrace was originally built as three storey residential properties with front gardens that extended into the street (now demarcated by the change in paving treatment). As Spring Bank developed "from a suburban 'promenade' to a shopping 'centre', the gardens were removed and the ground floors converted to shops with new decorative shopfronts added. The bay windows were retained to the first floor level and dormer windows were located to the roof to provide accommodation within the roofspace.

The building today has lost some of its historical features, although evidence is retained in the adjacent shopfronts along Emporium Buildings that would enable some or all of these features to be restored. The first floor bay window has been retained. Although the glazing has been replaced with new double glazed timber framed windows, this has been executed sympathetically. A number of the dentil details to the cornice of the bay window require replacing. The slate roof, cast iron downpipe have been removed and the roof replaced with terracotta concrete pantiles. The timber gutter has been retained. The dormer windows have been removed and replaced with a rooflight. Remnants of the original shopfront fascia and cornice may have been retained behind the new signage.

- Remove the shopfront and reinstate the original shopfront design with corbels, pilasters, fascia sign, all consistent with the other buildings in the group.
- Reinstall the dormer window using the dormer window to 141 as a template.
- Remove the pantile roof finish and replace with slate.
- Replace the rainwater downpipes with cast iron.
- Repair and restore the timber gutter and support bracket detail.
- Replace the chimney pots with those matching the chimney to No 137.
- Consistent paint colour throughout the group to windows, gutter brackets and fascias.

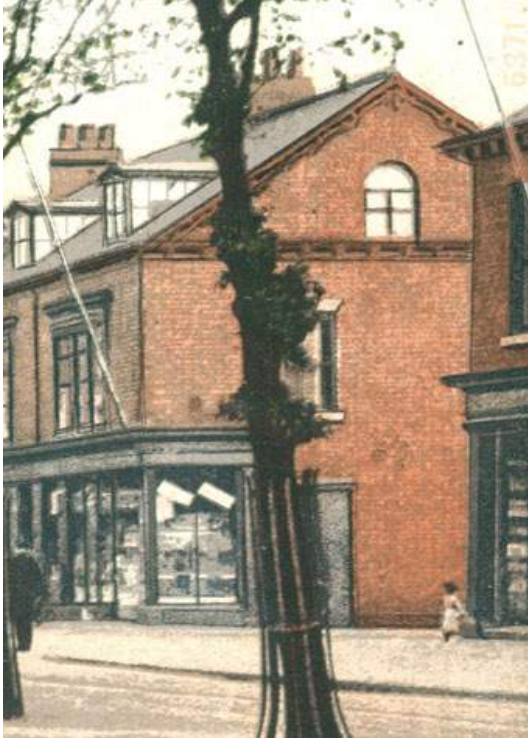
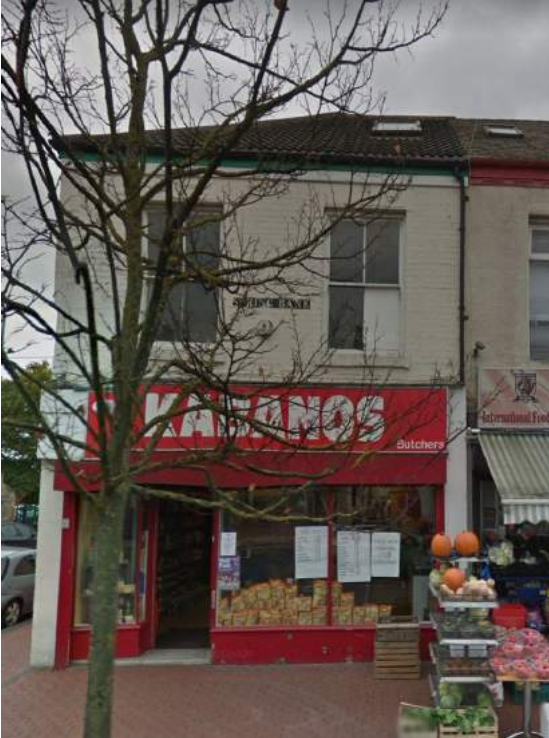
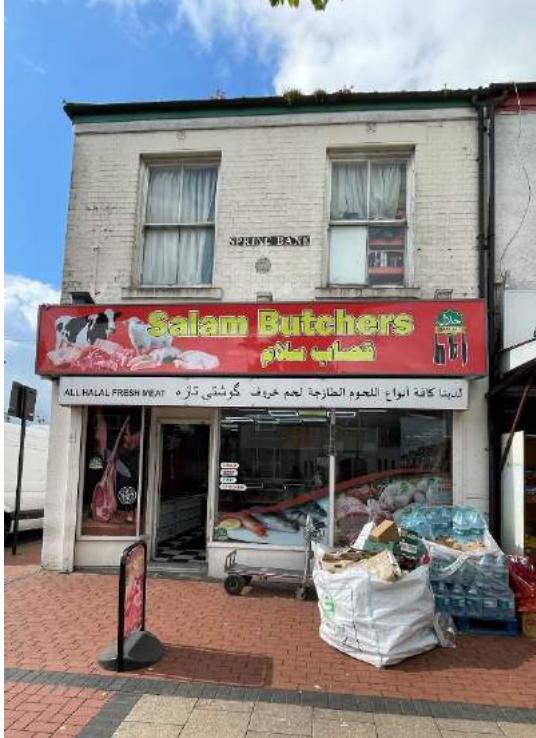
Street:	Spring Bank/Sutton Street		Address	Salam Butchers, 143 Spring Bank	
Historic Photo from early 1900's (Hull Daily Mail) – note colour wash incorrectly shown as red brick rather than buff	Historic Photo from 2015 (Google maps)		Current Photo – 11/05/2023 (author)

Building Notes	<p>Built between 1856-1893, No 143 forms part of a group of 2 buildings along with the adjacent 145 Spring Bank. The group appears to have been built after the adjacent terrace from 147 -155 but has some continuity in the proportions of the window openings at first floor level. These two storey buildings were constructed with buff brickwork walls, slate roof finish, cast iron downpipes and gutters. Unlike the adjacent group (147-155), the decorative stonework lintels form a flat head to the window, rather than arched, although they share similar carving details with rosettes at the centre of the lintel to the Spring Bank elevation. The windows to the Sutton Street elevation, however, have splayed stone lintels of a similar design to No 143 opposite. This suggests the hierarchy of streets, with Spring Bank being more prominent and decorative than Sutton Street. A door opening was located on the Sutton Street elevation to</p>

<p>provide access to the first floor level accommodation. The historical photo from early 1900's shows the corner of No 143 and the original shopfront design and the decorative expressed eaves level with a timber gutter and decorative timber support brackets.</p> <p>The shopfront on the photographs from 2009 and 2023 is consistent and the existing shopfront appears to be the original Victorian shopfront with a recessed glazed door with a mosaic tiled threshold, timber frames split vertically with elegant curved mullions, a stone stall riser (which has since been painted) and a curved timber cill. An external roller shutter has been added and the pilasters concealing part of the shopfront windows and the corbel brackets and fascia have been removed (although evidence of these may be concealed behind the later fascia sign. To the first floor the original timber sash windows have been retained in situ. The side entrance door to access the first floor accommodation has been blocked up and the buff brickwork has been painted throughout which has visually lost the lintel details over the windows to both the Spring Bank and Sutton Street elevation. The buff brick to the rear elevation of the original building (later extended in red brick) is still visible. The decorative frieze detail beneath the eaves has been covered over with the new uPVC fascia. The slate roof finish has been removed and replaced with concrete pantiles.</p>

<p>Monitoring Notes</p>	<p>The first floor level windows are the original Victorian windows and any application to remove the Hampel should not be permitted.</p> <p>On site investigation into whether the shopfront is original to be undertaken. Any works to remove the shopfront should not be approved.</p>
<p>Recommended Actions</p>	<p>As one of the last remaining early shopfronts on Spring Bank and a key focal corner building No 143 would be worth considering restoration.</p> <ul style="list-style-type: none"> • Remove paint from stone stall riser. • Remove signage and reinstate the cornice, fascia, pilasters and console bracket (as early 1900's photo) • Undertake paint analysis on shopfront to establish the original colour scheme. • Remove paint from buff brickwork and decorative lintels to reveal the details to both Spring Bank and Sutton Street elevations. • Reinstate former entrance door from Sutton Street (if feasible internally). • Remove pantile roof and replace with slate. • Reinstate the timber gutter and decorative support brackets. • Replace PVC downpipes with cast iron.

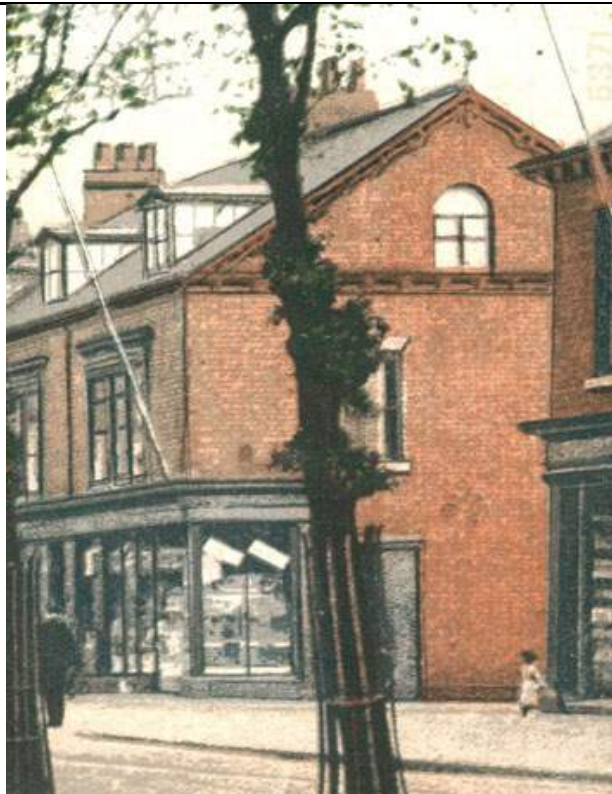
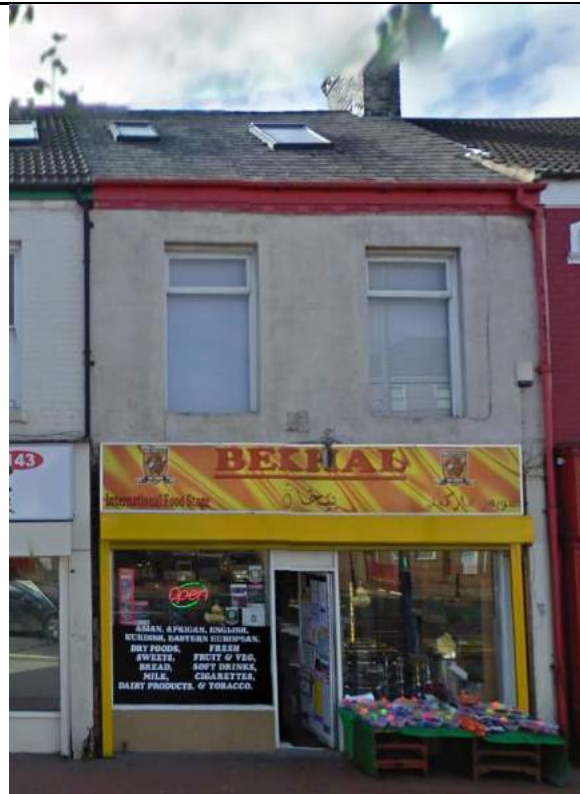
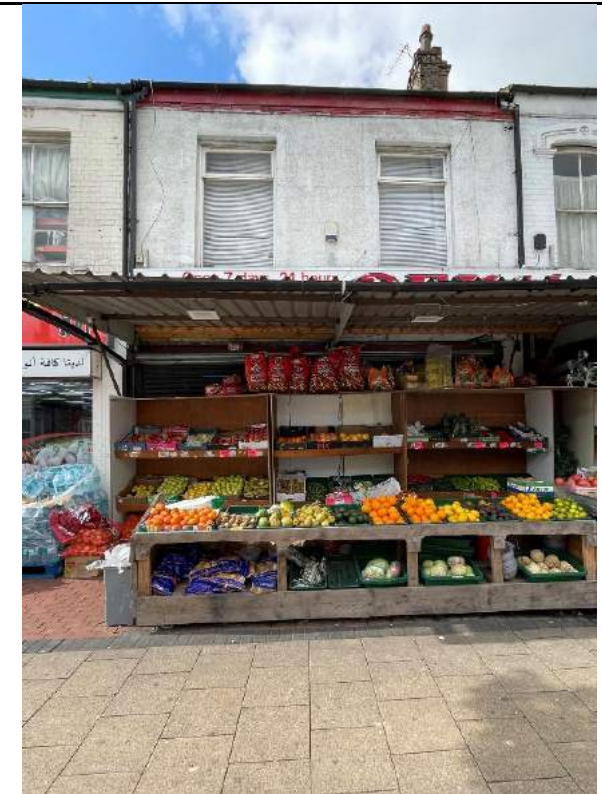
Built between 1856-1893, No 145 forms part of a group of 2 buildings along with the adjacent 143 Spring Bank. The group appears to have been built after the adjacent terrace from 147 -155 but has some continuity in the proportions of the window openings at first floor level. These two storey buildings were constructed with buff brickwork walls, slate roof finish, cast iron downpipes and gutters. Unlike the adjacent group (147-155), the decorative stonework lintels form a flat head to the window, rather than arched, although they share similar carving details with rosettes at the centre of the lintel to the Spring Bank elevation.

An external roller shutter has been added and the original shopfront, pilasters, corbel brackets and fascia have been removed (although evidence of these may be concealed behind the later fascia sign). To the first floor the original timber sash windows have been removed and replaced with uPVC in a proportion that does not complement the proportions of the building. The slate roof finish has been removed and replaced with concrete pantiles and the timber gutter and support brackets have been removed and replaced with PVC. A low quality, permanent metal sheet canopy has been installed that, although provides an external area where fruit and vegetables can be displayed, giving activity and colour to the street, the quality is very poor and has a negative impact on the character of the street. The shop unit at 145 has also been extended into the adjacent 147 unit with a fascia sign extended across both units.

The external canopy does not appear to be structurally designed and could lift during high winds causing a health and safety risk. This should be removed as a matter of urgency.
The cement render system will be damaging the first floor brickwork and should be removed in the short term to avoid long term damage to the buff brickwork.

Recommended Actions	<p>As a group of two with No 143 and with sufficient retained detail and photographic evidence it would be worth considering restoration along with 143.</p> <ul style="list-style-type: none"> • Remove permanent external canopy and replace with new retractable canopies to both 145 and 147. • Remove later shopfront and reinstate the original shopfront based on the adjacent 143. • Remove signage and reinstate the cornice, fascia, pilasters and console bracket (as early 1900's photo) • Remove render from buff brickwork and restore the stone decorative lintels and stone cills to reveal the details and to allow the brickwork to evaporate water build up. • Remove pantile roof and replace with slate. • Reinstall the timber gutter and decorative support brackets. • Replace PVC downpipes with cast iron. • Retain and restore the original windows to first floor level. <p>Consistent colour scheme to lintels, gutter and eaves supports as No 145 to form a visually cohesive group.</p>

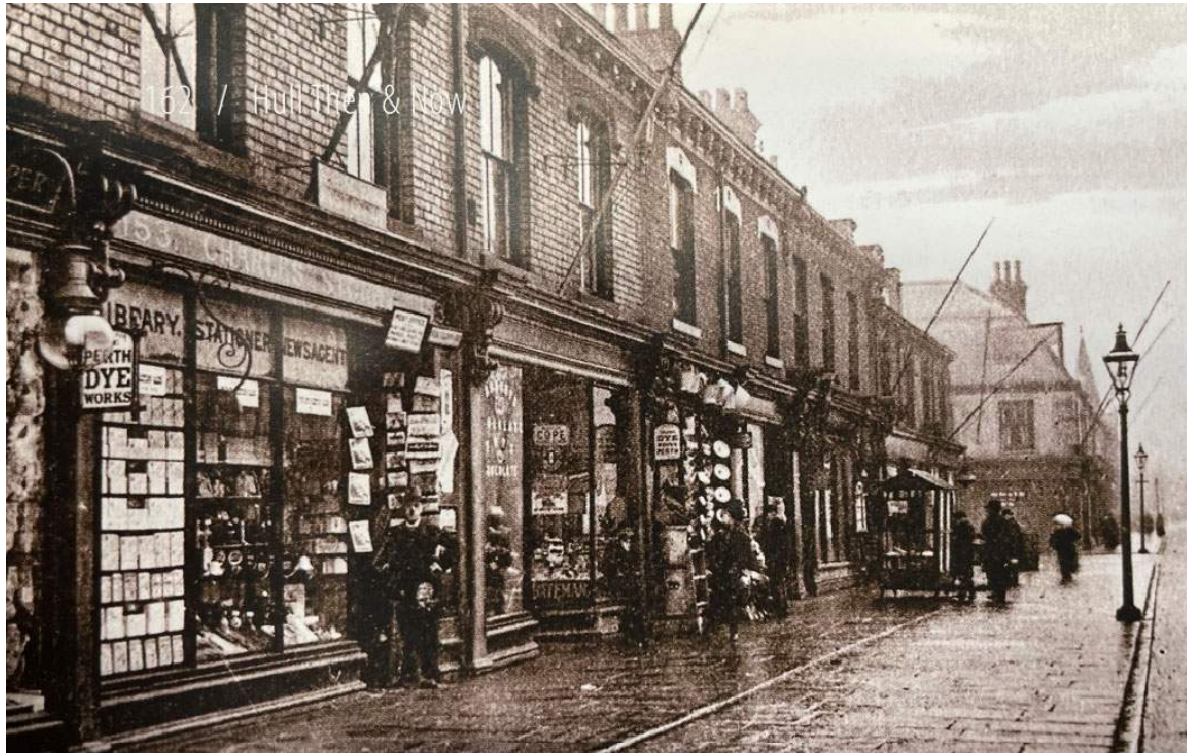
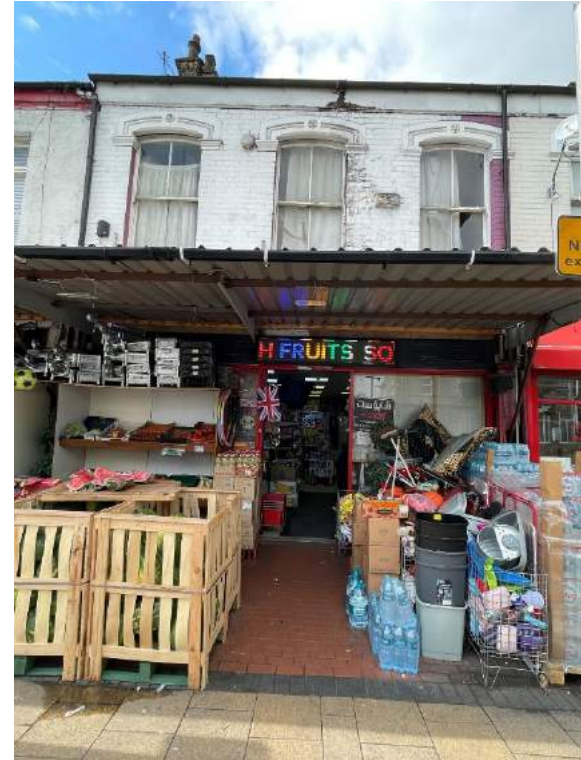
Street:	Spring Bank	Address	Bekhal International Supermarket, 147
Historic Photo from 1903 (Hull Then and Now 1, Paul Gibson)		Current Photo – 11/05/2023 (author)

Built between 1856-1893, No 147 forms part of a group of 5 buildings along with the adjacent 149, 151, 153 and 155 Spring Bank. The group appears to have been built prior to the adjacent terrace 143 and 145. The group is clearly distinguished by the highly decorative stone carved lintels to the first floor windows which form a curved head to the window. The units within the group generally comprise of a two bay arrangement, however, No 147 comprises of three bays.

Monitoring Notes	The external canopy does not appear to be structurally designed and could lift during high winds causing a health and safety risk. This should be removed as a matter of urgency.
Recommended Actions	<p>As a group of five buildings with 149, 151, 153 and 155 Spring Bank and with sufficient retained detail and photographic evidence it would be worth considering restoration as a cohesive group.</p> <ul style="list-style-type: none"> • Remove permanent external canopy and replace with new retractable canopies to both 145 and 147. • Remove later shopfront and reinstate the original shopfront based on the photographic evidence. • Remove signage and reinstate the cornice, fascia, pilasters and console bracket (as early 1900's photo with retained console bracket to No 151 used as a template). • Remove paint from brickwork, stone lintels and cills. Repair and repoint brickwork as required. • Remove pantile roof and replace with slate. • Reinstate the timber gutter and decorative support brackets (as retained at No 155). • Replace PVC downpipes with cast iron. • Retain and restore the original windows to first floor level. • Consistent colour scheme to lintels, gutter and eaves supports to the group to form a visually cohesive group.

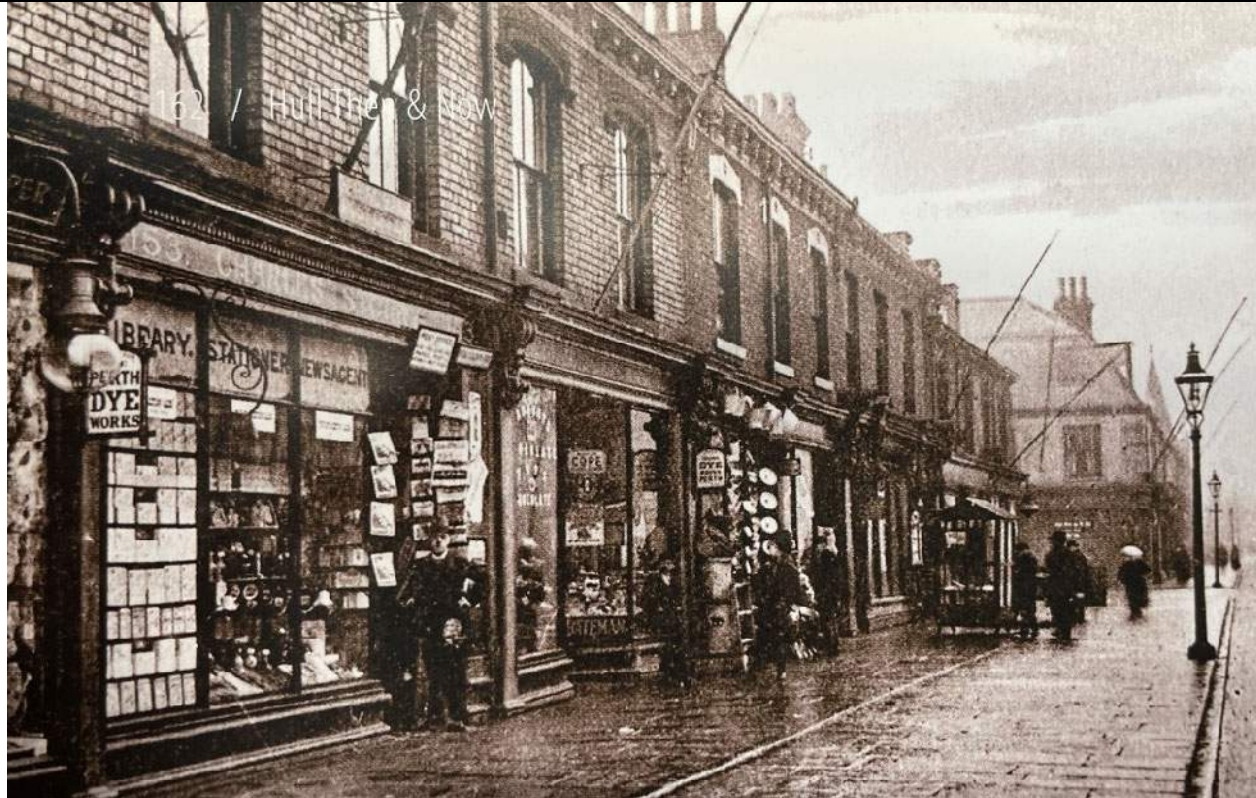
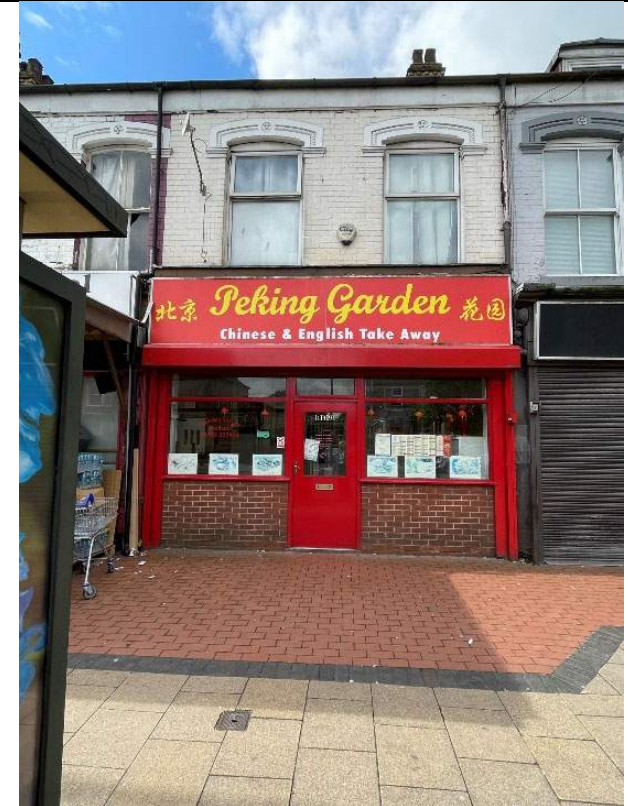
Built between 1856-1893, No 149 forms part of a group of 5 buildings along with the adjacent 147, 151, 153 and 155 Spring Bank. The group appears to have been built prior to the adjacent terrace 143 and 145. The group is clearly distinguished by the highly decorative stone carved lintels to the first floor windows which form a curved head to the window. The units within the group generally comprise of a two bay arrangement, however, No 149 comprises of two bays.

Monitoring Notes	<p>Limited historic features retained. Possible remnants concealed behind existing fascia sign which should be retained if altered in the future. No immediate action items identified.</p>
Recommended Actions	<p>As a group of five buildings with 147, 151, 153 and 155 Spring Bank and with sufficient retained detail and photographic evidence it would be worth considering restoration as a cohesive group.</p> <ul style="list-style-type: none"> • Remove later shopfront and reinstate the original shopfront based on the photographic evidence. • Remove signage and reinstate the cornice, fascia, pilasters and console bracket (as early 1900's photo with retained console bracket to No 151 used as a template).

- Remove paint from brickwork, stone lintels and cills. Repair and repoint brickwork as required.
- Remove pantile roof and replace with slate.
- Reinststate the timber gutter and decorative support brackets (as retained at No 155).
- Replace PVC downpipes with cast iron.
- Remove the uPVC windows to first floor level and replace with new timber framed sash windows (as 147).
- Consistent colour scheme to lintels, gutter and eaves supports to the group to form a visually cohesive group.

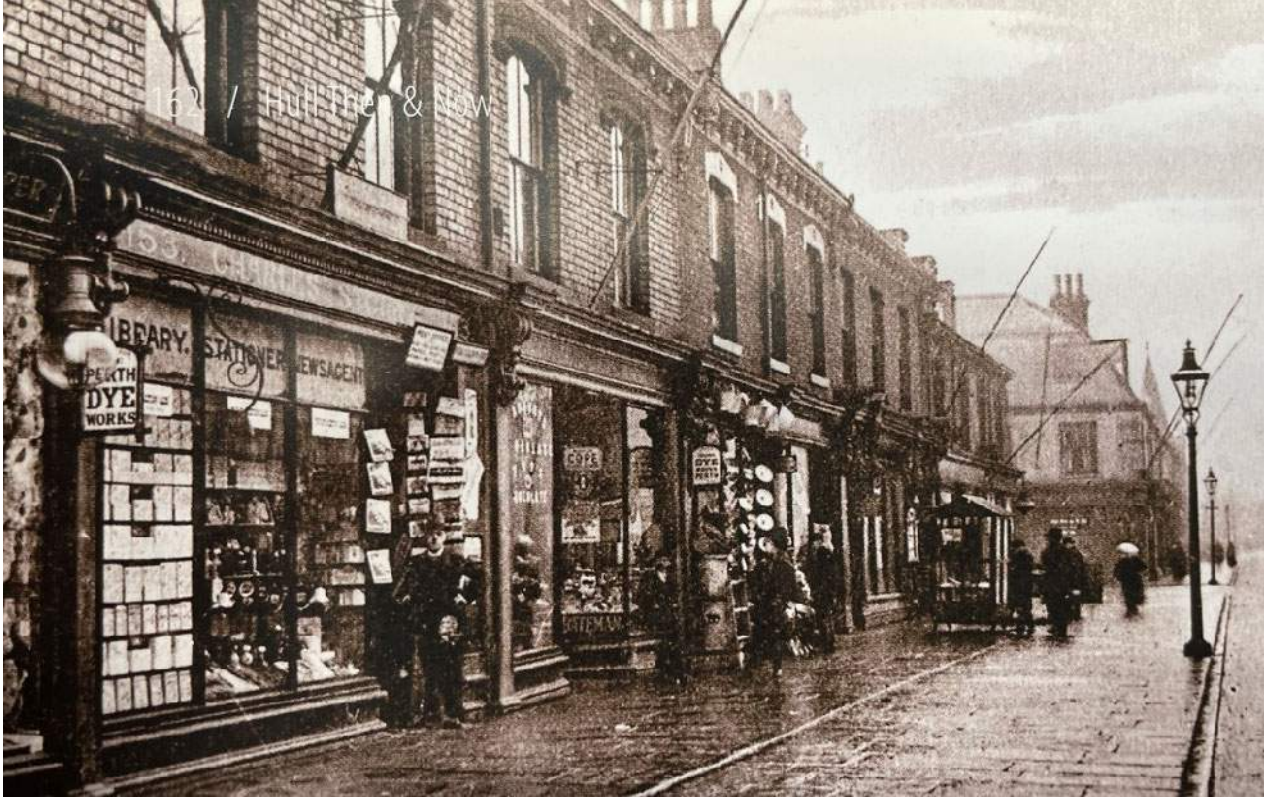
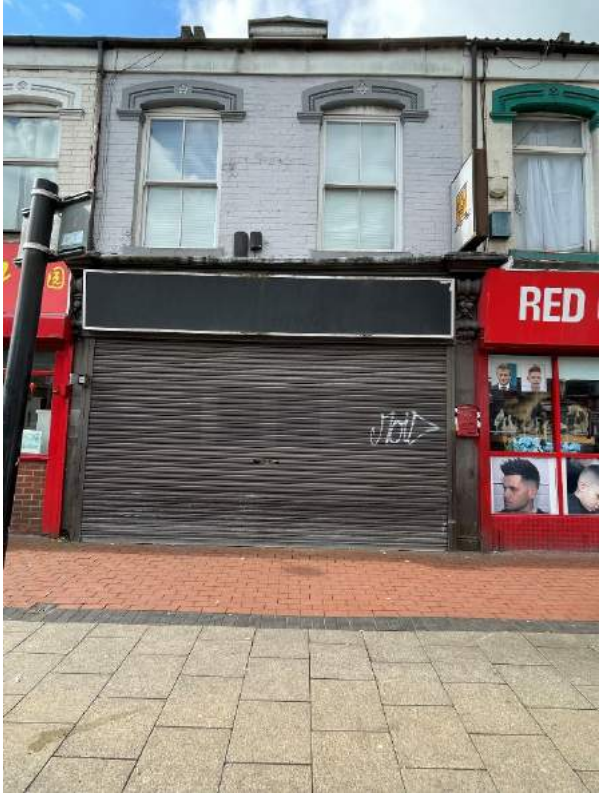
Street:	Spring Bank	Address	Vacant, 151
Historic Photo from 1903 (Hull Then and Now 1, Paul Gibson)		Current Photo – 11/05/2023 (author)

Building Notes	<p>Built between 1856-1893, No 151 forms part of a group of 5 buildings along with the adjacent 147, 149, 153 and 155 Spring Bank. The group appears to have been built prior to the adjacent terrace 143 and 145. The group is clearly distinguished by the highly decorative stone carved lintels to the first floor windows which form a curved head to the window. The units within the group generally comprise of a two bay arrangement, however, No 147 comprises of three bays.No . No 151 comprises of two bays.</p> <p>The external walls to 151 Spring Bank were of buff brickwork with slate roof finish and highly decorative timber gutters with decorative support brackets. Cast iron rainwater pipes were located</p>

between every other unit. The historical photograph shows the highly decorative vertical fascia with a deep cornice detail, decorative corbel brackets and pilasters. The original timber shopfronts have a carved stone stall riser with a curved profile that is consistent across all units. The shopfronts varied with some having a left or right hand side recessed door and some with a centrally positioned recessed door. Shopfronts had vertical mullions to reduce the size of the glass and to create an elegant vertical emphasis. Some shopfronts had fanlights at the top of the shopfront used for additional signage. The original windows to first floor level were vertical sliding sash with a central bead.

Today, the building has retained some of the original features including the decorative stone arched lintels. The buff brickwork has been painted grey along with the highly decorative stone window lintels which is painted dark grey. The contrasting colours do at least emphasise the decorative lintels from the wider elevation. The first floor windows have been replaced with uPVC double glazed windows with proportions that reflect the proportions of the original windows. A large fascia sign has been installed which extends up and conceals the stone cills to the windows above. The shop front has retained details including the pilasters, console brackets, deep cornice and fascia which are in good condition and could be used as a template to reinstate the shopfronts to the wider group. The slate roof finish has been removed and replaced with concrete pantiles with a dormer window retained (albeit with uPVC windows) and the timber gutter and support brackets have been removed and replaced with PVC. The original shopfront has been removed and replaced with a new metal framed shopfront with brick stall riser and central double doors.

Building has been relatively well maintained with historic details retained. No immediate risk action items identified.
Recommended Actions	<p>As a group of five buildings with 147, 151, 153 and 155 Spring Bank and with sufficient retained detail and photographic evidence it would be worth considering restoration as a cohesive group.</p> <ul style="list-style-type: none"> • Remove later shopfront and reinstate the original shopfront based on the photographic evidence. • Remove signage and repair the retained cornice, fascia, pilasters and console brackets. Reinstall the missing pilasters. • Remove paint from brickwork, stone lintels and cills. Repair and repoint brickwork as required. • Remove pantile roof and replace with slate. • Reinstall the timber gutter and decorative support brackets (as retained at No 155). • Replace PVC downpipes with cast iron. • Remove the uPVC windows to first floor level and replace with new timber framed sash windows (as 147). • Consistent colour scheme to lintels, gutter and eaves supports to the group to form a visually cohesive group.

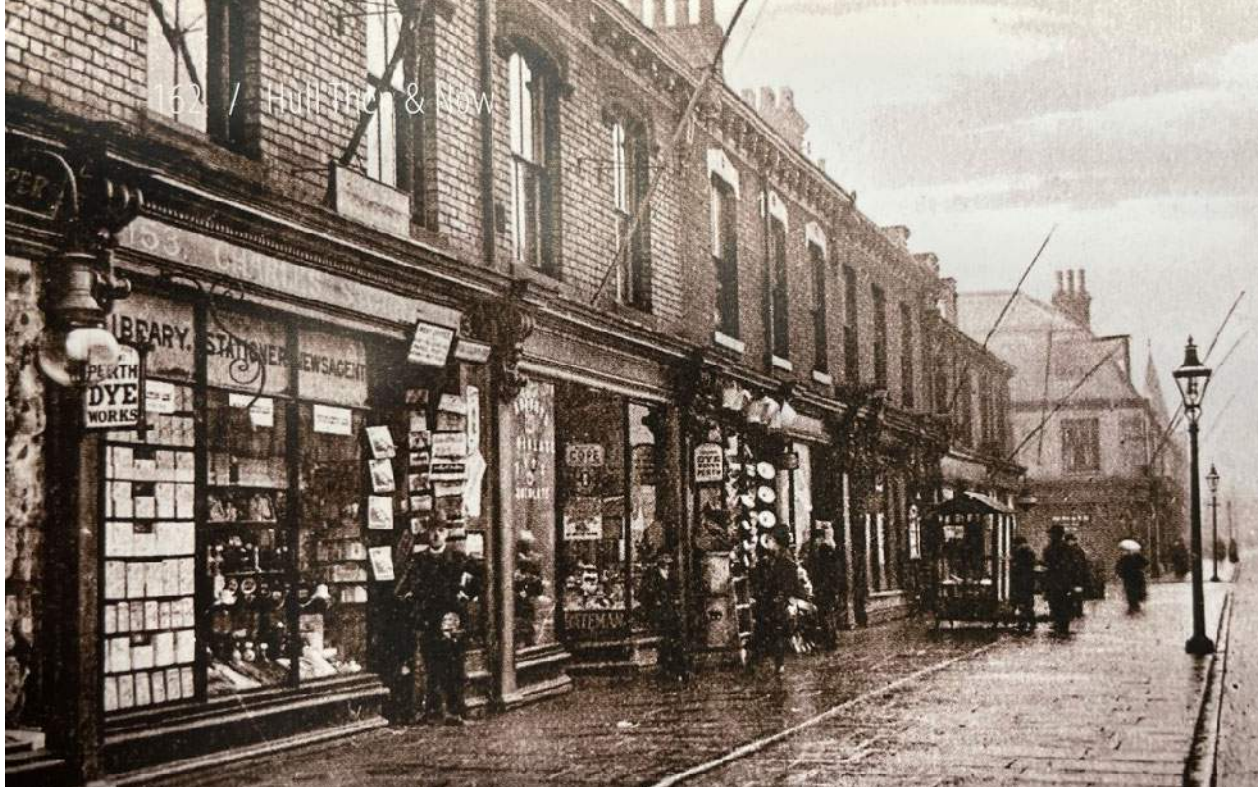
Street:	Spring Bank	Address	Red One Barbers, 153
Historic Photo from 1903 (Hull Then and Now 1, Paul Gibson)		Current Photo – 11/05/2023 (author)

Building Notes	<p>Built between 1856-1893, No 153 forms part of a group of 5 buildings along with the adjacent 147, 149, 151 and 155 Spring Bank. The group appears to have been built prior to the adjacent terrace 143 and 145. The group is clearly distinguished by the highly decorative stone carved lintels to the first floor windows which form a curved head to the window. The units within the group generally comprise of a two bay arrangement, however, No 147 comprises of three bays. No. 153 comprises of two bays.</p> <p>The external walls to 153 Spring Bank were of buff brickwork with slate roof finish and highly decorative timber gutters with decorative timber support brackets. Cast iron rainwater pipes were</p>

<p>located between every other unit. The historical photograph shows the highly decorative vertical fascia with a deep cornice detail, decorative corbel brackets and pilasters. The original timber shopfronts have a carved stone stall riser with a curved profile that is consistent across all units. The shopfronts varied with some having a left or right hand side recessed door and some with a centrally positioned recessed door. Shopfronts had vertical mullions to reduce the size of the glass and to create an elegant vertical emphasis. Some shopfronts had fanlights at the top of the shopfront used for additional signage. The original windows to first floor level were vertical sliding sash with a central bead.</p> <p>Today, the building has retained some of the original features including the decorative stone arched lintels. The buff brickwork has been painted white along with the highly decorative stone window lintels which are painted dark green. The contrasting colours do at least emphasise the decorative lintels from the wider elevation. The first floor windows have been replaced with uPVC double glazed windows with proportions that do not reflect the proportions of the original windows. A large fascia sign has been installed which may have retained cornice and fascia details behind. The shop front has lost details including the pilasters, console brackets, deep cornice and fascia although these are retained on other buildings within the group which could be used as a template to reinstate the shopfronts to the wider group. The slate roof finish has been removed and replaced with concrete pantiles with a rooflight installed and the timber gutter and support brackets have been removed and replaced with PVC. The original shopfront has been removed and replaced with a new metal framed shopfront with a metal infill panel stall riser and central single door.</p> <p>The building has been subject to a number of planning applications. In 2001 an application to install an ATM was submitted (Ref No : 01/01397/PF) – status unknown. In 2004 an application to install an external steel staircase to the rear and install velux rooflights to replace the front and rear dormers was submitted and approved (Ref No: 04/01147/FUL).</p>

Monitoring Notes	<p>May have retained the original cornice and fascia behind the existing sign. No works should be permitted that involve the removal of any elements behind the sign without consultation. Building has been relatively well maintained. No immediate risk action items identified.</p>
Recommended Actions	<p>As a group of five buildings with 147, 149, 151 and 155 Spring Bank and with sufficient retained detail and photographic evidence it would be worth considering restoration as a cohesive group.</p>

- Remove later shopfront and reinstate the original shopfront based on the photographic evidence.
- Remove signage and repair the cornice, fascia, pilasters and console brackets based on the retained details at No 151.
- Remove signage to first floor level.
- Remove paint from brickwork, stone lintels and cills. Repair and repoint brickwork as required.
- Remove pantile roof and replace with slate.
- Reinstall the timber gutter and decorative support brackets (as retained at No 155).
- Replace PVC downpipes with cast iron.
- Remove the uPVC windows to first floor level and replace with new timber framed sash windows (as 147).
- Consistent colour scheme to lintels, gutter and eaves supports to the group to form a visually cohesive group.

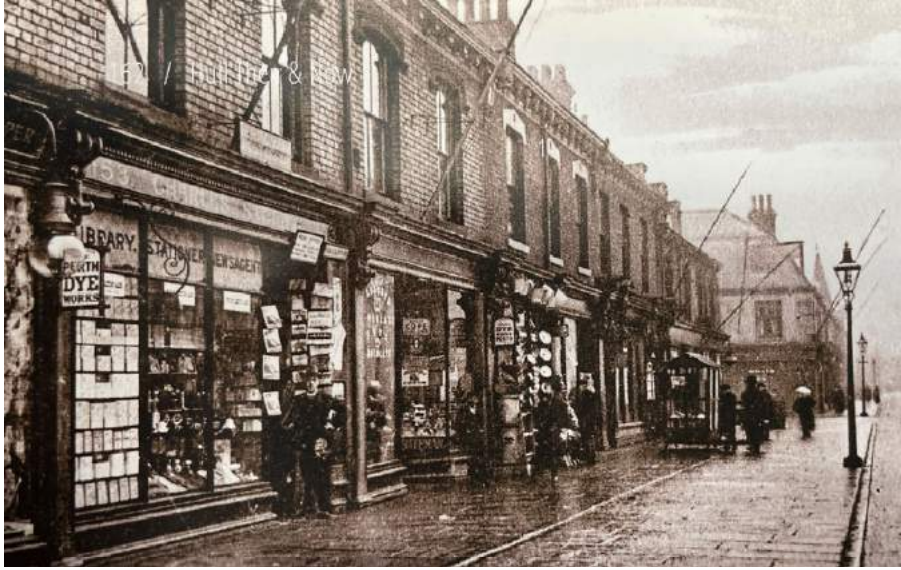
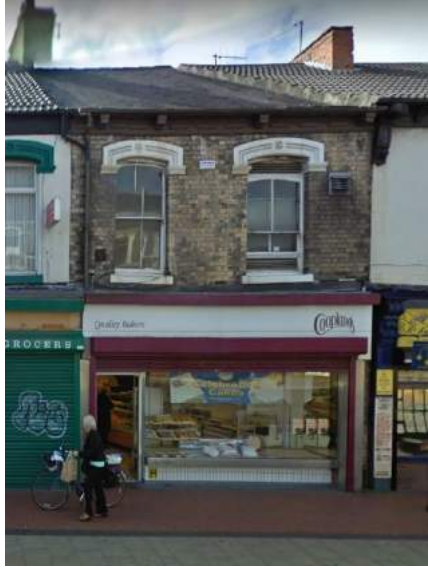
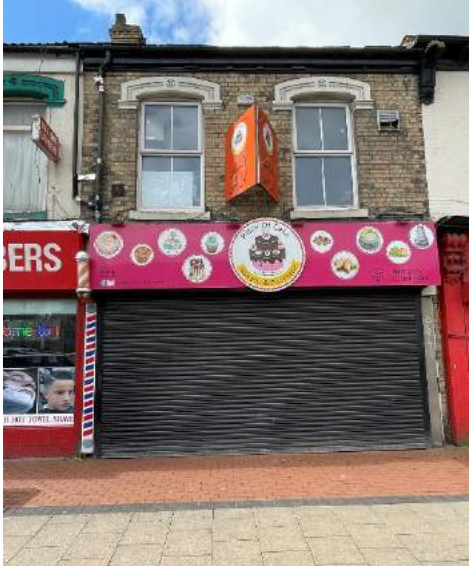
Street:	Spring Bank		Address	Piece of Cake, 155	
Historic Photo from 1903 (Hull Then and Now 1, Paul Gibson)		Historic Photo from 2015 (Google maps)		Current Photo – 11/05/2023 (author)

Building Notes		<p>Built between 1856-1893, No 155 forms part of a group of 5 buildings along with the adjacent 147, 149, 151 and 153 Spring Bank. The group appears to have been built prior to the adjacent terrace 143 and 145. The group is clearly distinguished by the highly decorative stone carved lintels to the first floor windows which form a curved head to the window. The units within the group generally comprise of a two bay arrangement, however, No 147 comprises of three bays. No. 155 comprises of two bays.</p> <p>The external walls to 155 Spring Bank were of buff brickwork with slate roof finish and highly decorative timber gutters with decorative timber support brackets. Cast iron rainwater pipes were located between every other unit. The historical photograph shows the highly decorative vertical fascia with a deep cornice detail, decorative corbel brackets and pilasters. The original timber shopfronts have a carved stone stall riser with a curved profile that is consistent across all units. The shopfronts varied, with some having a left or</p>

<p>right hand side recessed door and some with a centrally positioned recessed door. Shopfronts had vertical mullions to reduce the size of the glass and to create an elegant vertical emphasis. Some shopfronts had transom lights at the top of the shopfront used for additional signage. The original windows to first floor level were vertical sliding sash with a central bead.</p> <p>Today, the building has retained some of the original features including the decorative stone arched lintels. The buff brickwork has not been painted unlike all other buildings within the group which emphasises the texture and detail of the curved lintels. The first floor windows have been replaced with uPVC double glazed windows with proportions that do reflect the proportions of the original windows but are casement windows. A large fascia sign has been installed which may have retained cornice and fascia details behind. The shop front has lost details including the pilasters, console brackets, deep cornice and fascia, although these are retained on other buildings within the group which could be used as a template to reinstate the shopfronts to the wider group. The slate roof finish has been retained but the original dormer windows have been removed and replaced with rooflights. The timber gutter and support brackets have been removed and replaced with PVC gutter and downpipe. The original shopfront has been removed and replaced with a new metal framed shopfront with a tiled stall riser and single door to the LHS of the shopfront.</p> <p>There are no planning applications on record for this property.</p>

Monitoring Notes	<p>May have retained the original cornice and fascia behind the existing sign. No works should be permitted that involve the removal of any elements behind the sign without consultation.</p> <p>Building has been relatively well maintained. No immediate risk action items identified.</p>
Recommended Actions	<p>As a group of five buildings with 147, 149, 151 and 153 Spring Bank and with sufficient retained detail and photographic evidence it would be worth considering restoration as a cohesive group.</p> <ul style="list-style-type: none"> Remove later shopfront and reinstate the original shopfront based on the photographic evidence.

- Remove signage and repair the cornice, fascia, pilasters and console brackets based on the retained details at No 151.
- Remove signage to first floor level.
- Repair and repoint the brickwork.
- Remove pantile roof and replace with slate.
- Reinststate the timber gutter and decorative support brackets (as retained at No 155).
- Replace PVC downpipes with cast iron.
- Remove the uPVC windows to first floor level and replace with new timber framed sash windows (as 147).

Consistent colour scheme to lintels, gutter and eaves supports to the group to form a visually cohesive group.

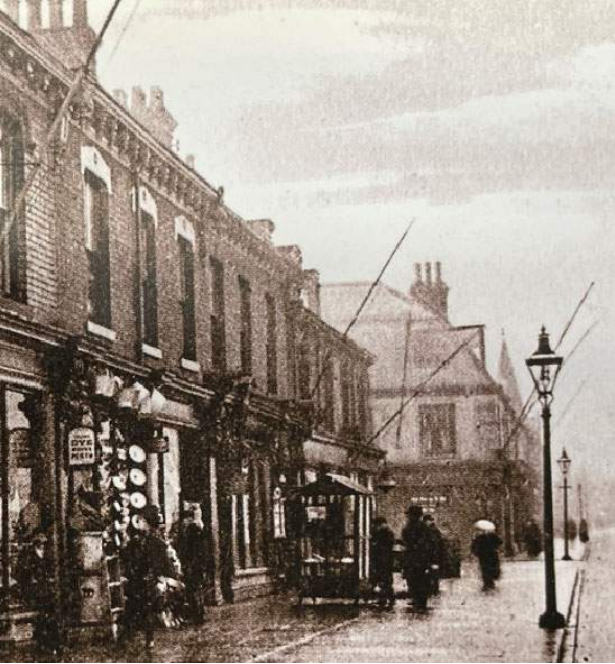
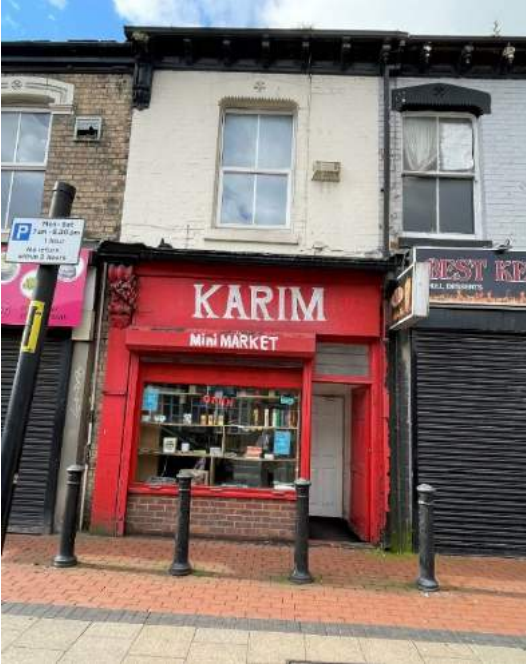
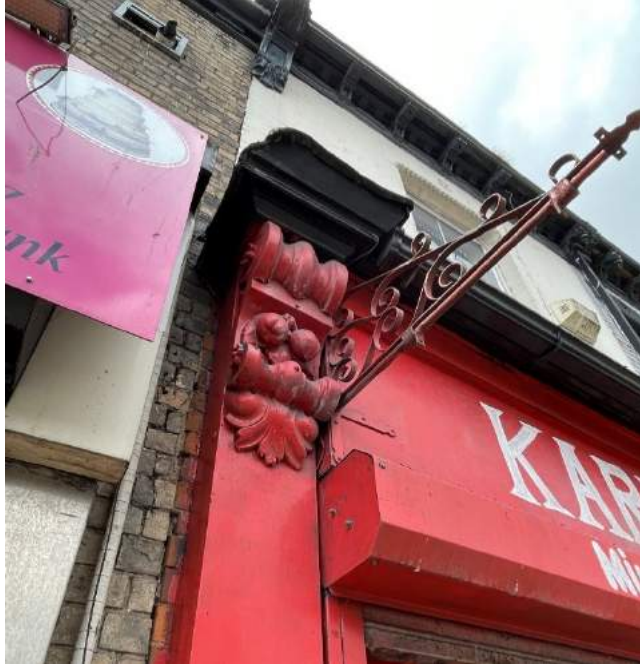
Street:	Spring Bank	Address	Karim Mini Market, 157
Historic Photo from 1903 (Hull Then and Now 1, Paul Gibson)	Current Photo – 11/05/2023 (author)		Current Photo – 11/05/2023 (author)

Building Notes	<p>Built between 1856-1893, No 157 forms part of a group of buildings along with the adjacent 157, 159, 161 and 163 Spring Bank. The group is clearly distinguished by the highly decorative stone carved lintels to the first floor windows with a decorative rosette in the centre and cut detail to the bottom edge. The decorative brackets at eaves level would suggest that the group originally comprised of two buildings of three bays. In more recent years, however, the LHS building is split into 157 and 159 Spring Bank with 157 being a single bay wide and 159 being two bays wide. This is demonstrated in the photograph from 1903.</p> <p>The external walls are a red brickwork finish with timber sliding sash windows with a vertical bead centrally on each sash. A decorative bracket is located to the LHS of the unit at eaves level and the</p>

<p>gutter comprises of a timber gutter with decorative eaves brackets to support the gutter. The roof finish was originally a slate tile finish.</p> <p>The 1903 photograph shows the highly decorative large scale scroll details to the console bracket above the pilaster, the original shopfront and a stone carved stall riser.</p> <p>Today the building has retained some of the original details. One of the original console brackets has been retained to the LHS of the shopfront. The original cornice also appears to be retained although it is partially concealed by the later addition fascia. The decorative stone lintels are still retained. The red brick walls have been painted cream along with the decorative stone lintel. The prominence of the stone lintel has been lost due the lack of contrast between the brickwork and the lintel. The original decorative timber gutter and eaves brackets have been retained and in good condition. The timber windows have been removed and replaced with new uPVC casement windows although the adjacent No 159 has retained its sliding sash windows which can be used as a template for replacement of No 157. The slate roof tiles have been removed and replaced with concrete pantiles. PVC rainwater downpipes have been installed to replace the cast iron downpipes. External metal roller shutter installed</p> <p>Planning applications submitted relate to the construction of semi -detached dwellings to the rear of the site which was refused (Ref No 16/01731/FULL).</p>

Monitoring Notes	<p>No works to removed the retained historic console bracket and the timber gutter, decorative supports and brackets should be permitted.</p> <p>Building in reasonable condition with no immediate risk items identified.</p>
Recommended Actions	<p>As a group of two three bay buildings with 157, 159, 161 and 163 Spring Bank and with sufficient retained detail and photographic evidence, it would be worth considering restoration as a cohesive group.</p> <ul style="list-style-type: none"> • Remove paint to first floor red brickwork, repair brickwork and repoint. • Remove existing shopfront and reinstate original details including based on photographic records and retained details within the group. • Retain, restore and replicate the retained console bracket and use as a template to reinstate the console bracket to the other units within the group. • Retain, repair and redecorate the timber gutter detail decorative supports and decorative brackets to a consistent colour within the group. • Remove PVC rainwater goods and replace with cast iron.

- Replace uPVC window to first floor with timber sliding sash to match No 159.
- Remove concrete pantile roof finish and replace with slate.
