**Spring Bank Conservation Area
Management Plan (South side)**
Draft for Review

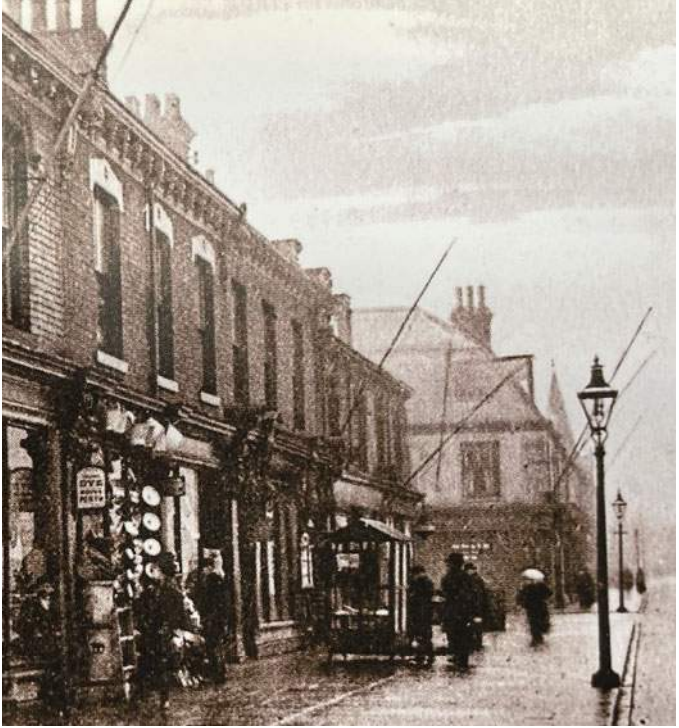
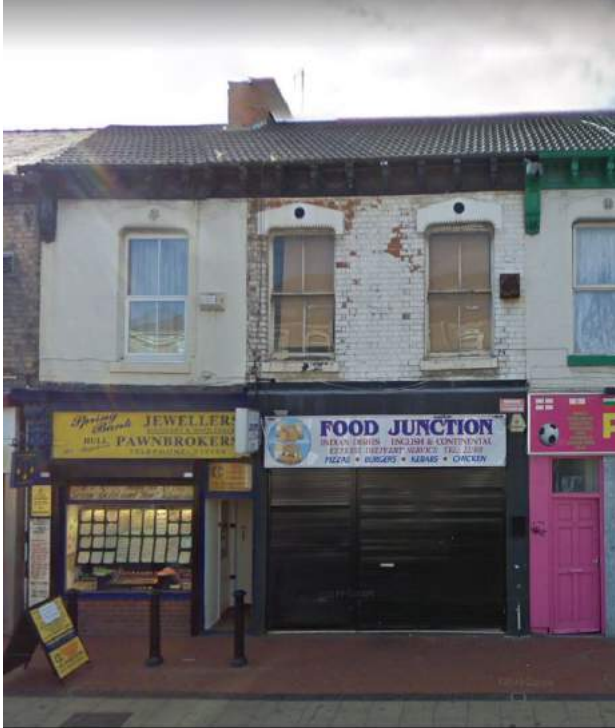
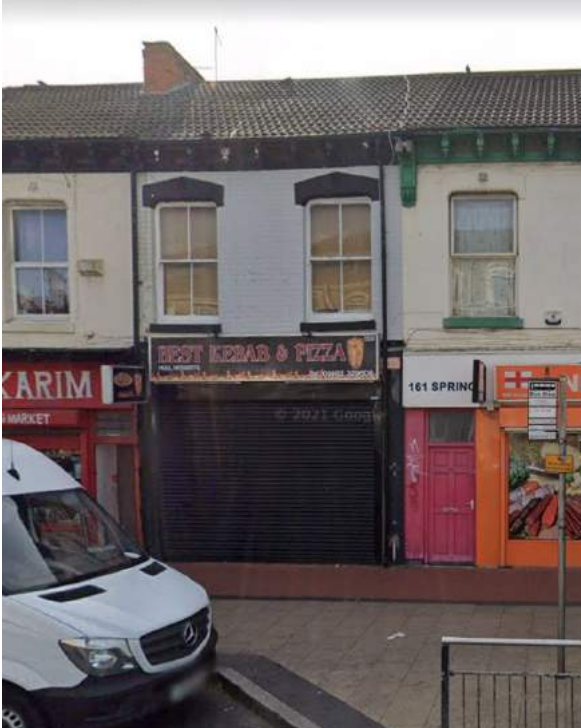
Street:	Spring Bank	Address	Nasza Biedronka, 159
Historic Photo from 1903 (Hull Then and Now 1, Paul Gibson)	Historic Photo from 2009 (Google maps)	Current Photo – 11/05/2023 (author)

Building Notes	<p>Built between 1856-1893, No 159 forms part of a group of buildings along with the adjacent 157, 161 and 163 Spring Bank. The group is clearly distinguished by the highly decorative stone carved lintels to the first floor windows with a decorative rosette in the centre and cut detail to the bottom edge. The decorative brackets at eaves level would suggest that the group originally comprised of two buildings of three bays. In more recent years, however, the LHS building is split into 157 and 159 Spring Bank with 157 being a single bay wide and 159 being two bays wide. This is demonstrated in the photograph from 1903.</p> <p>The external walls are a red brickwork finish with timber sliding sash windows with a vertical bead centrally on each sash. A decorative bracket is located to the RHS of the unit at eaves level and the gutter</p>

comprises of a timber gutter with decorative eaves brackets to support the gutter. The roof finish was originally a slate tile finish.

Today the building has retained some of the original details. The original console brackets have been removed from No 161 but one has been retained to the adjacent No 159. The original cornice may be retained in part but concealed by the later addition sign. The decorative stone lintels to the first floor windows are still retained. The red brick walls have been painted grey along with the decorative stone lintel. The original decorative timber gutter and eaves brackets have been retained and in reasonable condition. The timber sliding sash windows have been retained to No 159 and can be used as a template for replacement of No 157, 161 and 163. The slate roof tiles have been removed and replaced with concrete pantiles. PVC rainwater downpipes have been installed to replace the cast iron downpipes. External metal roller shutter installed

Monitoring Notes No works to remove the retained timber gutter, decorative supports and brackets should be permitted. Building in reasonable condition with no immediate risk items identified.

Recommended Actions **As a group of two three bay buildings with 157, 161 and 163 Spring Bank and with sufficient retained detail and photographic evidence, it would be worth considering restoration as a cohesive group.**

- Remove paint to first floor red brickwork, repair brickwork and repoint.
- Remove existing shopfront and reinstate original details including based on photographic records and retained details within the group.
- Reinstall the corbel brackets based on the retained console bracket to No 157.
- Retain, repair and redecorate the timber gutter detail decorative supports and decorative brackets to a consistent colour within the group.
- Remove PVC rainwater goods and replace with cast iron.
- Repair and redecorate retained timber sash window to first floor.
- Remove concrete pantile roof finish and replace with slate.

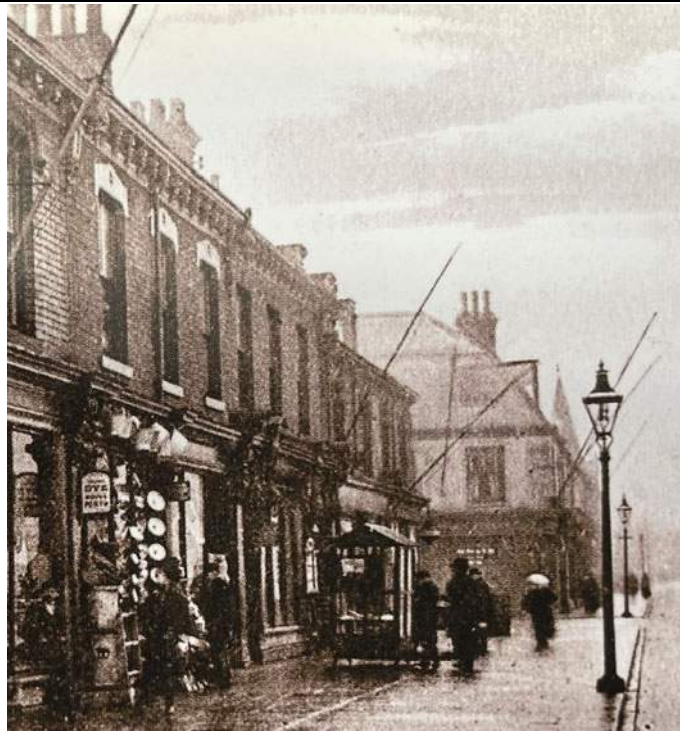
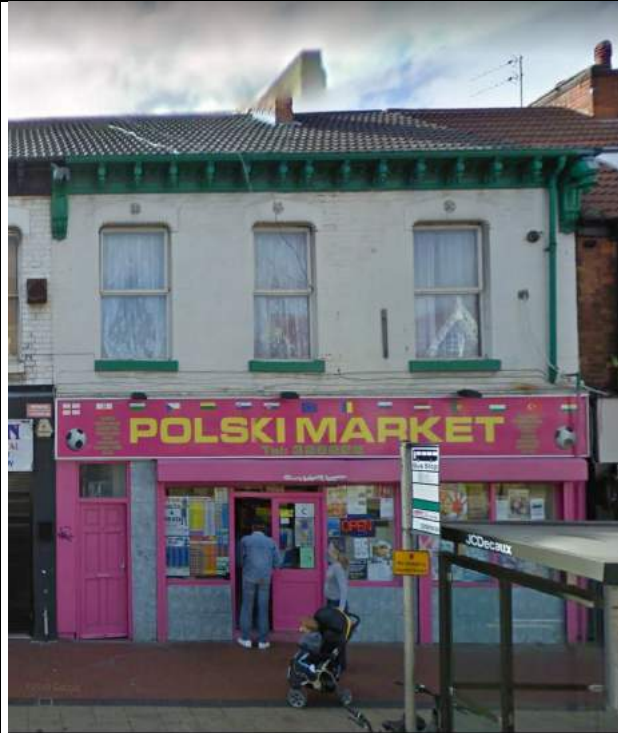
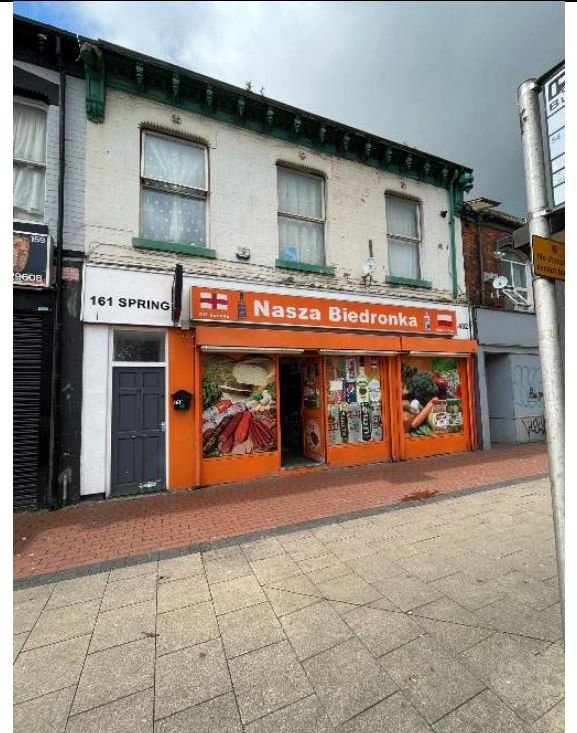
Built between 1856-1893, No 161 and 163 forms part of a group of buildings along with the adjacent 157 and 159 Spring Bank. The group is clearly distinguished by the highly decorative stone carved lintels to the first floor windows with a decorative rosette in the centre and cut detail to the bottom edge. The decorative brackets at eaves level would suggest that the group originally comprised of two buildings of three bays. In more recent years, however, the LHS building is split into 157 and 159 Spring Bank with 157 being a single bay wide and 159 being two bays wide. This is demonstrated in the photograph from 1903.

Monitoring Notes	<p>No works to remove the retained timber gutter, decorative supports and brackets should be permitted. Building in reasonable condition with no immediate risk items identified.</p>
Recommended Actions	<p>As a group of two three bay buildings with 157, 161 and 163 Spring Bank and with sufficient retained detail and photographic evidence, it would be worth considering restoration as a cohesive group.</p> <ul style="list-style-type: none"> • Remove paint to first floor red brickwork, repair brickwork and repoint. • Redecorate lintels. • Remove existing shopfront and reinstate original details including console bracket, pilasters, stall riser and fascia based on photographic records and retained details within the group. • Reinstall the console brackets based on the retained console bracket to No 157. • Retain, repair and redecorate the timber gutter detail decorative supports and decorative brackets to a consistent colour within the group. • Remove PVC rainwater goods and replace with cast iron.

- Remove uPVC windows and replace with new timber sliding sash windows.
- Remove concrete pantile roof finish and replace with slate.

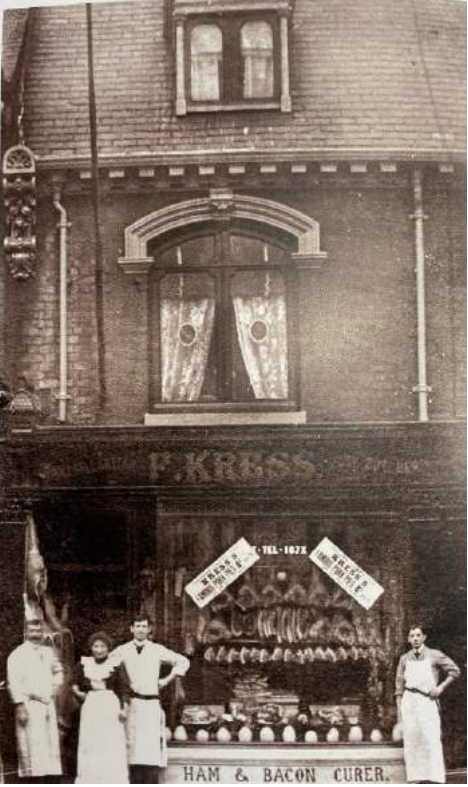
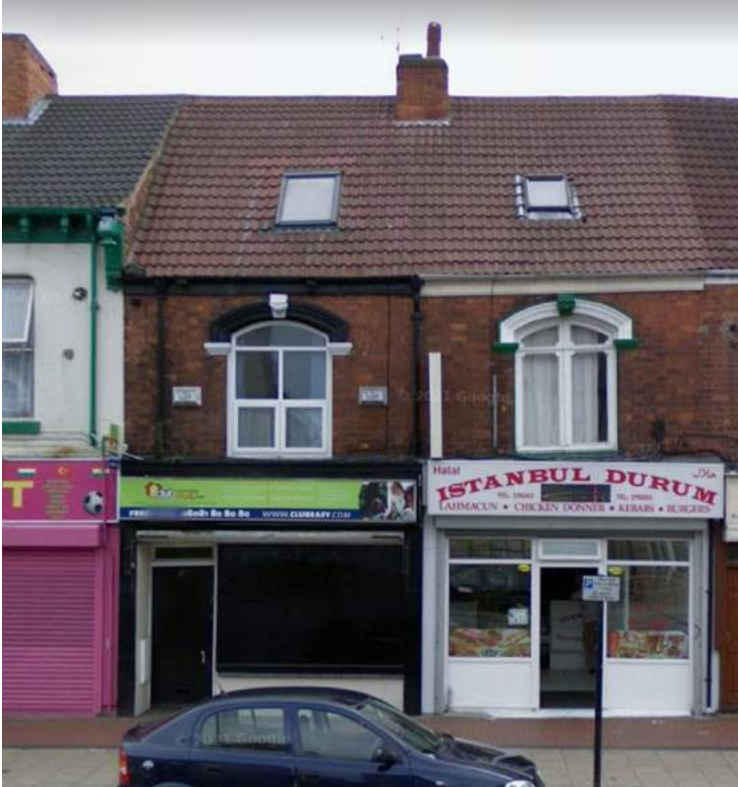
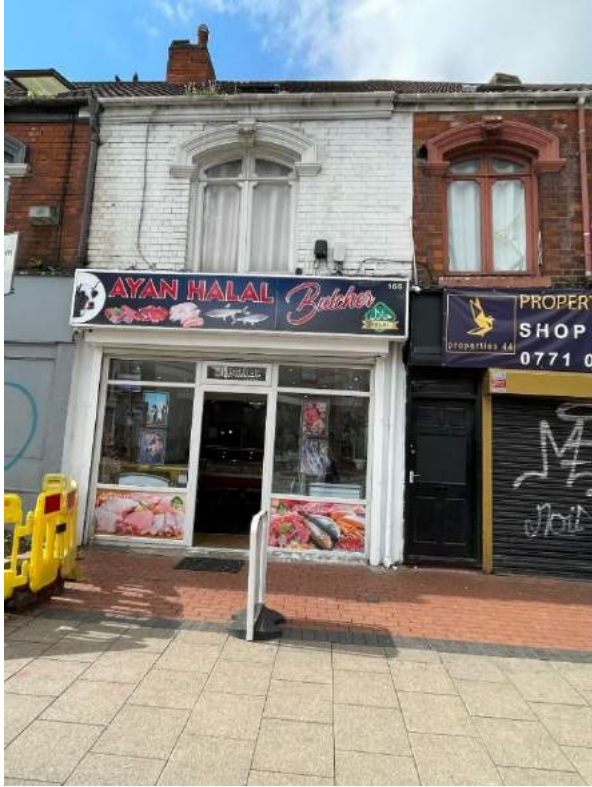
Street: Spring Bank	Address	Vacant/Ayan Halal Butchers, 165
Historic Photo from 1905 (Hull Then and Now 1, Paul Gibson)	Historic Photo from 2008 (Google maps)	Current Photo – 11/05/2023 (author)

Building Notes	<p>Built between 1856-1893, No 165 forms part of a group of buildings along with the adjacent 167 Spring Bank. The group is clearly distinguished by the highly decorative arched stone lintels with the central swag detail to the first floor windows and the distinctive timber casement windows.</p> <p>The external walls are a red brickwork finish with distinctive and unusual timber casement windows. A decorative console bracket is located to the RHS of the unit at eaves level in the 1905 photo and the gutter comprises of a timber gutter with decorative eaves brackets to support the gutter. The roof finish was originally a slate tile finish. A dormer window was located above each bay.</p>

<p>The 1904 photograph shows highly decorative console bracket above the pilaster, the original shopfront, fascia, cornice and timber stall riser. The entrance door is positioned to the LHS of the shopfront.</p> <p>Today the building has retained some of the original details. The original console brackets have unfortunately been removed from 165 and the adjacent 167. The original cornice may be retained in part but concealed by the later addition sign. The decorative stone arched lintels to the first floor windows are still retained. The red brick walls have been painted white to the LHS bay along with the decorative stone lintel which loses the impact of the decorative detail. The original decorative timber gutter and eaves brackets have been removed and PVC rainwater goods fitted. The timber casement windows have been removed and replaced with uPVC to the LHS unit but retained to the RHS bay. The slate roof tiles have been removed along with the dormer window and the roof finish replaced with concrete pantiles. PVC rainwater downpipes have been installed to replace the cast iron downpipes. External metal roller shutter installed.</p> <p>A planning application has been submitted in 2006 for the change of use from retail (A1) to hot food takeaway (A5).</p>

Monitoring Notes	The removal of the remaining timber casement windows should not be permitted.
Recommended Actions	<p>As a group of two three bay buildings with 167 Spring Bank and with sufficient retained detail and photographic evidence, it would be worth considering restoration as a cohesive group.</p> <ul style="list-style-type: none"> • Remove paint to first floor red brickwork to RHS bay. Repair brickwork and repoint. • Redecorate lintels. • Remove existing shopfront and reinstate original details including console bracket, pilasters, stall riser and fascia based on photographic records and retained details within the group. • Reinstall the console brackets based on the photographic evidence. • Reinstall the timber gutter detail decorative supports and decorate with a consistent colour across the group. • Remove PVC rainwater goods and replace with cast iron. • Remove uPVC window to LHS bay and replace with new timber casement windows to match original (see adjacent bay). • Remove concrete pantile roof finish and replace with slate. Reinstall dormer window.

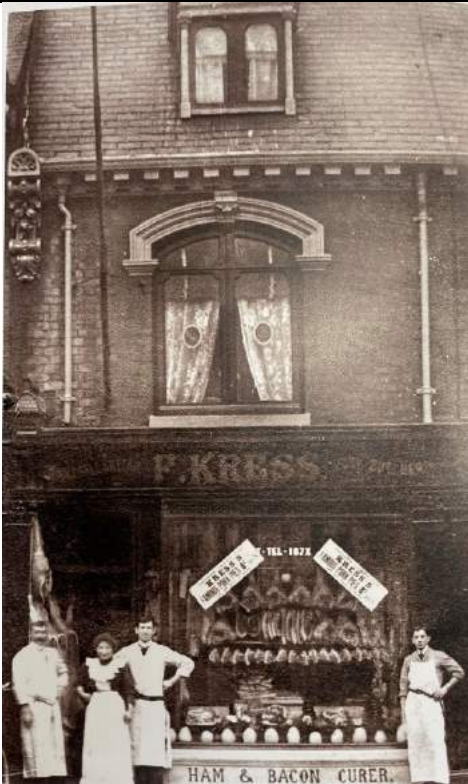
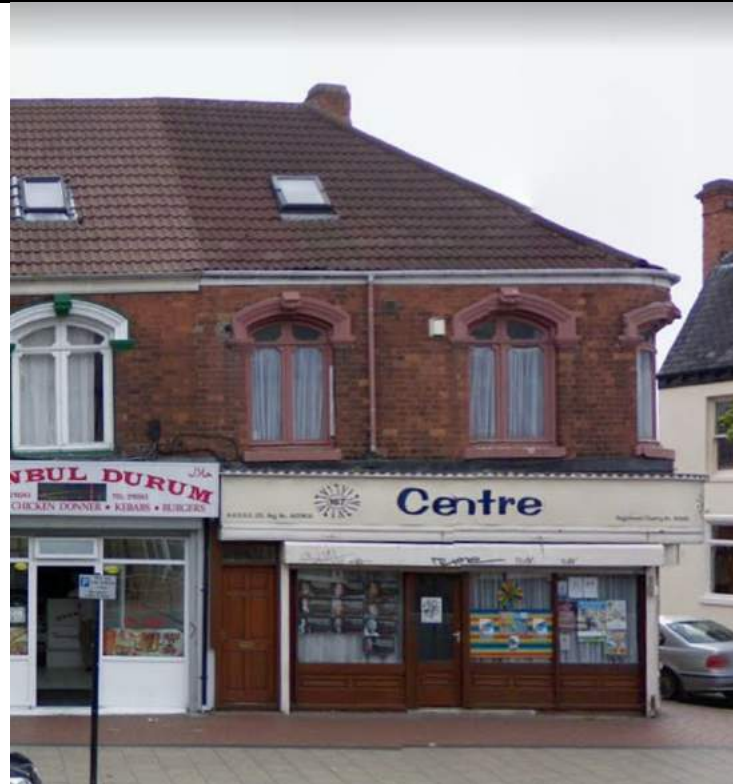
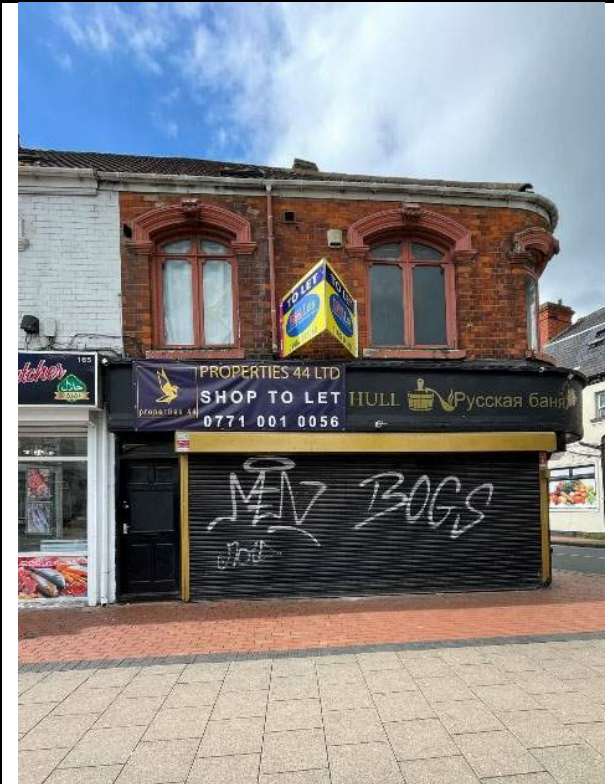
Built between 1856-1893, No 165 forms part of a group of buildings along with the adjacent 167 Spring Bank. The group is clearly distinguished by the highly decorative arched stone lintels with the central swag detail to the first floor windows and the distinctive timber casement windows.

Monitoring Notes	The removal of the remaining timber casement windows should not be permitted.
Recommended Actions	<p>As a group of two three bay buildings with 165 Spring Bank and with sufficient retained detail and photographic evidence, it would be worth considering restoration as a cohesive group. This is also a key focal corner building.</p> <ul style="list-style-type: none"> • Repair brickwork and repoint. • Redecorate lintels. • Remove existing shopfront and reinstate original details including console bracket, pilasters, stall riser and fascia based on photographic records and retained details within the group. • Reinstall the console brackets based on the photographic evidence. • Reinstall the timber gutter detail decorative supports and decorate with a consistent colour across the group. • Remove PVC rainwater goods and replace with cast iron. • Remove concrete pantile roof finish and replace with slate. Reinstall dormer window. • Remove bricked up window openings to West Parade elevation and reinstate windows.

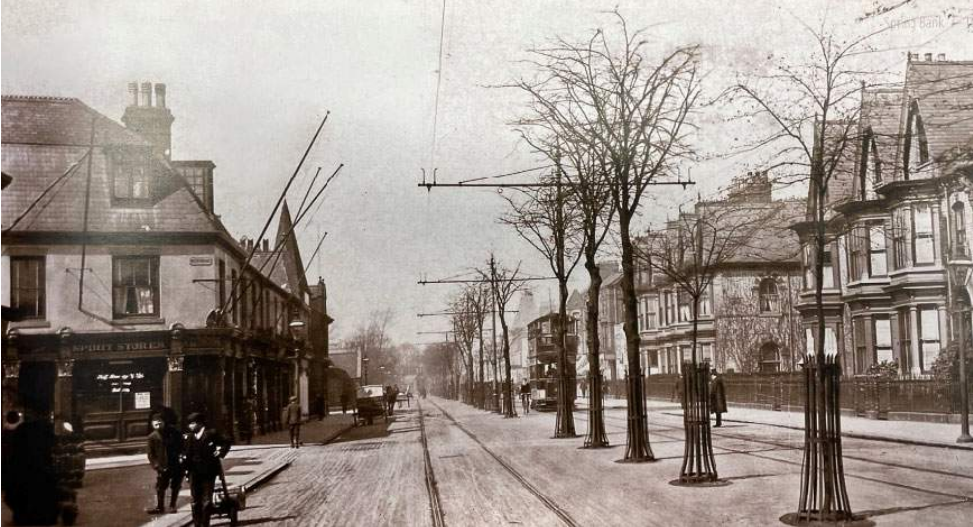
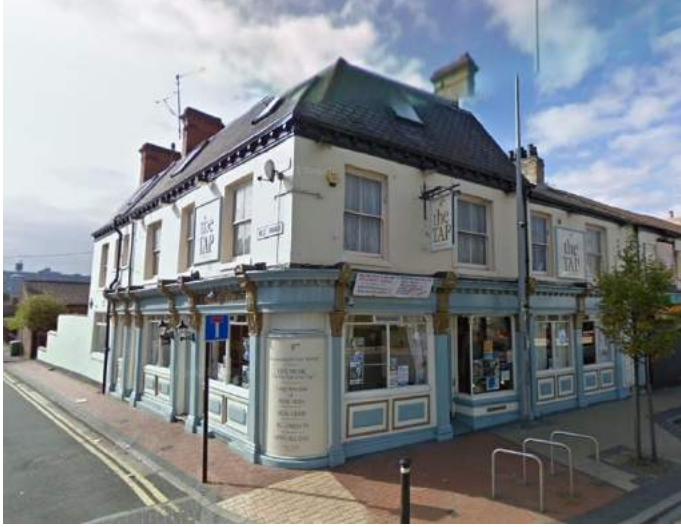
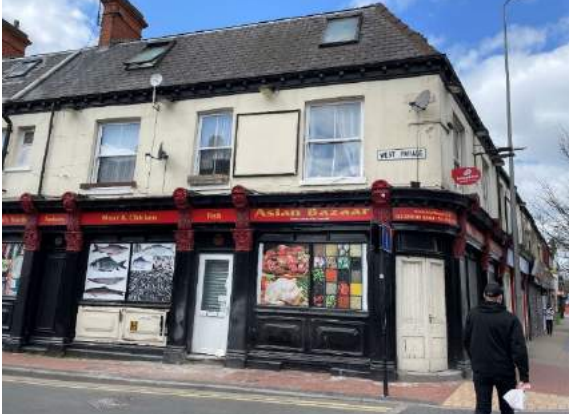
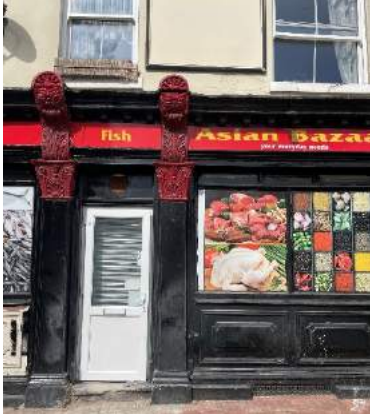
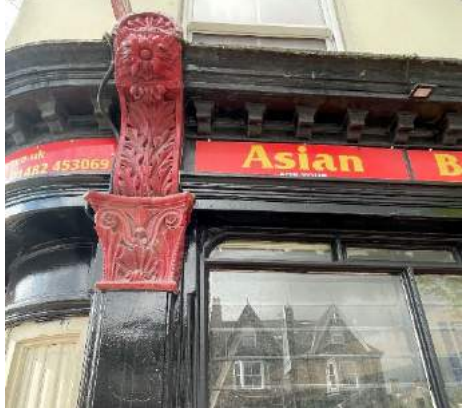
Street:	Spring Bank		Address	Asian Bazaar (formerly tap &spile/ eagle inn), 169	
Historic Photo from 1905 (Hull Then and Now 1, Paul Gibson)			Historic Photo from 2008 (Google maps)

Building Notes		The Eagle (later renamed as the Tap and Spile) public house dates from the 1830's and was, until recently, identified as a Locally Listed Building.

<p>The building has retained many of its original features including the highly decorative corbel details framing each door into the building, the decorative fascia and cornice brackets, the decorative mullions to the shopfront and the panelled stallrisers.</p> <p>When in use as the Tap and Spile,</p> <p>The building has, more recently in 2014, been converted to retail use after the demand for public houses and drinking establishments in the area reduced considerably. Since the change of use, the building has been used as a Butchers and has recently been changed again into a Barbers. Each of these changes of use have eroded the quality and character of the building through the use of unsympathetic signage and colour schemes.</p> <p>The building has been subject to a number of planning applications.</p>
<p>Monitoring Notes</p>	<p>Recent installation of signage and external lighting associated with the conversion to a Barbers Shop is detrimental to the character of the building and the Conservation Area. Any further works to remove existing features should not be permitted.</p>

<p>Recommended Actions</p>	<ul style="list-style-type: none"> • Remove the extensive signage to the external frontage and repair damage caused by works. • Redecorate using a more sympathetic colour scheme that is more muted in tone.

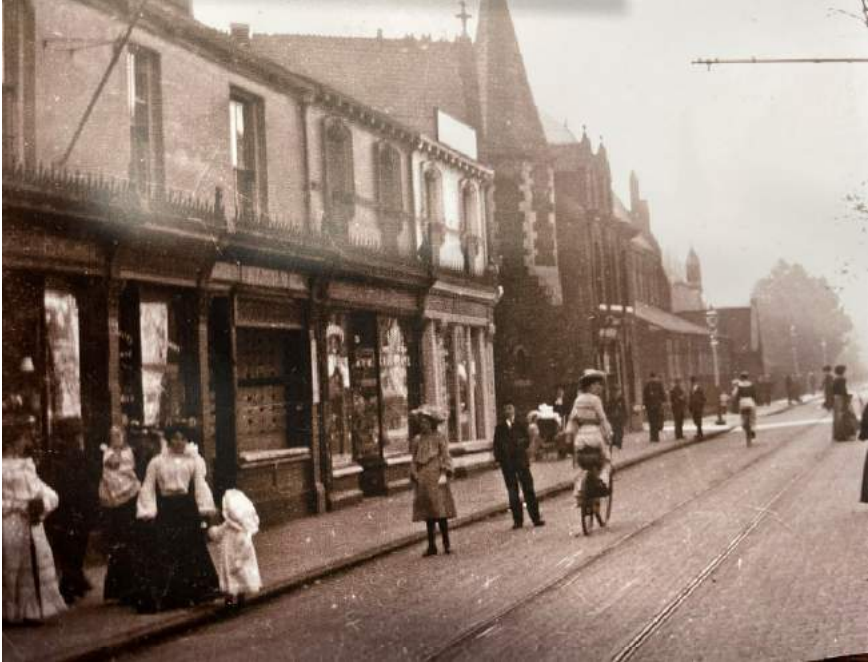
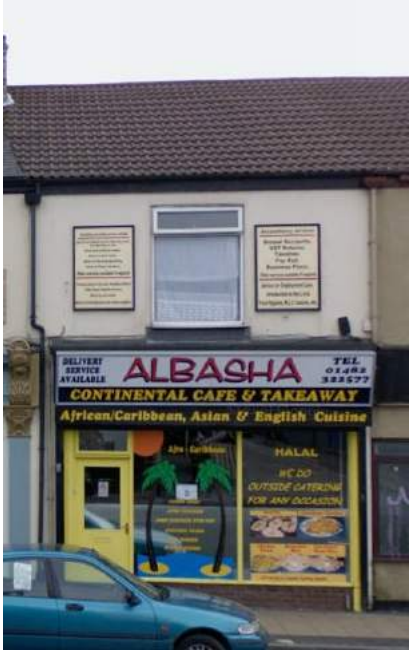
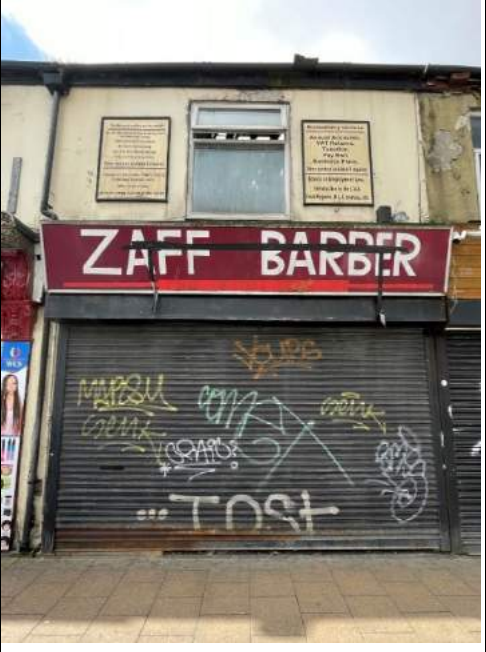
Street: Spring Bank	Address Vacant (formerly Zaff Barber), 173	
Historic Photo from 1905 (Hull Then and Now 1, Paul Gibson)	Historic Photo from 2008 (Google maps)	Current Photo – 11/05/2023 (author)

Building Notes	<p>Built between 1856-1893, No 173 forms part of a group of three buildings including No 171 and 175 adjacent. Unlike 171 and 175 adjacent that are two bays in width, No 173 is a narrow one bay building. The historical photograph dating from 1905 (with 173 at the far left) shows that the shopfront fascia, cornice and console brackets to the shopfronts to the full extent of this urban block including 171, 173, 177 and 179 had a consistent design that was a continuation of the shopfront at the Tap and Spile. This included a flat vertical fascia, deep, decorative cornice with dentil support detail to the underside of the cornice and highly decorative console brackets. The photograph also shows that the cornice was topped by decorative ironwork with decorative support brackets on the top of the console bracket. The shopfront to 173 had the entrance door to the centre of the unit with a recessed door and is likely to have had a timber panelled stall riser as No 175 in the 1905 photo. The Spring Bank elevation was rendered at the first floor level and the windows to No 171, 173 and 175 were much simpler in design detail than others in the street, with no decorative stone lintels or cills. The windows</p>

<p>were vertical sliding sash windows with a central vertical bead. The roof finish was slate with timber gutters and decorative timber support brackets at approx. 1m centres and cast iron gutters.</p> <p>The 2008 photograph shows that, by this time, the majority of the original features have been lost. The shopfront has been removed and replaced with a new timber shopfront with a low brick stall riser. The cornice, pilasters and console brackets have all been removed (although remnants may be found beneath the existing sign). The door has been relocated to the LHS and the first floor window has been replaced with a new timber window that is of a proportion that does not reflect the proportions of the original design. The roof slates have been replaced with concrete pantile roof tiles and the timber gutters and cast iron downpipes have been removed and replaced with PVC.</p> <p>Today, the building has continued to dilapidate since 2008 and was subject to a fire in 2021 that started in the adjacent No 175 which has left the building in a severe state of disrepair. The roof structure was significantly damaged by the fire and is now open to the elements with a large opening in the roof. Since the fire, no works have been undertaken to restore the damage or to protect the building from further degradation. The building requires significant investment to protect it for the future.</p> <p>INSERT PLANNING HISTORY</p>

<p>Monitoring Notes</p>	<p>Since the fire in the building in 2021, no works have been undertaken to protect the building and the building is now in a severe state of disrepair. The roof structure is exposed to the elements which has allowed continual water ingress and is likely to have destroyed the timber internal structure to the roof and floors. It is likely that the building will need to be stripped back to the external walls with all timber floor and roof structures removed due to the damage from the fire, followed by continual water ingress in order to bring the building back into use. The building is currently unsafe and is having a harmful impact on the character of the Conservation Area and causes a lack of active frontage along this section of Spring Bank.</p>
<p>Recommended Actions</p>	<p>The building is currently unsafe and requires a significant investment to bring it back into use but would benefit from a complete restoration as a group with the adjoining No 175 following the fire damage.</p> <p>The recommended actions are as follows :-</p> <ul style="list-style-type: none"> • Remove the pantile roof finish, gutters, downpipes and rooflights and assess the structural damage to the roof and floor structure for the potential to retain any of the original timber structure where possible. • Remove all debris and guano from inside the building.

- Remove the windows, shopfront and roller shutter and take back the building to its external walls.
- Assess the external walls for structural damage.
- If the render is cement based render, remove the render from the external walls.

- Repair any damage to the external brickwork, window cills and lintels and undertake any repairs/replace the Bessemer beam to the shopfront.
- Assess structural stability of the floor joists and retain if possible. If extensively damaged by fire, replace timber floor joists and install new timber floors throughout.

- Replace floor and roof structure as required.
- Reinststate roof with slate roof tiles and reinststate the timber gutter with decorative brackets and cast iron downpipes.

- Reinststate timber vertical sliding sash windows to the first floor level.
- Lime render the external elevations at first floor level.

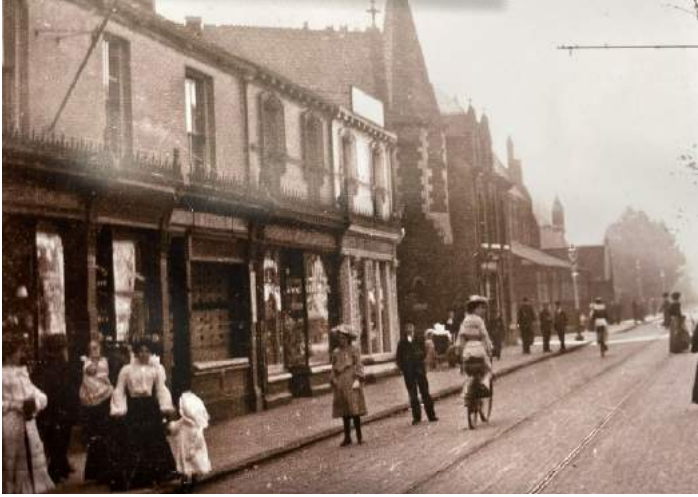
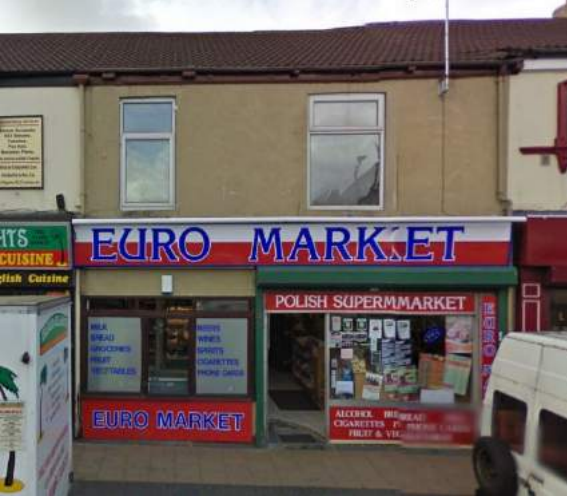
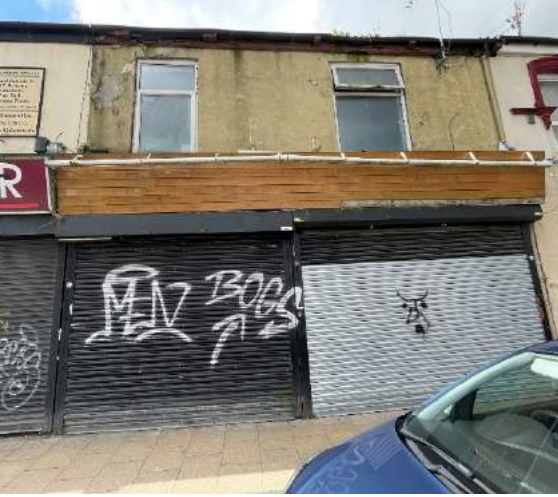
Street: Spring Bank	Address	Vacant, 175
Historic Photo from 1905 (Hull Then and Now 1, Paul Gibson)	Historic Photo from 2010 (Google maps)	Current Photo – 11/05/2023 (author)

Building Notes	<p>Built between 1856-1893, No 175 forms part of a group of three buildings including No 171 and 175 adjacent. Unlike the adjacent 173 which is one bay wide, No 175 is two bays wide. The historical photograph dating from 1905 (with 175 towards the left) shows that the shopfront fascia, cornice and console brackets to the shopfronts to the full extent of this urban block including 171, 173, 177 and 179 had a consistent design that was a continuation of the shopfront at the Tap and Spile. This included a flat vertical fascia, deep, decorative cornice with dentil support detail to the underside of the cornice and highly decorative console brackets. The photograph also shows that the cornice was topped by decorative ironwork with decorative support brackets on the top of the console bracket. The shopfront to 175 had the entrance door to the centre of the unit with a recessed door with decorative pilasters (but no console brackets) to each side of the entrance door and had a timber panelled stall riser in the 1905 photo. The Spring Bank elevation was rendered at the first floor level and the windows to No 171, 173 and 175 were much simpler in design detail than others in the street, with no decorative stone lintels or cills. The windows were vertical sliding sash windows with a central vertical bead. The roof finish was slate with timber gutters and decorative timber support brackets at approx. 1m centres and cast iron gutters.</p>

<p>The 2008 photograph shows that, by this time, the majority of the original features have been lost. The shopfront has been removed and replaced with a new metal shopfront with a low brick stall riser. The cornice, pilasters and console brackets have all been removed (although remnants may be found beneath the existing sign). The door has been relocated to the LHS and the first floor window has been replaced with a new timber window that is of a proportion that does not reflect the proportions of the original design. The roof slates have been replaced with concrete pantile roof tiles and the timber gutters and cast iron downpipes have been removed and replaced with PVC.</p> <p>Today, the building has continued to dilapidate since 2008 and was subject to a fire in 2021 that started in the Pudding Company unit in 175 which has left the building in a severe state of disrepair. The roof structure was significantly damaged by the fire and is now open to the elements with a large opening in the roof. Since the fire, no works have been undertaken to restore the damage or to protect the building from further degradation. The building requires significant investment to protect it for the future.</p> <p>INSERT PLANNING HISTORY</p>

<p>Monitoring Notes</p>	<p>Since the fire in the building in 2021, no works have been undertaken to protect the building and the building is now in a severe state of disrepair. The roof structure is exposed to the elements which has allowed continual water ingress and is likely to have destroyed the timber internal structure to the roof and floors. It is likely that the building will need to be stripped back to the external walls with all timber floor and roof structures removed due to the damage from the fire, followed by continual water ingress in order to bring the building back into use. The building is currently unsafe and is having a harmful impact on the character of the Conservation Area and causes a lack of active frontage along this section of Spring Bank.</p>
<p>Recommended Actions</p>	<p>The building is currently unsafe and requires a significant investment to bring it back into use but would benefit from a complete restoration as a group with the adjoining No 175 following the fire damage.</p> <p>The recommended actions are as follows :-</p> <ul style="list-style-type: none"> • Remove the pantile roof finish, gutters, downpipes and rooflights and assess the structural damage to the roof and floor structure for the potential to retain any of the original timber structure where possible. • Remove all debris and guano from inside the building. • Remove the windows, shopfront and roller shutter and take back the building to its external walls. • Assess the external walls for structural damage. • If the render is cement based render, remove the render from the external walls.

- Repair any damage to the external brickwork, window cills and lintels and undertake any repairs/replace the Bessemer beam to the shopfront.
- Assess structural stability of the floor joists and retain if possible. If extensively damaged by fire, replace timber floor joists and install new timber floors throughout.
- Replace floor and roof structure as required.
- Reinststate roof with slate roof tiles and reinststate the timber gutter with decorative brackets and cast iron downpipes.
- Reinststate earlier shopfront design based on historical photos and the adjacent Tap and Spile with fascia, decorative cornice, pilasters and console bracket details to match the Tap and Spile.
- Reinststate timber vertical sliding sash windows to the first floor level.
- Lime render the external elevations at first floor level.

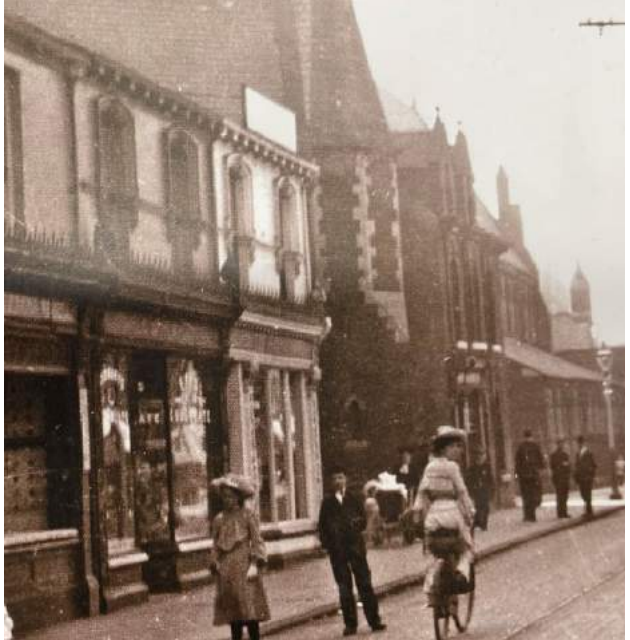
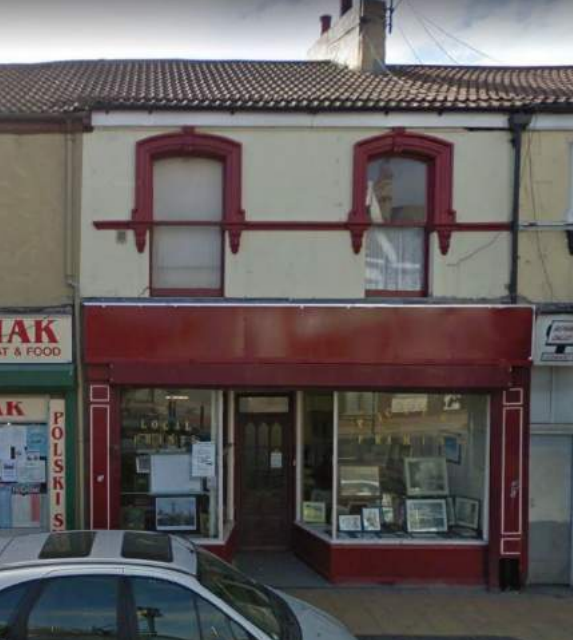
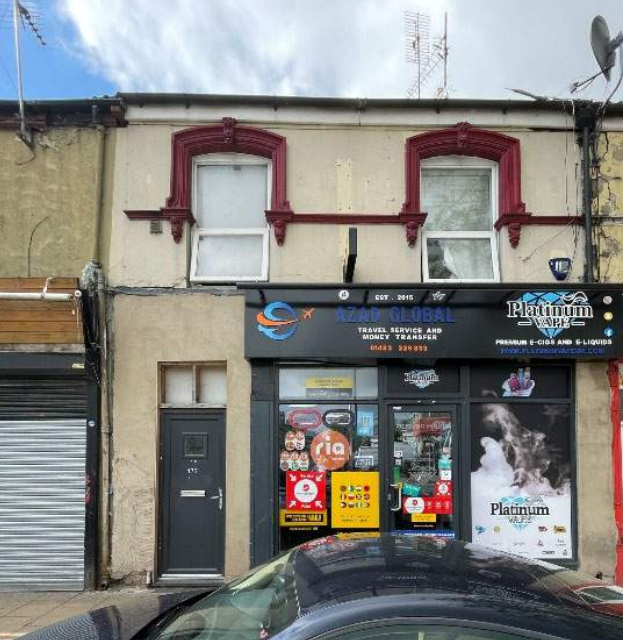
Street: Spring Bank	Address	Azad Globel, 175
Historic Photo from 1905 (Hull Then and Now 1, Paul Gibson)	Historic Photo from 2009 (Google maps)	Current Photo – 11/05/2023 (author)

Building Notes	<p>Built between 1856-1893, No 177 forms part of a group of two buildings including No 179 adjacent. Unlike the adjacent 173 which is one bay wide, No 175 is two bays wide. The group is distinguishable by the decorative stone carved hoodmould lintel and horizontal stone cornice detail adjoining the base of the lintels. The building is two storeys high and two bays wide. The historical photograph dating from 1905 (with 175 towards the left) shows that the shopfront fascia, cornice and console brackets to the shopfronts to the full extent of this urban block including 171, 173, 175 and 179 had a consistent design that was a continuation of the shopfront at the Tap and Spile. This included a flat vertical fascia, deep, decorative cornice with dentil support detail to the underside of the cornice and highly decorative console brackets. The photograph also shows that the cornice was topped by decorative ironwork with decorative support brackets on the top of the console bracket. The shopfront to 179 had the entrance door to the centre of the unit with a recessed door and had a stone carved stall riser. The Spring Bank elevation was rendered at the first floor level and the windows to No 17 and 175 were much simpler in design detail than others in the street, with no decorative stone lintels or cills. The windows</p>

were vertical sliding sash windows with a central vertical bead. The roof finish was slate with timber gutters and decorative timber support brackets at approx. 1m centres and cast iron gutters.
Monitoring Notes	
Recommended Actions
