Muswell Court, Hull

Type 3 Fire Risk Assessment

Prepared for:	Rebecca Franks, Building Safety Manager
Prepared by:	John Askew, Fire Risk Assessor, Holistic Fire Safety
Date:	12/09/2025
Document Reference:	HFS.HCC.MuswellCourt.FRA.3.0

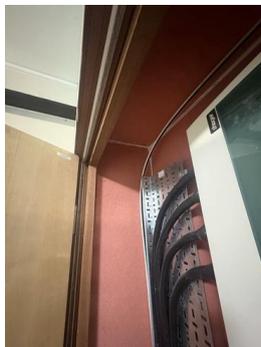
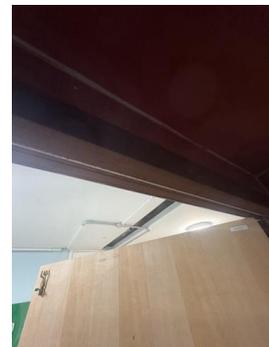
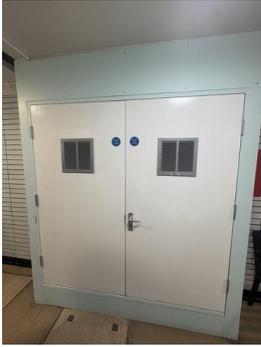
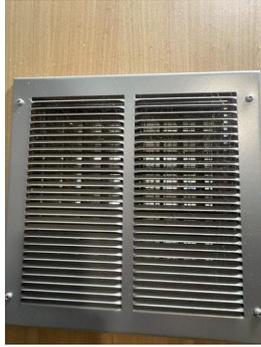
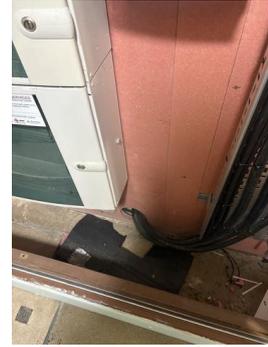
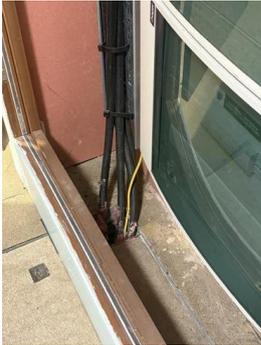
The mains electrical feed is located at the foot of the stair in a partially compartmented enclosure. Boards are mounted on MDF (combustible substrate), services penetrate MDF which could lead to uncontrolled fire spread and there are defects related to fire doors which enclose the area. Given its location at the foot of the single escape stair, it's strongly advised that a complete review of how the area is controlled is undertaken.

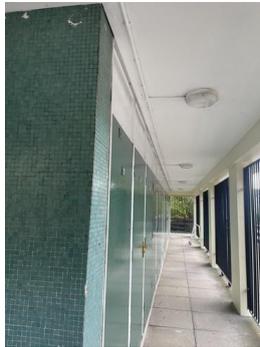
Photo 49

It has been confirmed the insulation present is flammable and should be removed. Any replacement should achieve Class A2-s1, d0 or better.

Remove insulation in areas on the ground floor. Any replacement should achieve Class A2-s1, d0 or better.

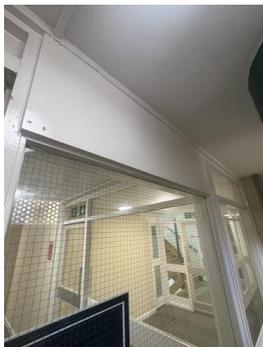
Photo 78

An area of what appears to be plywood with an unknown level of fire resistance is located in refuse chute areas above Georgian wired glass adjacent to the door. Further investigation should be carried out to establish if the material meets a minimum of 30 minutes' fire resistance.

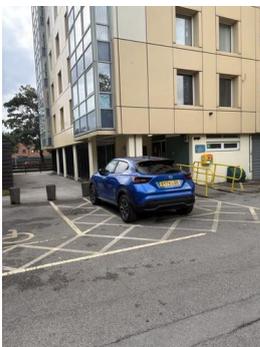
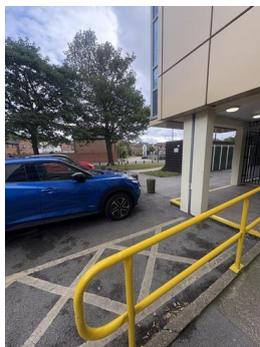
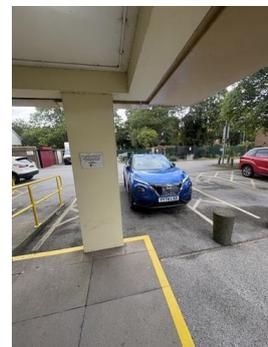
Disabled parking bays are provided outside the main entrance to the front of the building. One of the parking bays is positioned directly under the building which contains an external cladding system. It is reasonably foreseeable that a vehicle fire in this area could result in fire spread to the external cladding system and vertically up the building. It is advised to re-locate the nearest parking bay a sufficient distance away from the building.

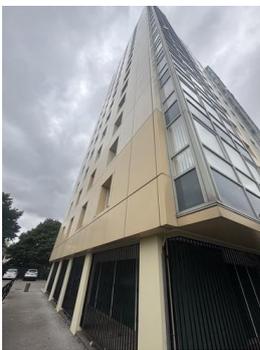
Photo 6

Following the Grenfell Tower tragedy, HCC commissioned UK LPP to complete a series of surveys on external cladding and external wall systems to HRBB's across Hull in 2017. Although findings of surveys confirmed that external walls systems met the functional requirements of Building Regulations and did not contain ACM's, reports provided limited information and potentially fall short of today's benchmarks for a PAS 9980 external wall survey.

Taking into consideration developments within the sector surrounding external wall systems, Holistic Fire Safety feel it would be prudent to undertake further surveys to confirm provisions. Surveys will provide assurances to the Building Safety team that external wall systems are compliant without exposing occupants to unnecessary risk. See 16.2.

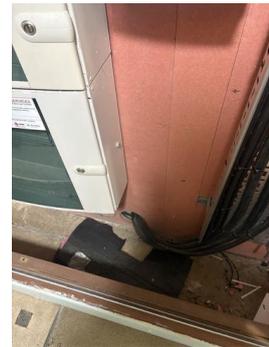
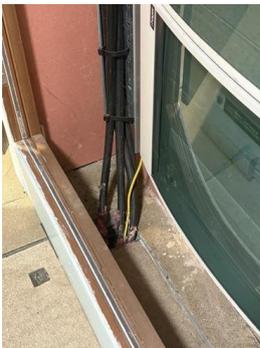
The mains electrical feed is located at the foot of the stair in a partially compartmented enclosure. Boards are mounted on MDF (combustible substrate), services penetrate MDF which could lead to uncontrolled fire spread and there are defects related to fire doors which enclose the area. Given its location at the foot of the single escape stair, it's strongly advised that a complete review of how the area is controlled is undertaken.

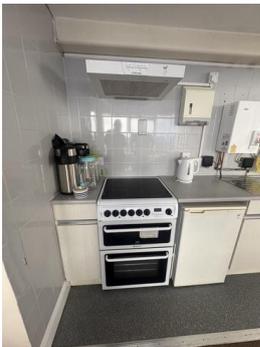
Photo 45

It is considered that HCC is doing all that is reasonable to prevent incidents involving fire from occurring within flats. It was previously advised to remove the electric oven and hob within the communal lounge as any resident occupying the building could maliciously use the appliances. It has been confirmed by HCC that plans are in place to remove the electric oven and hob.

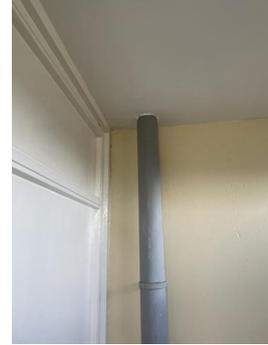
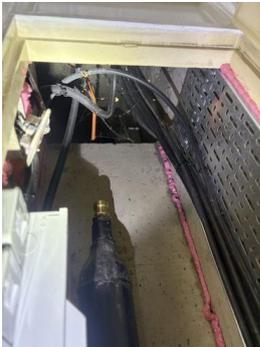
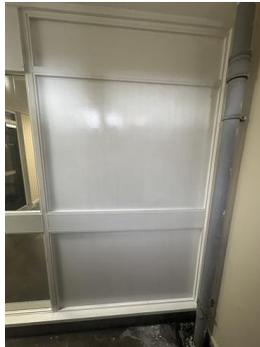
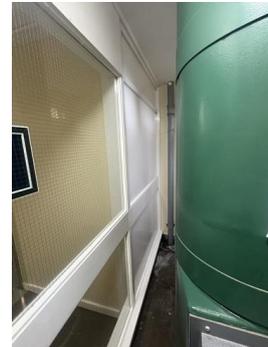
There are however, multiple defects within service risers where services are not adequately fire stopped as they enter adjacent compartments.

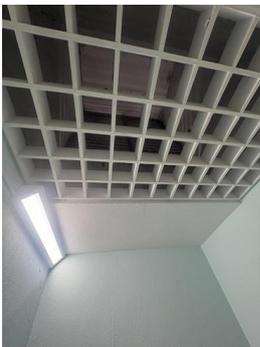
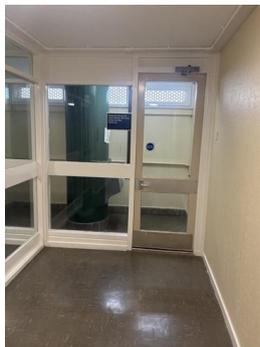
Since the production of the reports, there have been significant changes as a result of the Building Safety Act 2022 with the introduction of the Building Safety Regulator (BSR) with any changes to the building requiring approval. As changes to smoke control in protected lobbies will require approval from the BSR, it is proposed a site meeting is scheduled with HCC, HFS and HFRS to discuss options on a way forward.

The project is currently on hold pending the commencement of structural surveys being carried out on the building.

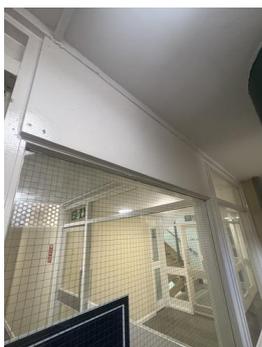
Photo 78

An area of what appears to be plywood with an unknown level of fire resistance is located in refuse chute areas above Georgian wired glass adjacent to the door. Further investigation should be carried out to establish if the material meets a minimum of 30 minutes' fire resistance.

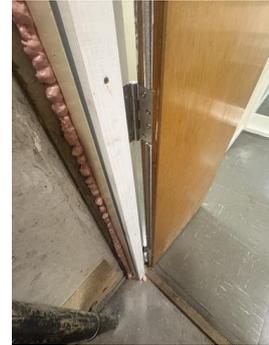
Photo 89

Defects consisted of:

HCC should refer to the fire door inspection report.

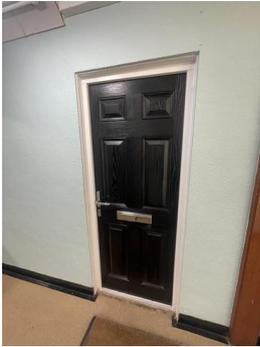
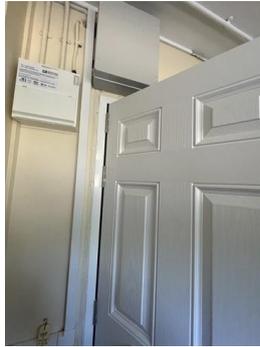
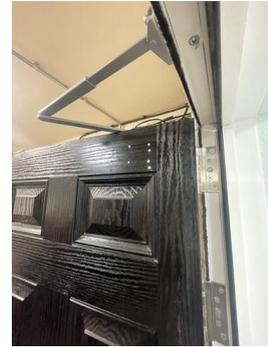
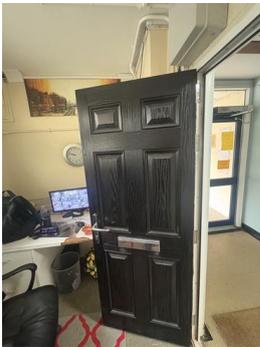
As described previously, there are varying standards of self-closing devices on communal doors ranging from pivot hinges, electronic open/closers to cater for mobility impaired residents and traditional overhead mounted devices.

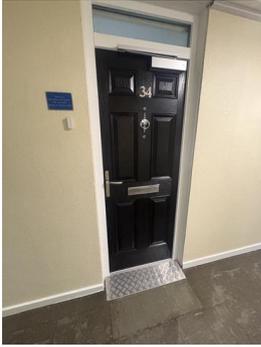
Photo 101

All flat entrance doors have been replaced with third party certified FD30s fire doorsets, which meet the requirements detailed in the ADBVol: 1 Appendix C1 2a for fire resistance and smoke control from both sides, and are fitted with an appropriate positive action self-closing device (BS 1154) and a single action mechanism which does not require the use of a key.

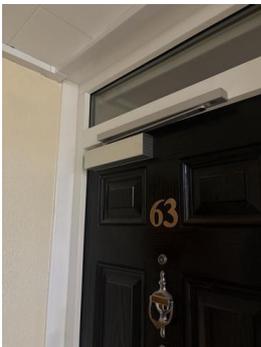
Photo 103

All replacement flat entrance doors are fitted with an appropriate overhead BS 1154 self-closing device.

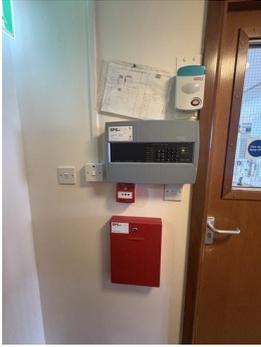
Photo 105

There is a fire alarm panel located on the 14th floor which is linked to detection within the communal lounge only. Should HCC renew automatic fire detection and install provisions within identified risk rooms and escape routes, control indicating equipment should be relocated adjacent to the front entrance on the ground floor.

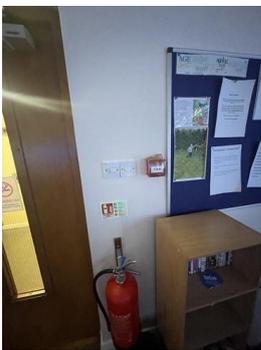
Photo 106

Manual call points are appropriately located within the communal lounge at final exits and outside the staff office.

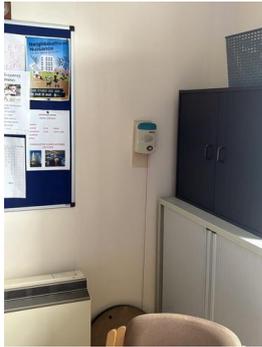
Photo 107

Automatic fire detection and warning within the communal lounge and residential dwellings is linked to the social tele care system, in the event of activation of a detector/pull cord, the alarm receiving centre will be notified.

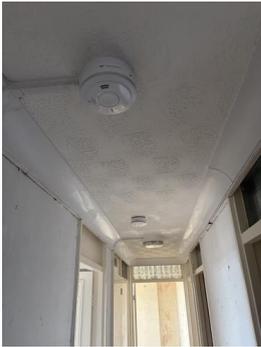
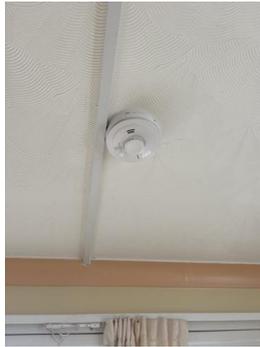
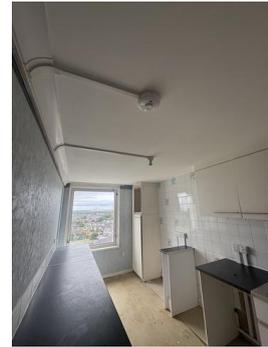
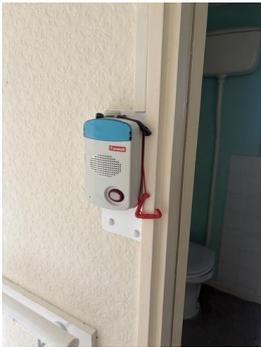
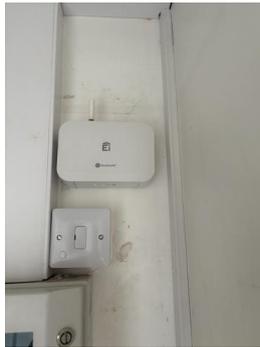
As described previously, the current level of automatic fire detection and warning is not considered adequate for the purpose group and building type. Detection which meet the requirements of a Grade A system which is in accordance with recommendations of BS 5839-1 for a category L4/5 system should be installed throughout communal areas of the block.

HCC confirmed that as part of future proofing of their HRRB's, as a baseline install within void properties, a Grade D1 LD2 fire alarm system is installed. HCC are also working on a system to cover the city fully which sends key information to the cloud. e.g. the system will identify issues in the event of an activation - HCC will be automatically notified. HCC do not currently have sufficient resources to monitor activations however, plans are being put in place to achieve this.

Install a Grade A automatic fire detection and warning system which is in accordance with recommendations of BS 5839-1:2017 for a category L4/5 system + variations. Operate as a silent system which is directly linked to the alarm receiving centre.

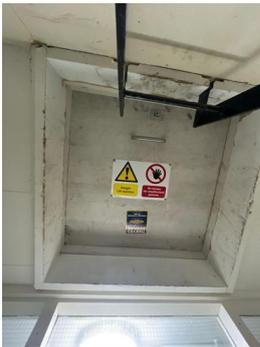
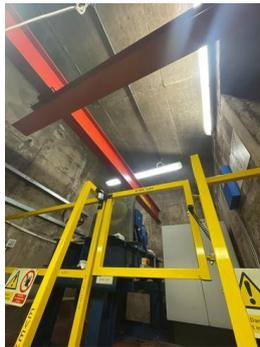
Hazard warning signage is in place on the external face of risk areas such as the lift motor room and the external electrical substation. Each individual ESU within the building is also provided with hazard warning signage to warn both occupants and responding fire crews.

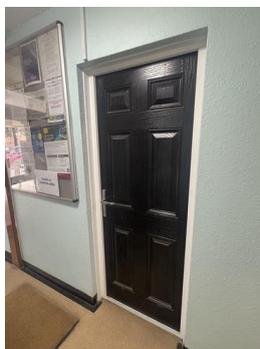
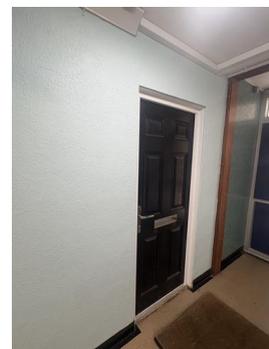
Ancillary room doors were observed to be missing appropriate fire safety signage e.g. 'Fire door, keep locked' 'Fire door, keep shut'.

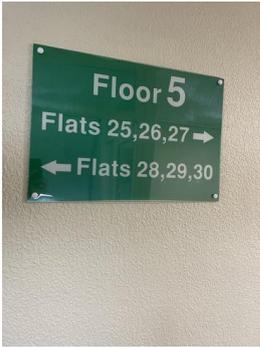
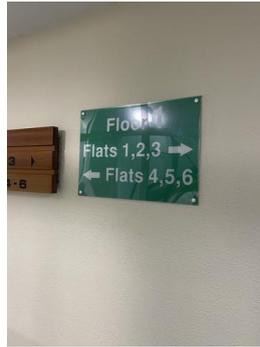
It is a requirement that floor numbers be clearly marked on each landing within the stairways and in a prominent place in all lobbies in such a way as to be visible both in normal conditions and in lowlighting or smoky conditions.

HCC are undertaking a procurement exercise to appoint a contractor to design and install an improved Wayfinding Signage system.

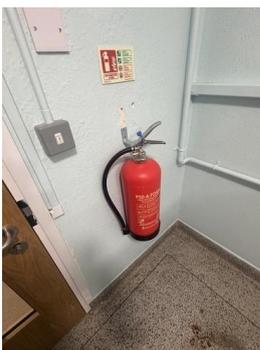
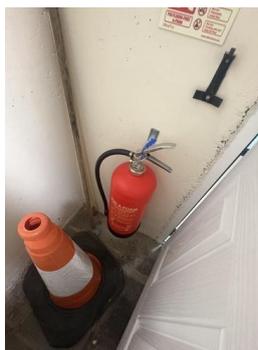
Extinguishers provided are composite P50 foam extinguishers.

Fire extinguishers were installed in 2024 and therefore due for their annual inspection soon. Consideration is being given to the provision of training and who this task of inspection will be allocated to.

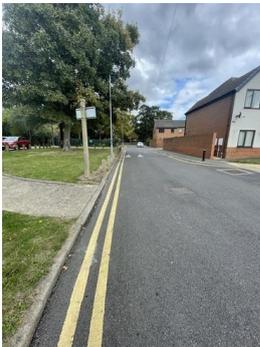
Photo 132

Current provisions provide a minimum of 3.7m in width and 4m in height to allow for unrestricted access for pumping and high reach appliances (ADB Vol 1. B5 Table 13.1).

There are no obvious signs of weight restrictions or anything that could impact appliance approach and positioning. The nearest point at which a fire appliance could position to the building is <18 meters.

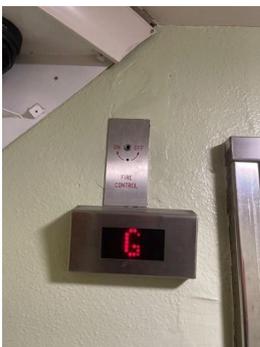
Photo 136

Lifts at Muswell Court are not designated firefighting lifts, however there is an agreement in place that lifts would be utilised by HFRS in the event of an incident.

Signage within communal areas clearly states that lifts are not to be used in the event of an incident by relevant persons and it was confirmed that the lift returns to the ground should the alarm sound within the communal lounge.

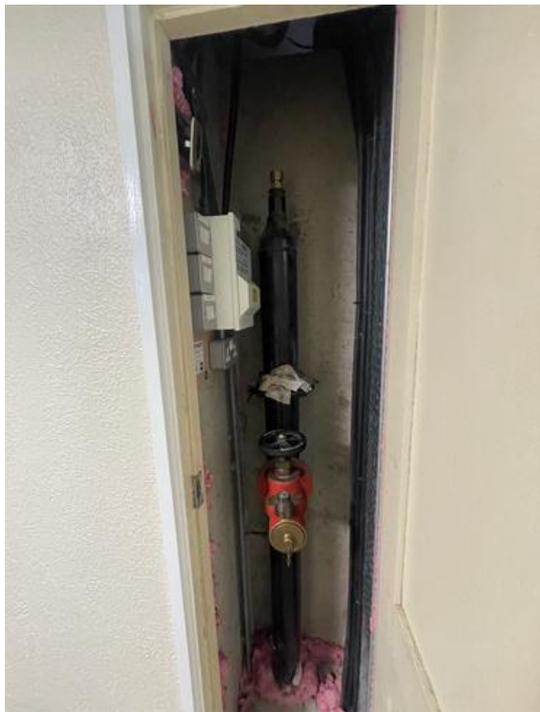
Photo 134

Dry riser enclosures have electrical distribution boards and electrical sockets located within them. Distribution boards are metal and RCD protected at the board and the main electrical supply. Electrical sockets are to be replaced with IP66 rated waterproof sockets.

Replace electrical sockets with IP66 rated waterproof sockets.
