Bayswater Court, Hull

Type 3 Fire Risk Assessment

Prepared for:	Rebecca Franks, Building Safety Manager
Prepared by:	John Askew, Fire Risk Assessor, Holistic Fire Safety
Date:	06/10/2025
Document Reference:	HFS.HCC.BayswaterCourt.FRA.3.1

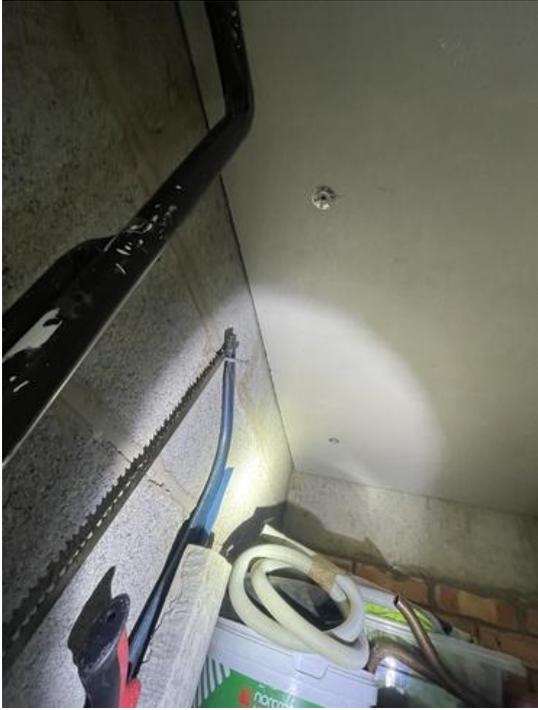
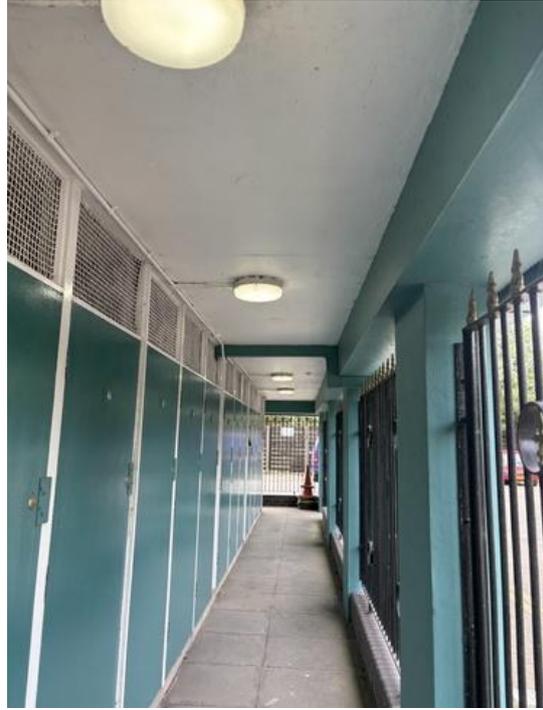
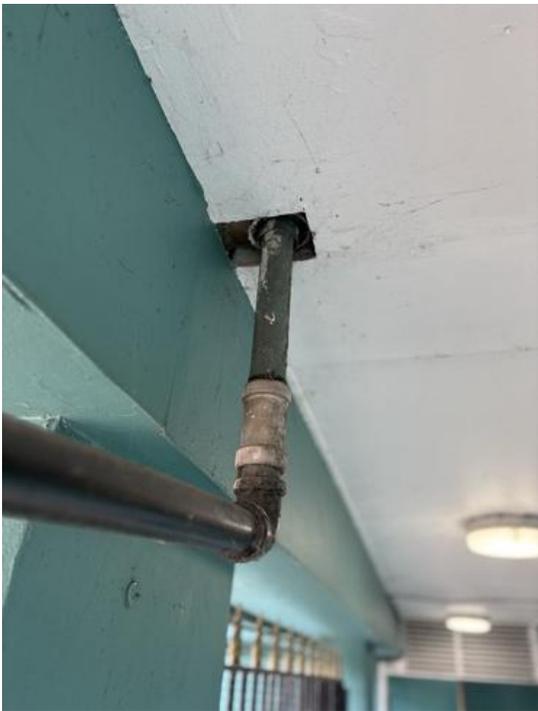
Photo 37

Photo 38

Photo 39

It has been confirmed the insulation present is flammable and should be removed. Any replacement should achieve Class A2-s1, d0 or better.

Photo 37

Photo 38

Photo 39

Remove insulation in areas on the ground floor. Any replacement should achieve Class A2-s1, d0 or better.
