113 - 224 Cambridge Street, Hull

Type 3 Fire Risk Assessment

Prepared for:	Rebecca Franks, Building Safety Manager
Prepared by:	John Askew, Fire Risk Assessor, Holistic Fire Safety
Date Submitted:	11/12/2025
Document Reference:	HFS.HCC.CambridgeStreet2.FRA.3.0

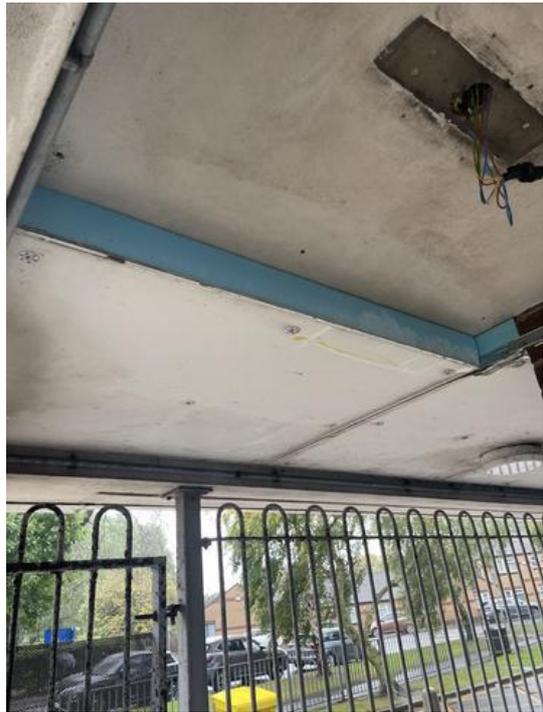
Photo 36

It has been confirmed the insulation present is flammable and should be removed. Any replacement should achieve Class A2-s1, d0 or better.

Remove insulation in areas on the ground floor. Any replacement should achieve Class A2-s1, d0 or better.

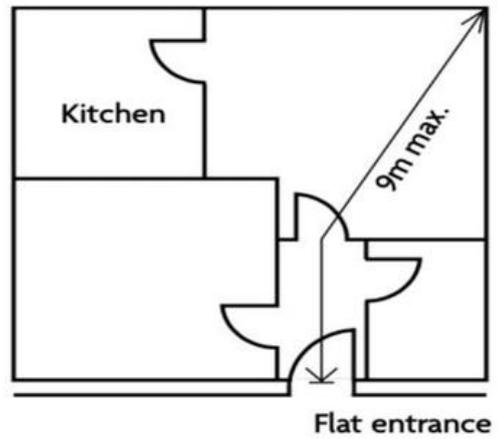
ADB B1 Diagram 3.3

Photo 55
