**Hull**

**Marfleet Village Conservation Area  
Character Appraisal & Management Plan  
Adopted October 2025**

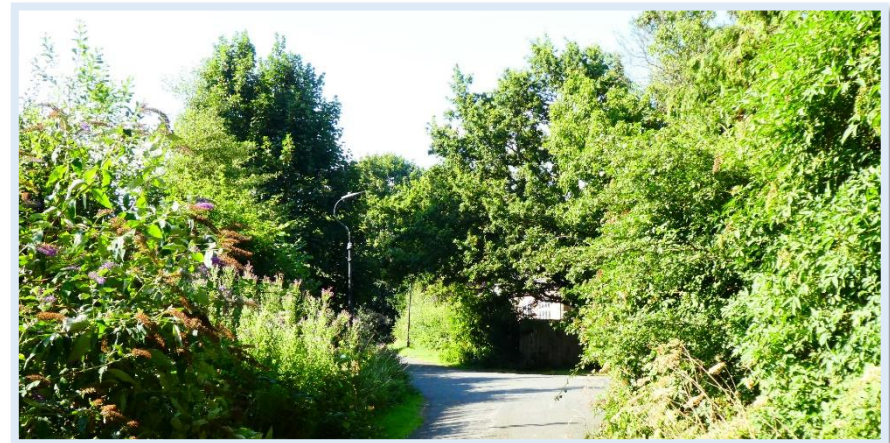
*Figure 1 - Rural character of Church Lane.*

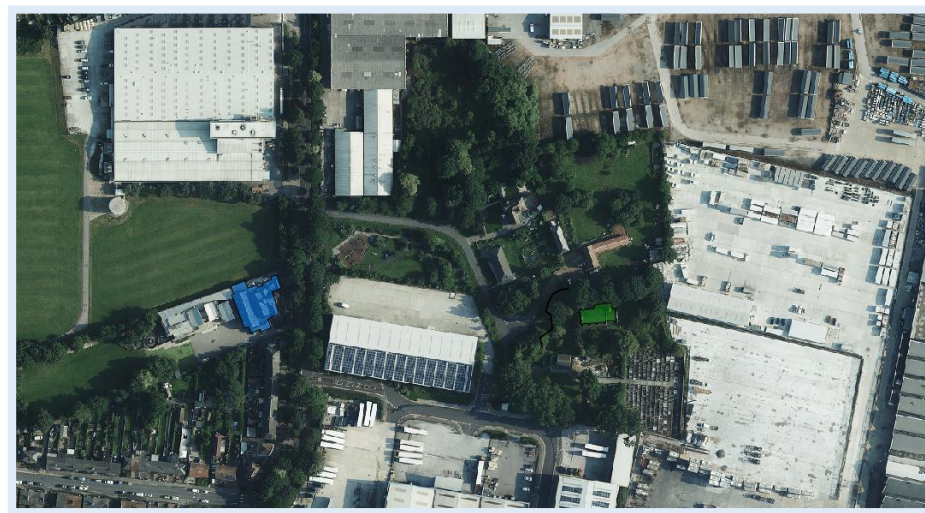
In combination the three planning applications have resulted in the loss of the former area of Medieval field system to the east of Marfleet Village and its replacement with industrial storage land and buildings. Accordingly, the area no longer forms a part of the special interest of the Conservation Area. It is proposed to remove the now industrial land from the designated boundary of the Conservation Area.

Figure 10 - Loss of green setting to the Conservation Area shown in 2024.

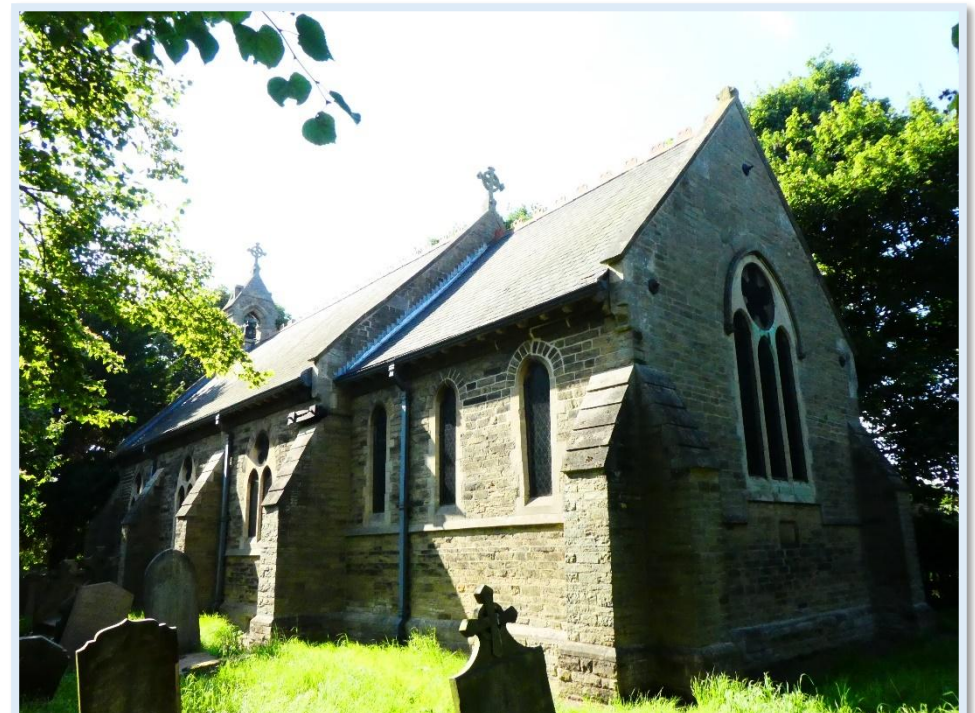
structure being re-built in 1793, to the designs of George Peyton. The 1883-4 re-build internally incorporates the Octagonal Font, Bell, and Wall Tablets from the 18<sup>th</sup> century building. Historic values associated with Church is the connection with Colonel Gerald Smith, as commemorated on its foundation stone. Colonel Smith became the director of the Hull Dock Company and first Chairman of the Hull Barnsley & West Riding Junction Railway Dock & Co; builders of Alexandra Dock. Smith later rose to become an MP and the first non-professional Governor of Western Australia.

Figure 14 - St Giles Church.

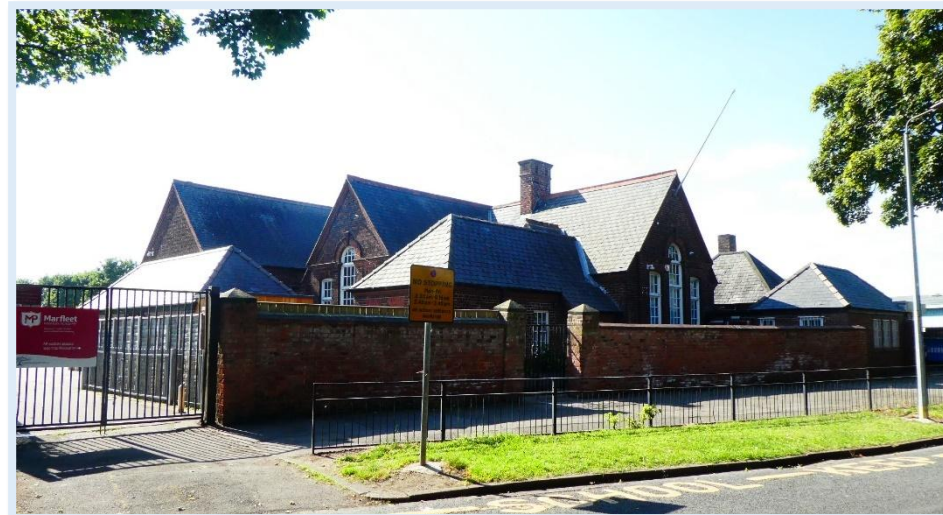
– The Education Act of 1870 started a period of construction of ‘Board’ Schools to provide national free education. In Hull, 37 schools were constructed by the Hull School Board. Of these 15 survive, of which 8 remain in educational use, including Marfleet Primary School. Marfleet School is the only single-story Board School introduced in Hull, reflecting its rural located. The School is constructed in the ‘William & Mary’ revival architectural style, to the designs of William Botterill, in the typical red brick and slate, material style of the period. In 2004 an extension was added to the school, which won the 2004 RIBA White Rose Awards for Design Excellence. The building represents the 19<sup>th</sup> century developments of Marfleet, as influenced by national legislation.

*Figure 15 - Marfleet Primary School*

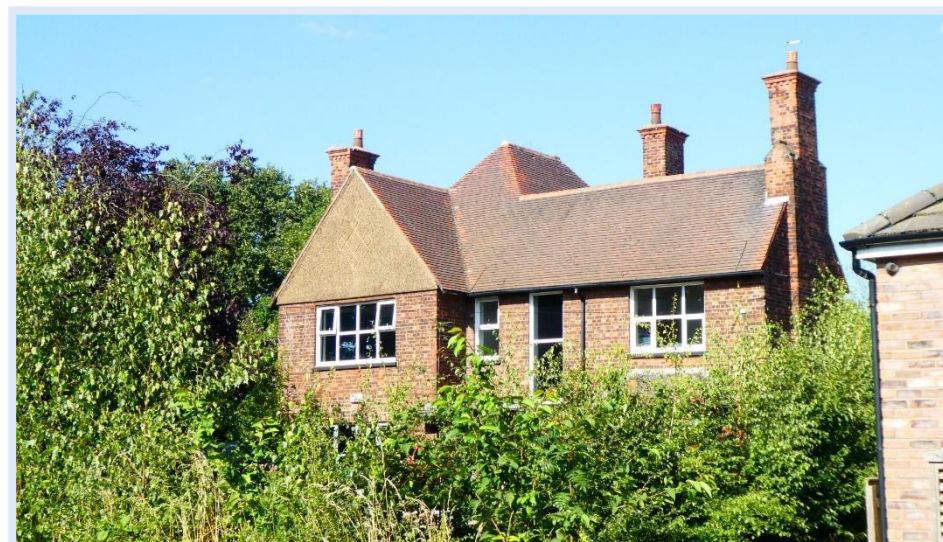
**Vicarage** – A vicarage was first mentioned in Marfleet in 1650, with a Parsonage showing on the 1888 survey. The current building was built in 1908 to the designs of Brodrick, Lowther and Walker; prominent Yorkshire based architects. The building is constructed in the red brick style of architecture of the period, with ‘Rosemary’ tile roof. An attractive feature of the building it is distinctive chimney stacks. The previously noted multi-paned over single paned sash windows, as referenced in 2005, have been removed from the building since time of last survey. The building positively contributes towards to the late Victorian and Edwardian character of the Conservation Area. The building is now a private residence.

*Figure 16 - The Former Vicarage*

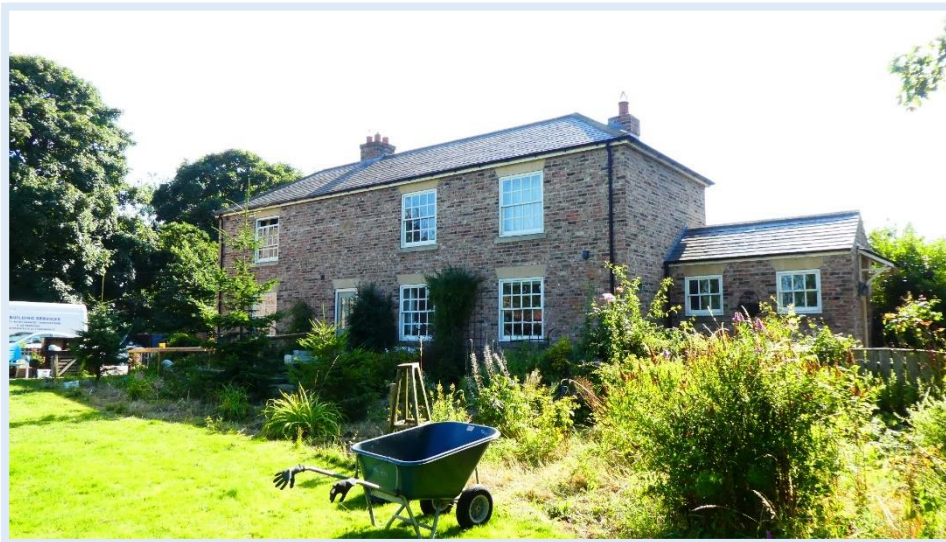
**Brickyard Cottage & Outbuildings** – The development is located on the site of the historic Brickyard cottages, which are shown on the 1850 Ordnance Survey. The cottages were named after the former Brickyard historically located to the east of the Conservation Area. At time of last survey the collection of buildings were described as “stand forlorn and derelict”. The site has since been re-developed and is a positive example of a re-developed 19<sup>th</sup> century cottage. The site also provides positive examples of rural outbuildings, albeit re-built, which would have previously been located within the farms forming Marfleet Village.

Figure 17 Brickyard Cottage

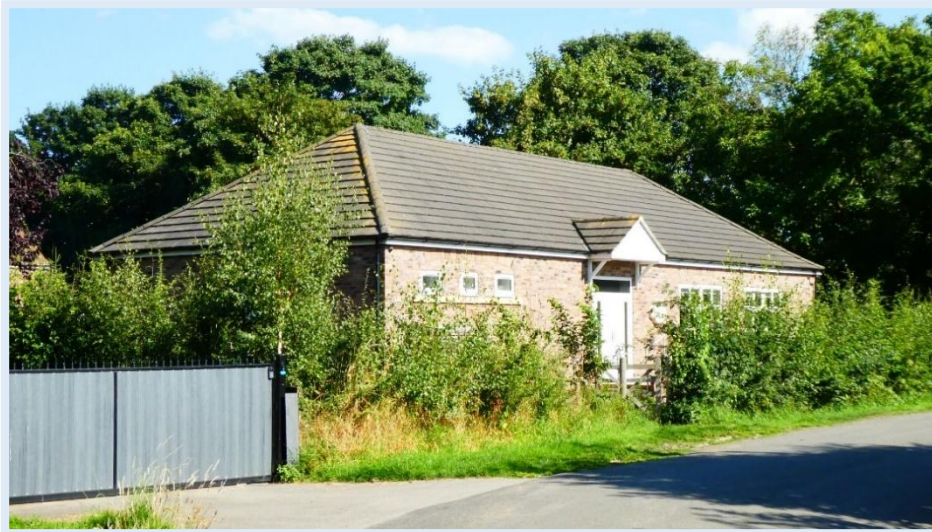
**Church Hall** – At time of last survey the Conservation Area included a timber-built church hall, located to the west of the Vicarage, along Church Lane. This has been replaced in c.2015 by a brick-built village hall. The building does not contribute towards the special interest of the Conservation Area.

Figure 19 - c.2015 Church Hall

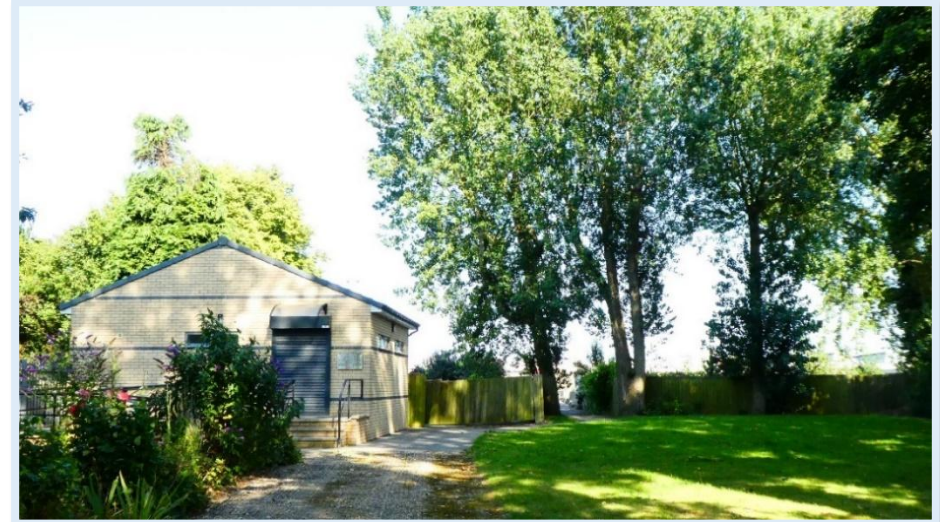
**Hebrew Prayer Hall, Church Lane** – Since time of last survey the 1972 prayer hall has been demolished and replaced by a new building post-2015. The replacement building does not contribute towards the special interest of the Conservation Area.

Figure 20 Entrance to the Hebrew Cemetery and Hebrew Prayer Hall.

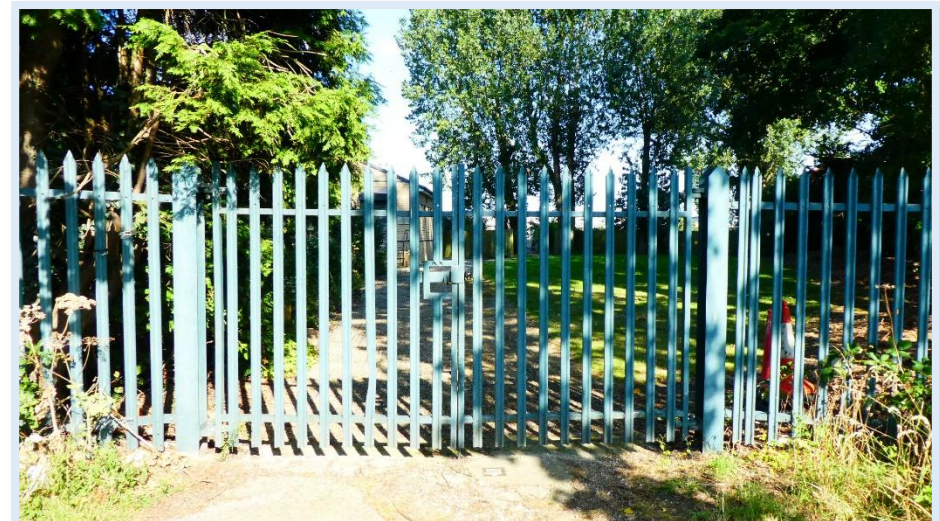
Figure 21 - Negative boundary treatment to the Hebrew Cemetery.

**Negative elements** of the Hebrew cemetery include the addition of a palisade fences around in boundary, in c.2000. The fence is prominent in views along Church Lane and within the setting of St Giles' cemetery. Around this time decorative boundary gates were lost, which were of architectural interest. The setting of the Churchyard has also been harmed by the visible encroachment of industrial development within its backdrop.

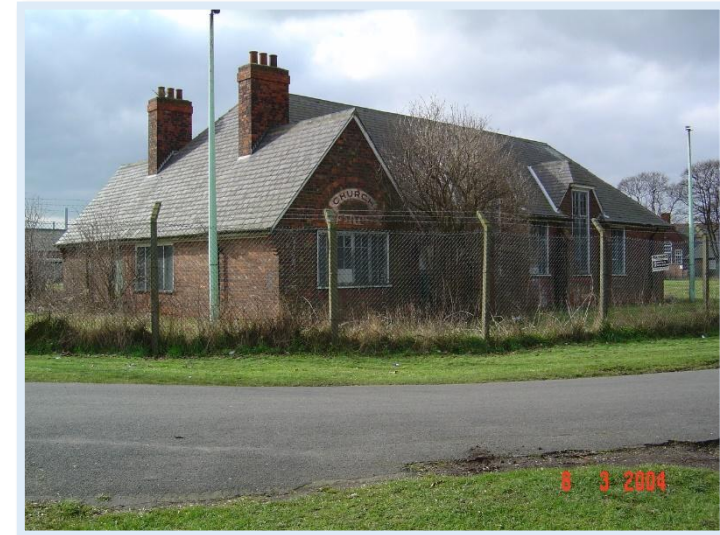
*Figure 23 - The Church Institute, photographed in 2004.*

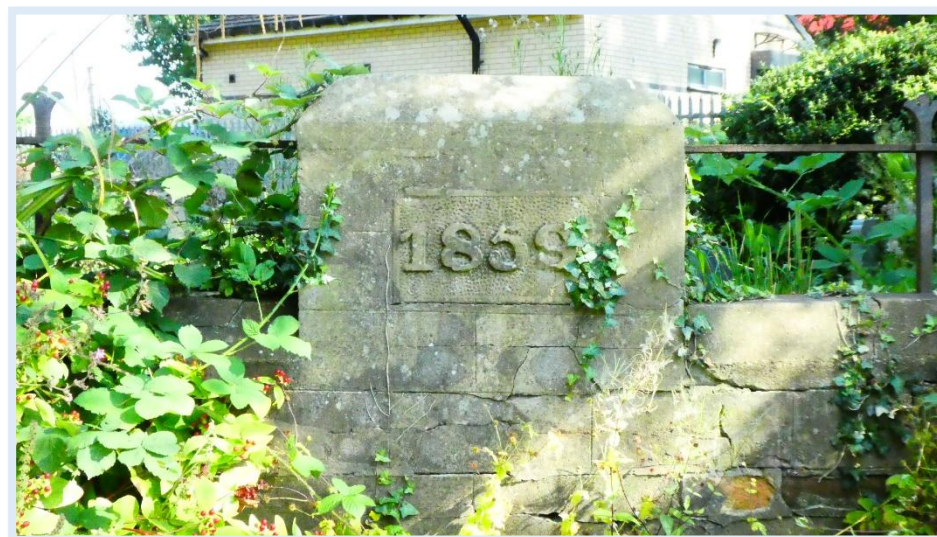
The Church Yard is enclosed by a crenelated wall of coursed square stone, partly rendered, with ashlar dressings and short and short lengths of iron railing between coped merlons (which are listed separately to the Church, as per Appendix 6). The Church Yard was extended following the demolished of the Reading Rooms in 1953. The boundary is typical of the 19<sup>th</sup> century and forms a key aspect of the 19th century rural character of the Conservation Area. A date stone within the boundary wall, is potentially the date stone of the former reading room and re-laid within the boundary wall.

*Figure 25 - Date stone located within the Grade II listed boundary wall to the Church Yard.*

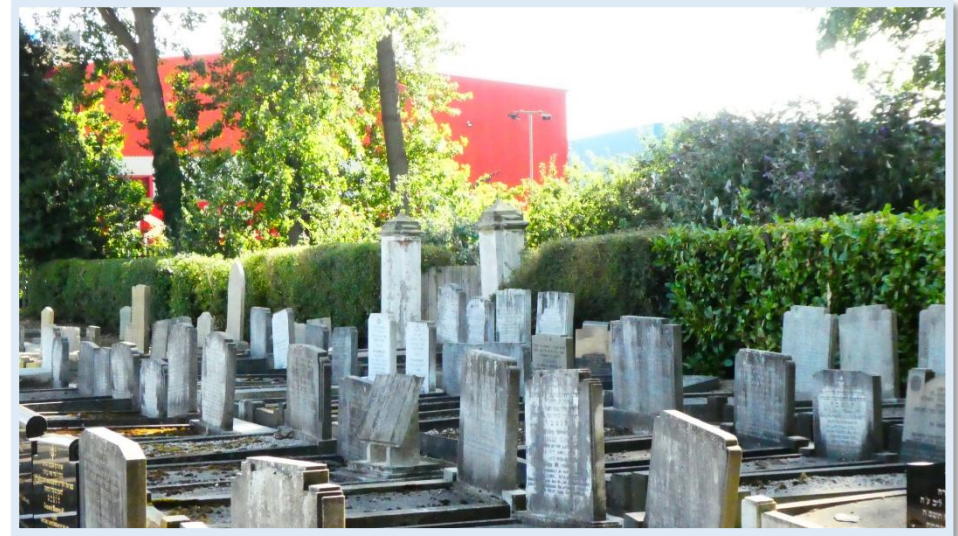
**Hebrew Burial Ground, Church Lane** – The burial ground, at its western end, encompasses the site and former gardens of Crosby House or Hall. A building was erected in 1889 by a Miss Crosby and was used for public meetings, entertainments etc. The house and gardens, along with some land to the east, were purchased in c.1930 by the Hull Old Hebrew Congregation. The land to the east became their burial ground and it is now densely populated with headstones, many bearing the Star of David and inscriptions in Hebrew, in north/south rows. Dividing the burial ground with the old Crosby House gardens is a high privet hedge with low cast iron railings at its base. A small central gap in the latter, guarded by two Victorian gate piers, affords access to both halves of the cemetery. Crosby House was initially used as a prayer room by the Jewish Community, with the remainder used as cottages, before their demolition in 1972 and 1958, respectively. A new prayer hall was constructed in 1972-3, which was subsequently replaced in 2015. Elements of the old 'prayer room' forms part of the southern boundary of St Giles' churchyard. The churchyard is representative of Hull's Jewish Heritage.

*Figure 26 - The Hebrew Burial Ground, with retain c.19th century gate posts.*

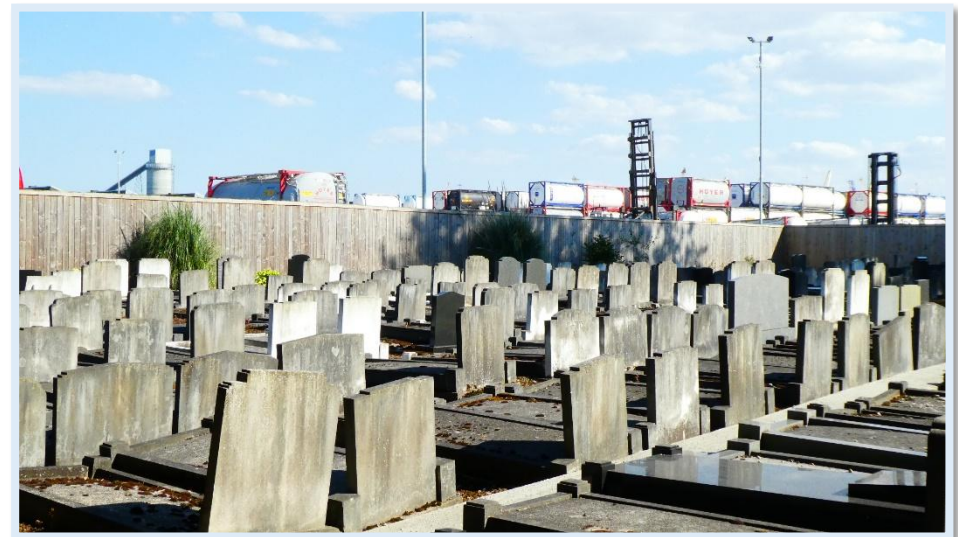
*Figure 27 - Industrial backdrop to the Hebrew Cemetery.*

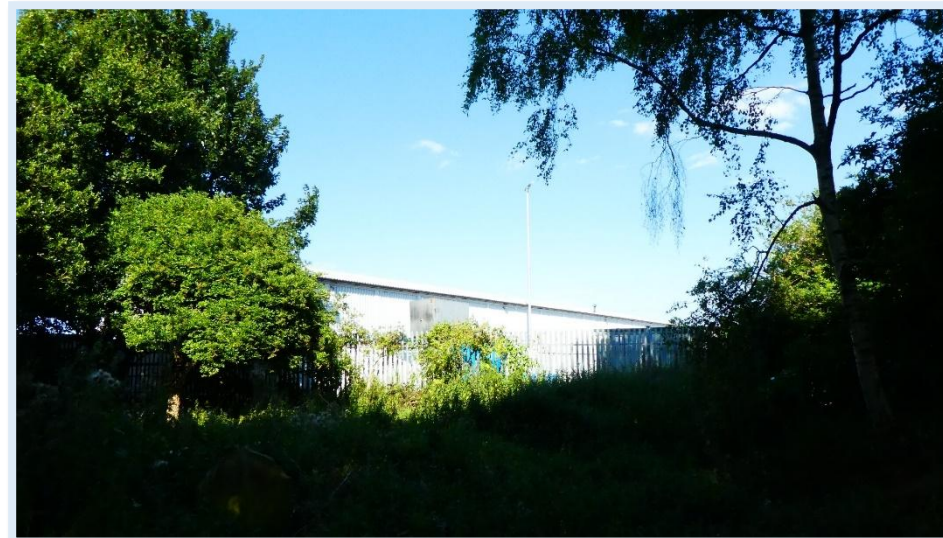
**East** - At time of designation the setting of the Conservation Area was formed by agricultural land to its east. The area of land was a remnant of the medieval open field system, enclosed by an Act of 173, and was brought into the designated boundary of the Conservation Area in 2004. In 2005 the described as containing ridge and furrow, which formed part of the medieval landscape of Marfleet Village. Subsequent development in 2004 and between 2018 and 2020 has removed the remaining agricultural landscape and mature trees, located to the east of Conservation Area. In its place hard landscaping and industrial buildings have been introduced. The setting to the east of the Conservation Area now consists of an industrial landscape, with all previous heritage values removed. The development has resulted in a negative setting to the eastern boundary of the Grade II listed St Giles Church.

*Figure 33 The setting to the east of the Conservation Area & St Giles Church Yard.*

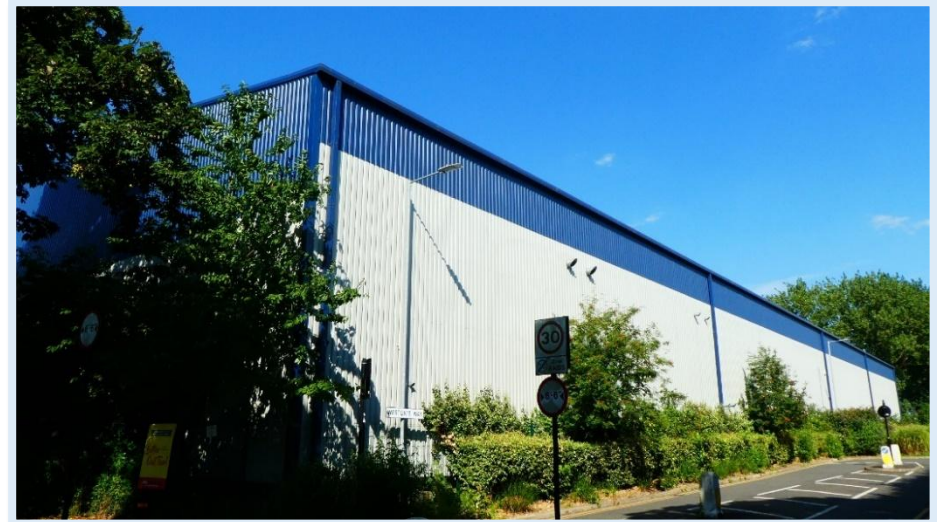
To the south of the pre-2024 Conservation Area and to the north of Hedon Road in the 1980s the Humbrol factory was constructed, introducing industrial development to the south of Marfleet Village. The Humbrol factory was demolished in the early 2000s and replacement industrial development, consist of large in scale warehouse. Their scale dominates the setting of the south of the Conservation.

Figure 35 Industrial development located to the South of the Conservation Area, and previously within its designated boundary. As viewed along the newly created Westgate Lane.

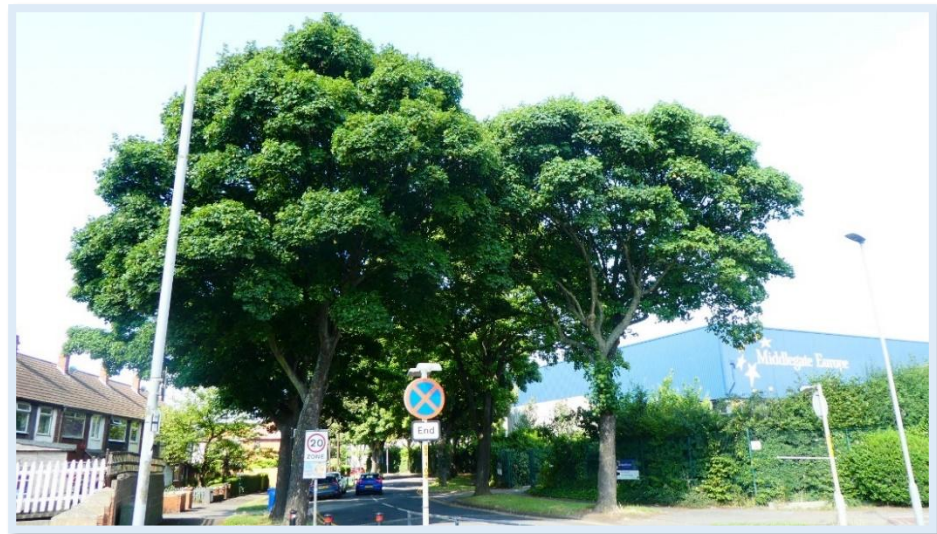
Figure 36 The Entrance to the Conservation Area along Marfleet Lane, with dominant industrial backdrop.

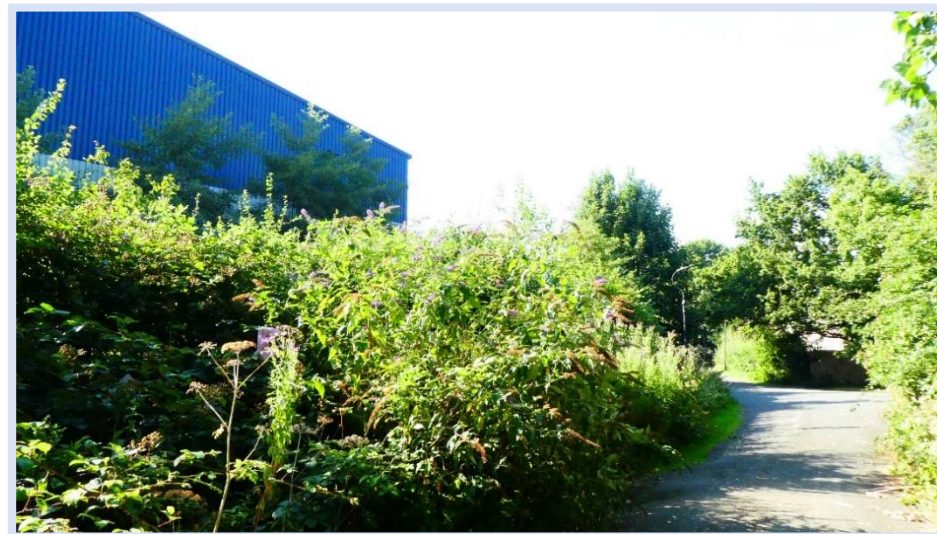
Figure 43 Negatively impacted view along Church Lane

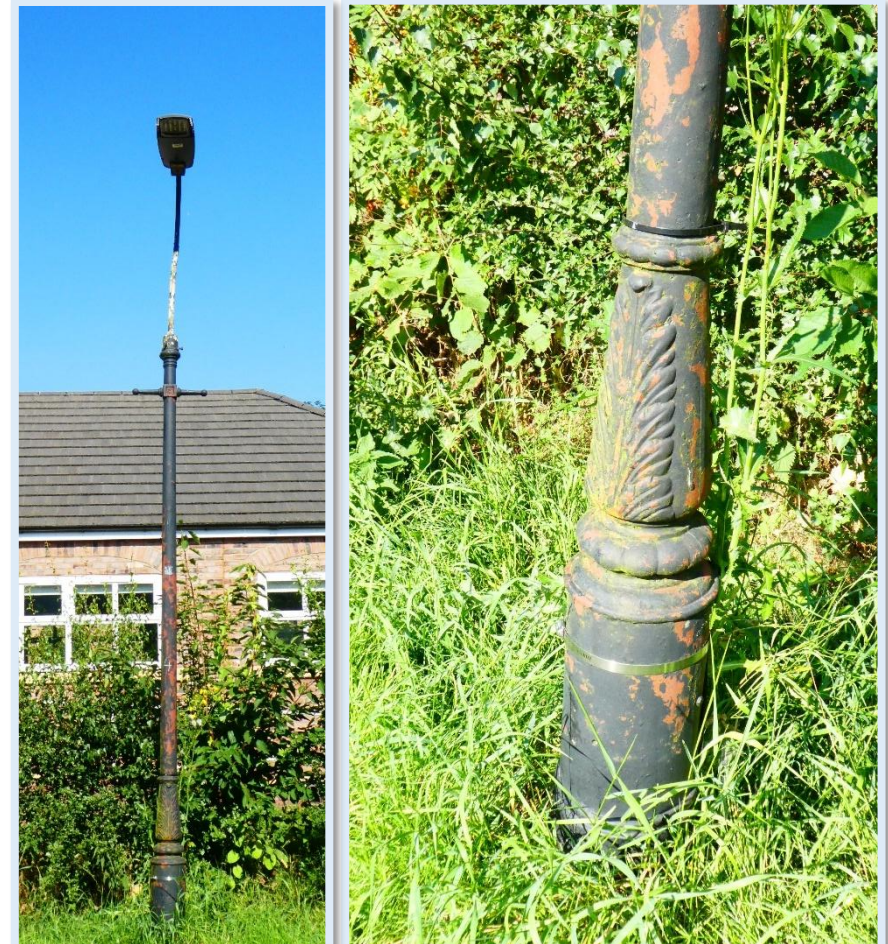
**11. Street Furniture** - Where it survives, historic street furniture adds to the character, richness and variety to the street scene. Unfortunately, such furniture is now rare within the appraisal area which makes the retention of the few surviving examples, such as the 7 gas lamp columns along Church Lane, all the more important. All the columns, however, with their distinctive cross bars (lamplighters ladder rests) and decoration, including fleurons, acanthus leaves and Hull's armorial ensign, are without their original lanterns.

*Figure 55 - Retained c.1950s Lampstand.*

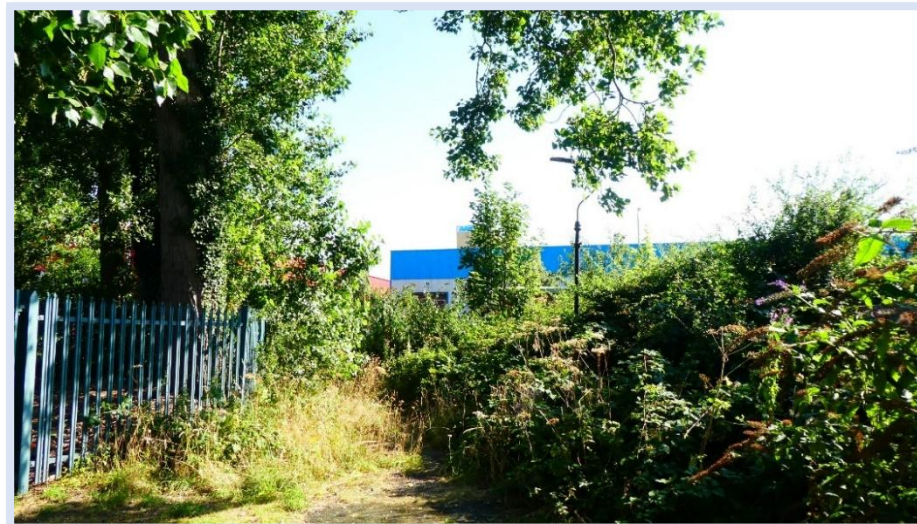
- The visibility of the palisade fence surrounding the Hebrew Cemetery which is visible within the Church Yard.
- When existing from the west end of the Church through the entrance Gate prominent back drop of industrial warehouse.
- Visibility of modern industrial development when travelling along Church lane.

*Figure 56 - Presence of in-appropriate boundary treatments and modern industrial backdrop to the Conservation Area.*

The remaining condition of the Conservation is **fair**, but its special interest has been eroded by development pre-2024 boundary and within its setting. In considering developments which impact upon the Conservation Area and its setting the following policies should be considered:

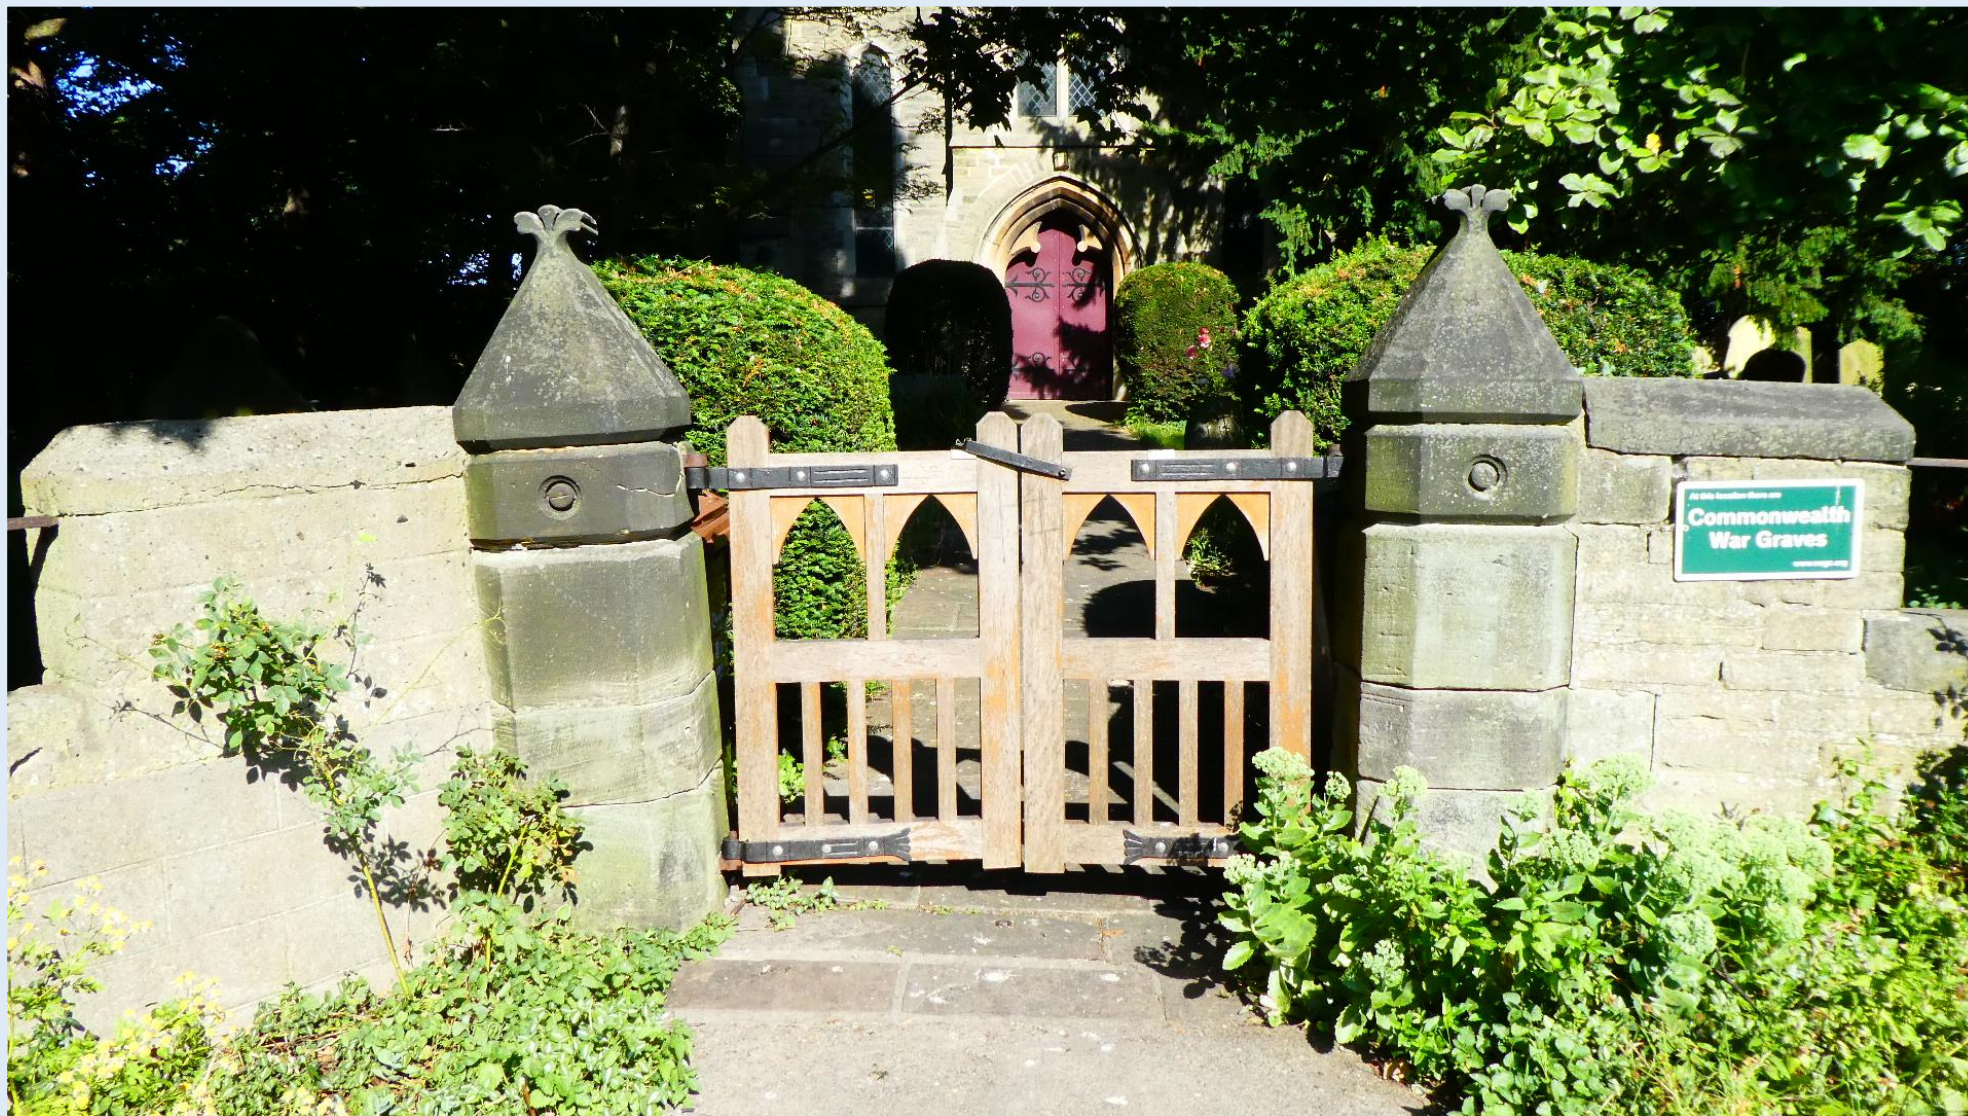
*Figure 75 - Grade II listed boundary wall and Gate to St Giles' Church.*
