# Hull City Council Flood Investigation Report

## City Wide Flash Flooding - August 2012

25 August 2012  
Investigation Ref No HCCFWMAS190001

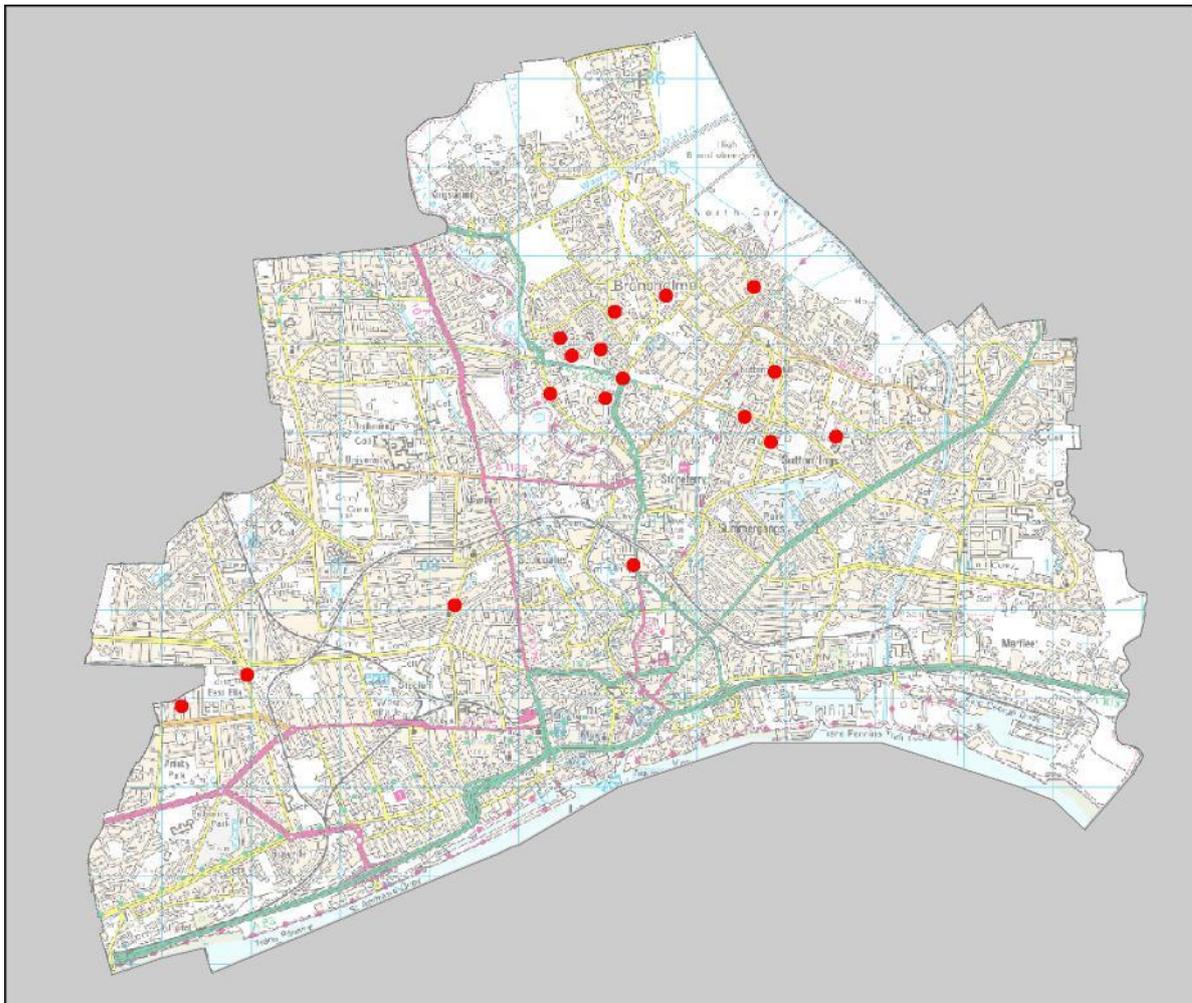
**Figure 1 - Indicative map of flooded locations 25<sup>th</sup> August 2012.**

The flood event of 25<sup>th</sup> August 2012 was caused by an intense storm localised to the city, surrounding areas have not reported similar incidents from this event and similarly many of the other events which caused problems in surrounding areas did not impact significantly on the city. Problems were reported across the city but are broadly concentrated in a 'central belt', see figure 1.

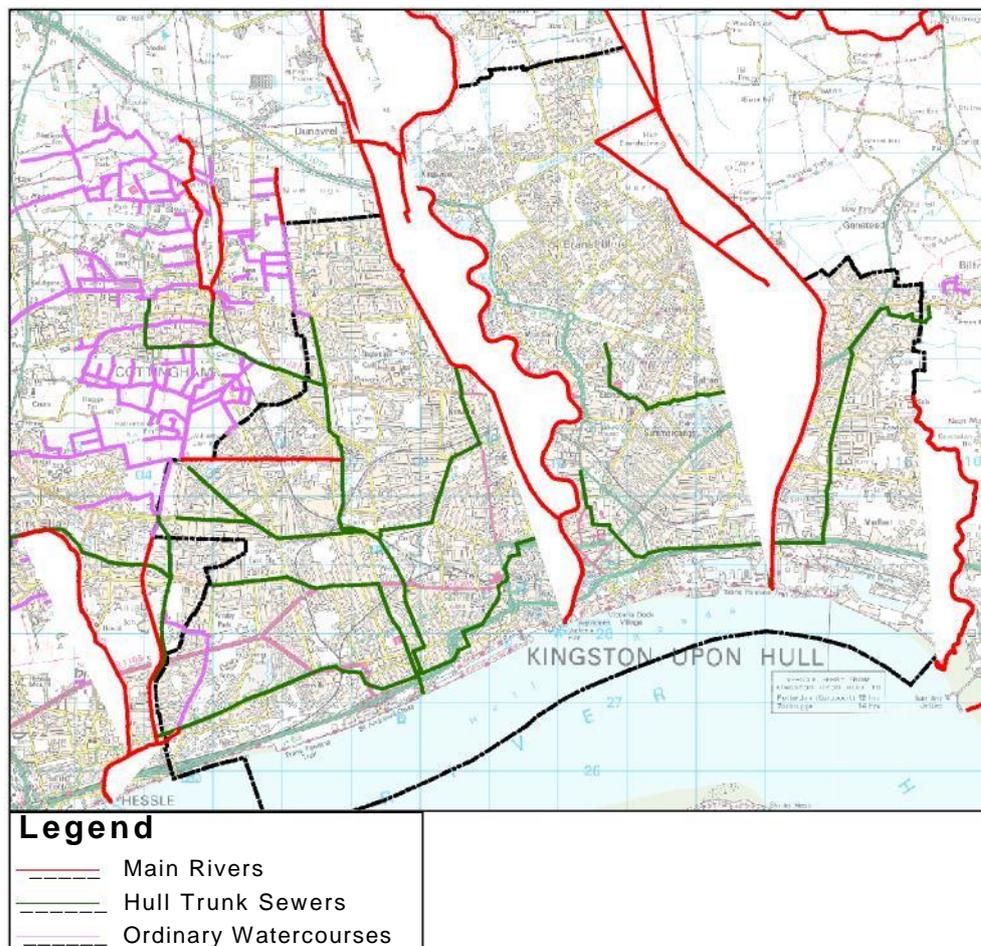
**Figure 2 Hull City Drainage Systems**

The Hull drainage system is a complex interaction of rivers, streams, ditches, dykes and sewers. Many streams and ditches flow into the city from the surrounding East Riding of Yorkshire Council area and flow through the city in a mixture of Main Rivers permissively managed by the Environment Agency (EA) and open drains and streams (Ordinary Watercourses permissively managed by local authorities, or often the responsibility of riparian landowners) but much of the system is culverted below ground.

The vast majority of the system is also classed as part of the sewerage system for the city as it passes flows derived from surface water drainage onto the hard surfaces across the city. The sewerage system is pumped in times of flood through a combination of pumping stations to the treatment works in the east of the city at Salt End, the pumping stations at West and East Hull are key to this operation. The Bransholme area of the city is served by a separate surface water drainage system which discharges flows into a storage lagoon before outfalling to the River Hull. Yorkshire Water is responsible for the cities sewerage system.

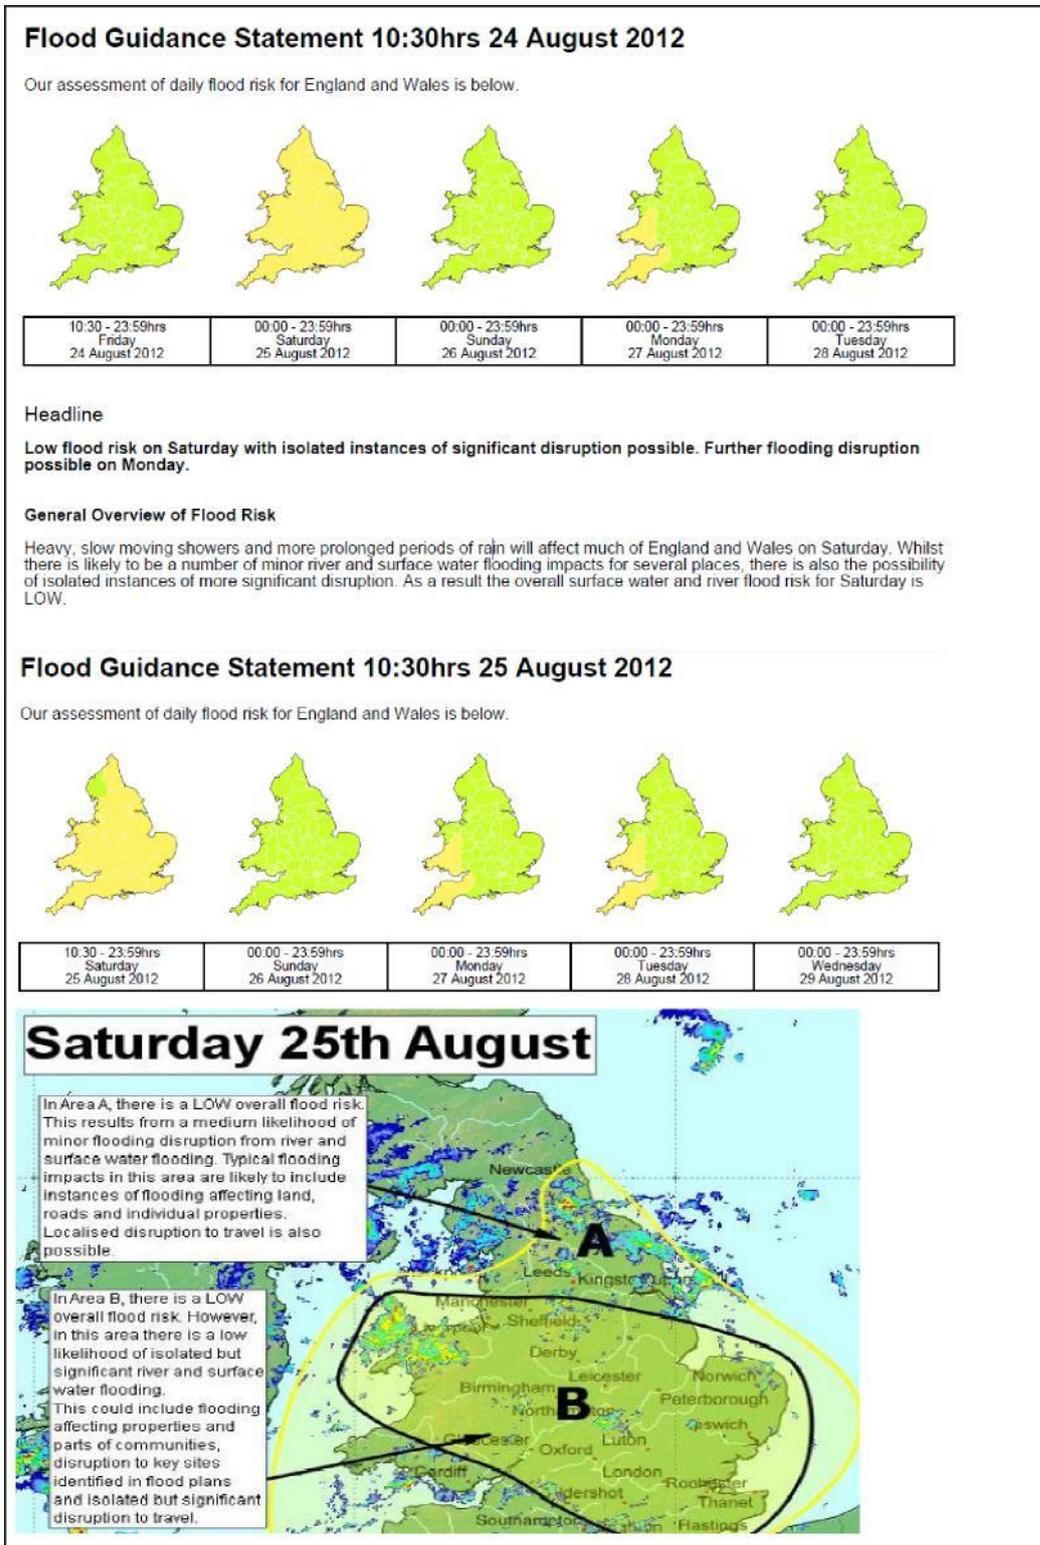
**Figure 3 Selected outputs from the EA and Met Office Flood Guidance Statement**

No targeted warnings were in force as this was a surface water event, in times of forecasted intense rainfall the EA and Met Office issue Weather Warnings and Flood Guidance Statements, both reports were received by the council at various frequencies leading up to the event and did not indicate a heightened

risk or requirement to mobilise resource, a selection of outputs from the report is highlighted in figure 3 below:

The council received advance weather warnings for the 25<sup>th</sup> August 2012 event as detailed in section 2.2, the warnings showed a limited risk and no special preparations were made because of this.
